# **Nomad**

## ALERT SERVICE BULLETIN

## ANMD-27-44

### FLIGHT CONTROLS — FLAPS — COMPONENT SAFE LIVES

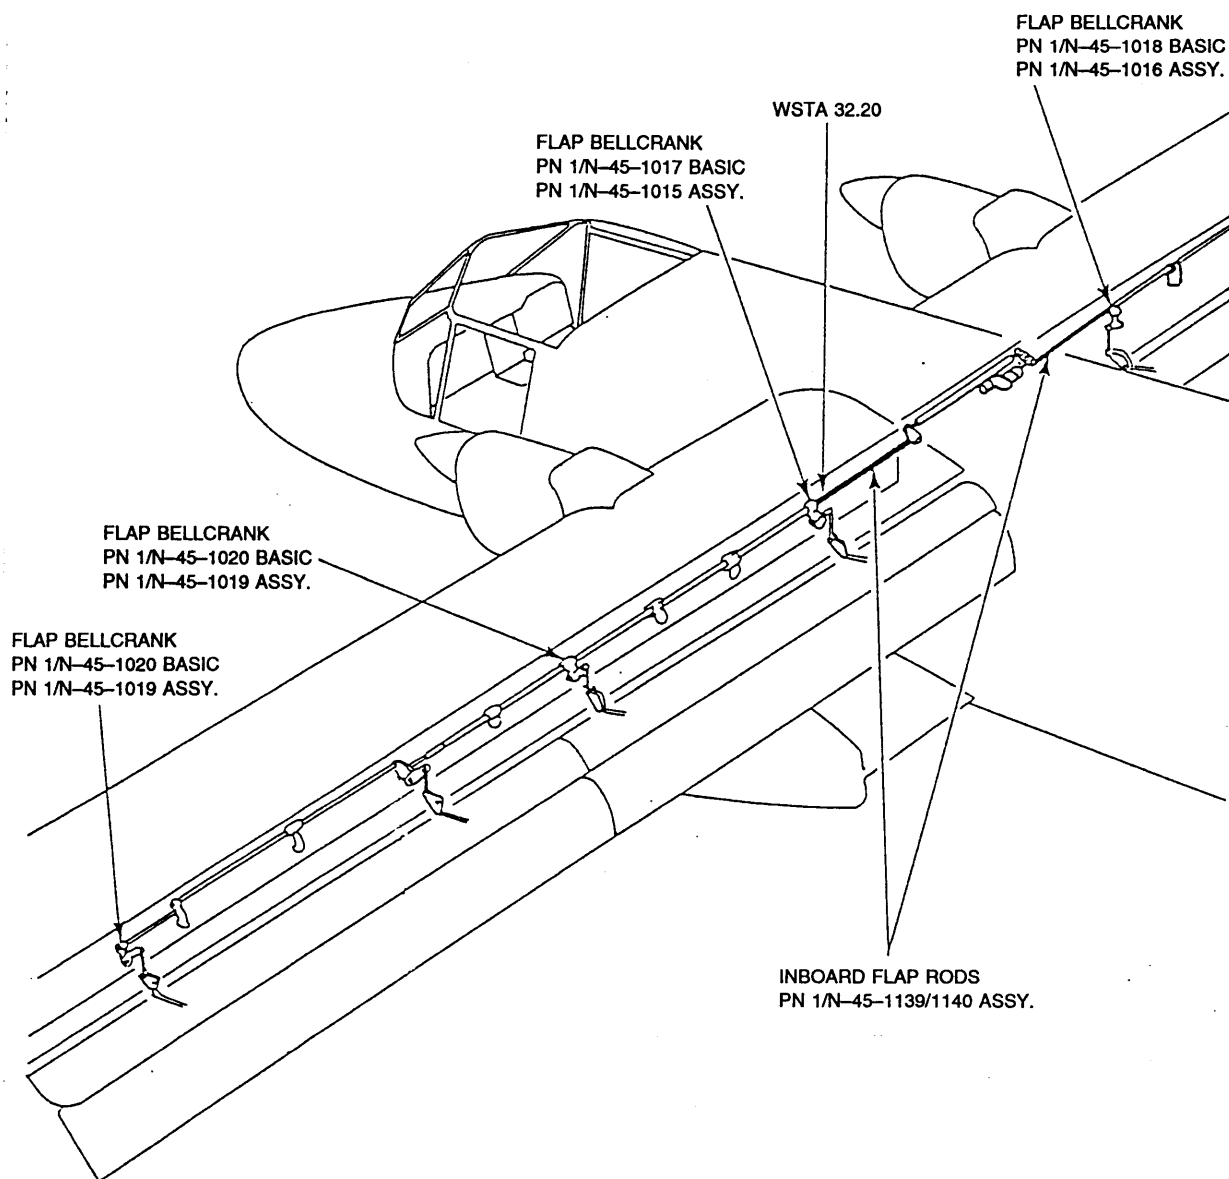
Figure 1 Flap Control Components, General Locations

According to the current aircraft usage records maintained at ASTA Defence, the above eight aircraft have exceeded the safe (retirement) lives of flap control components listed below.

The following flap control components are to be immediately replaced with new items.

- (2) Make sure aircraft electrical power is switched OFF and the flap circuit breakers are tripped.
- (3) Gain access to flap control rods PN 1/N-45-1139/1140, flap control bellcranks PN 1/N-45-1017/1018 and bellcranks PN 1/N-45-1020/1019 (Ref fig 1) by removing necessary access panels (Ref MM Chap 27-50-08).
- (4) Support the flap control surfaces.
- (5) As required, remove the existing flap control rods PN 1/N-45-1139/1140, bellcranks PN 1/N-45-1017/1018 and PN 1/N-45-1020/1019 (Ref fig 1) and replace with new items.
- (6) Remove the flap control surface supports.
- (7) Check the flap control system rigging (Ref MM Chap 27-50-00).

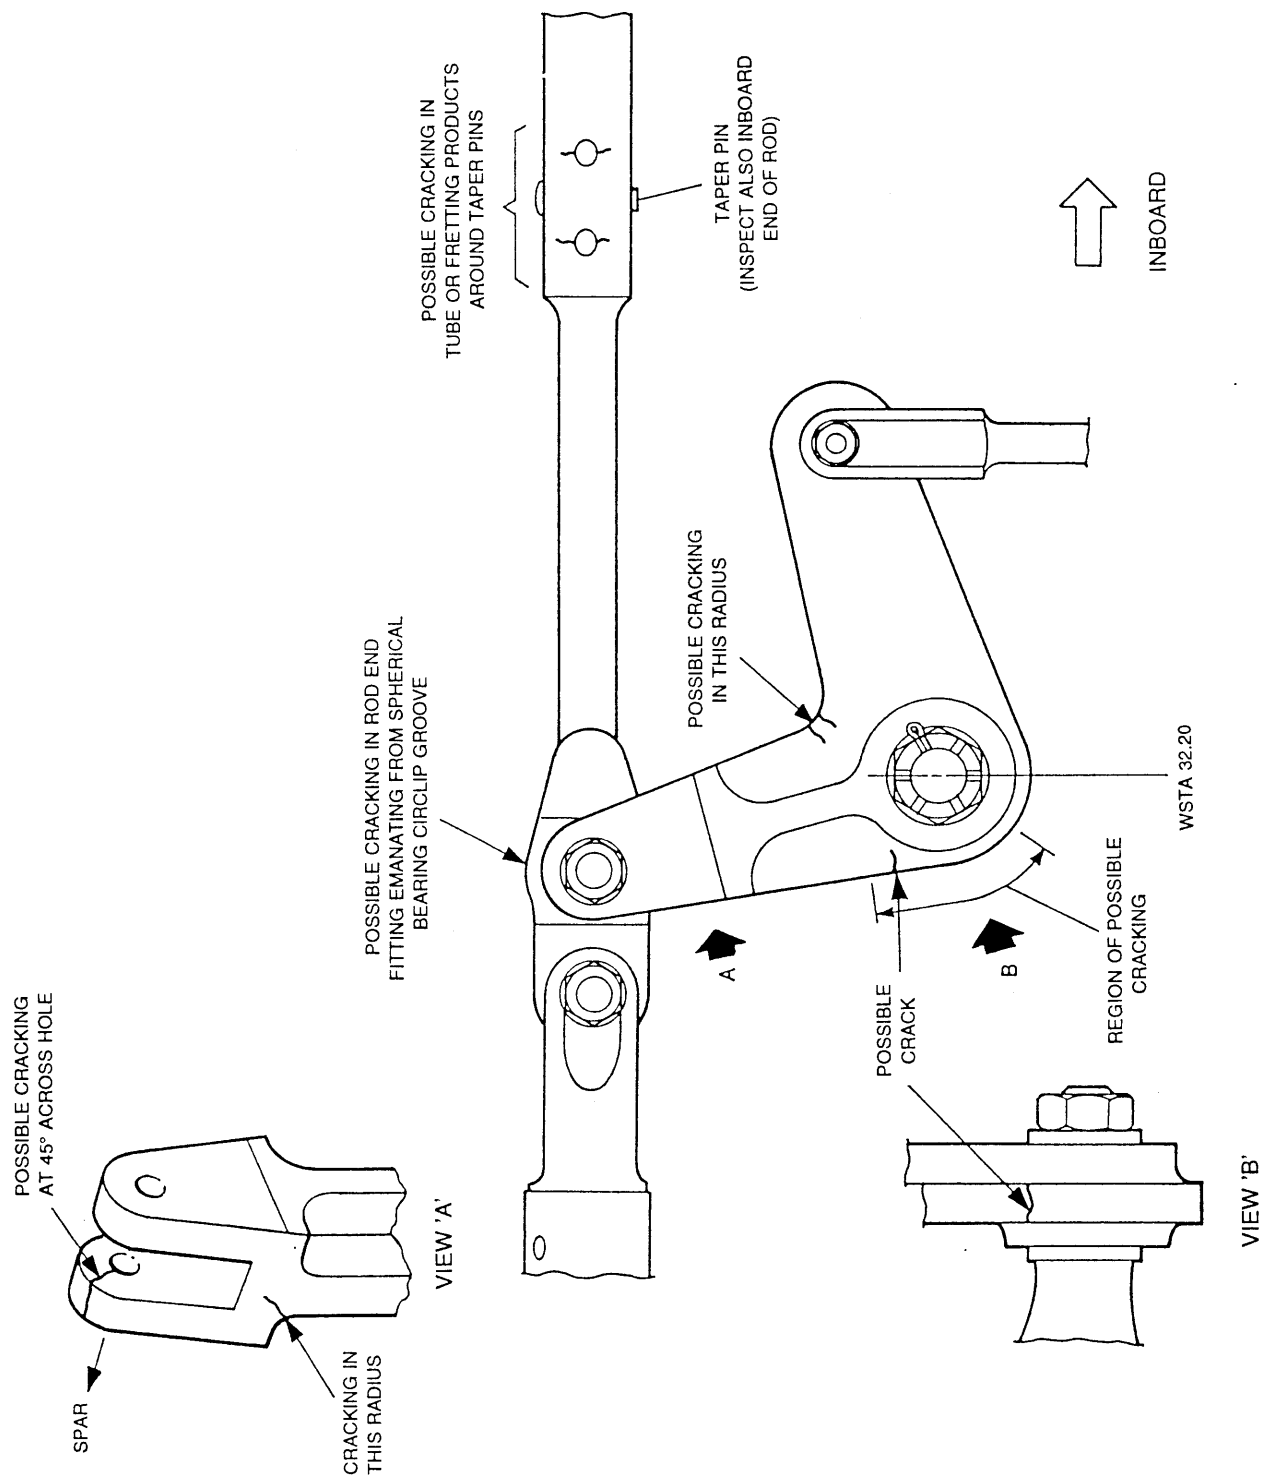
Figure 2 Possible Cracking on Flap Bellcrank and Flap Rod End Fittings

- (a) Visually inspect the inboard flap control rods PN 1/N-45-1139/1140 for cracking, fretting or corrosion and general condition, especially at the end fitting and taper pin areas (Ref Fig 2). A mirror will be required to view backside of the rods.

- Fatigue related damage (cracking, fretting etc) is likely to be in proportion to the loading seen by the rod therefore these inboard rods are more likely to have such damage than the outer rods, since their loading is higher.
  - Pay particular attention to the inspection of the end fitting attachment at wsta 32.20 (Ref Fig 2).
- (b) If pin or end fitting looseness or fretting is detected or cracking is suspected, the flap control rod is to be removed before further flight (Ref MM Chap 27-50-08) and an NDI inspection carried out using the dye penetrant or similar method.
- (c) If cracking is confirmed the item is to be renewed before further flight.

- (a) Visually inspect each of the bellcranks PN 1/N-45-1019/1020 (4 off) and PN 1/N-45-1017/1018 (Ref Fig 1) for possible cracking, corrosion and general condition (Ref Fig 2).
- (b) If cracking is detected or suspected, the bellcrank is to be removed before further flight (Ref MM Chap 27-50-00) and an NDI inspection carried out using the dye penetrant or similar method.
- (c) If cracking is confirmed, the item is to be renewed before further flight.
