ALERT SERVICE BULLETIN

FLIGHT CONTROLS — RUDDER CONTROL LEVER SHAFT

ANMD-27-51

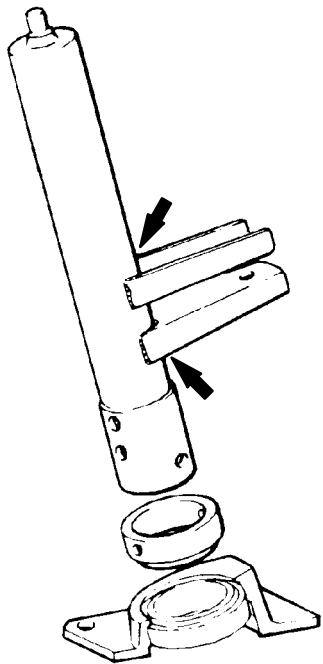
LH UPPER TORQUE SHAFT

Both upper and lower rudder pedal control lever torque shafts are subjected to an initial inspection (in-situ or removed) for signs of cracking at the lever weld joints and for adequate lever plate thickness, followed by a repeat inspection interval. The repeat inspection includes a requirement for an additional inspection after certain operating conditions occur involving the likelihood of abnormal rudder pedal loads.

Figure 1 Location of Welds to be Inspected

- (a) Remove the rudder pedal and control column guards in the flight compartment to gain access to the rudder control lever shafts.
- (b) Carry out a dye penetrant inspection of rudder control lever shafts P/N's 1/N-45-1102 or 2/N-45-1102, whichever is fitted, (LH and RH), 1/N-45-1103 and 1/N-45-1104 (Ref IPC Chap 27-20-02 Figure 4 Item 6, (2 off, 1 L/H and 1 R/H), also items 10 and 11) for cracking in the area of the welded joints between levers and the tubular shaft, paying particular attention to the ends of the welds at the lever flanges (Ref Fig 1). If the lever shafts are found to be cracked they shall be removed and replaced by new or serviceable items in accordance with Nomad MM Chap 27-20-09 before further flight.

- (c) Measure and record the thickness of all lever shaft side plates on items P/N's 1/N-45-1102 or 2/N-45-1102, whichever is fitted, (LH and RH), 1/N-45-1103 and 1/N-45-1104. Record dimension and condition of each item, on the Recording Page attached to this Alert Service Bulletin and forward to ASTA.

- (d) If lever shaft side plates are less than 0.050 in thickness, contact ASTA before fitment or further flight.
- (e) New lever shafts side plates should be measured before use. Any item found to be less than 0.050 in should not be used. If spares are not available contact ASTA for advice.
