Nomad

SERVICE BULLETIN

TRANSMITTAL LETTER
FOR
SERVICE BULLETIN NMD-55-5

**HORIZONTAL STABILISER — VERTICAL FIN AND TRIM TABS —
STRUCTURAL AND OPERATING MECHANISM INSPECTION
AND MODIFICATION**

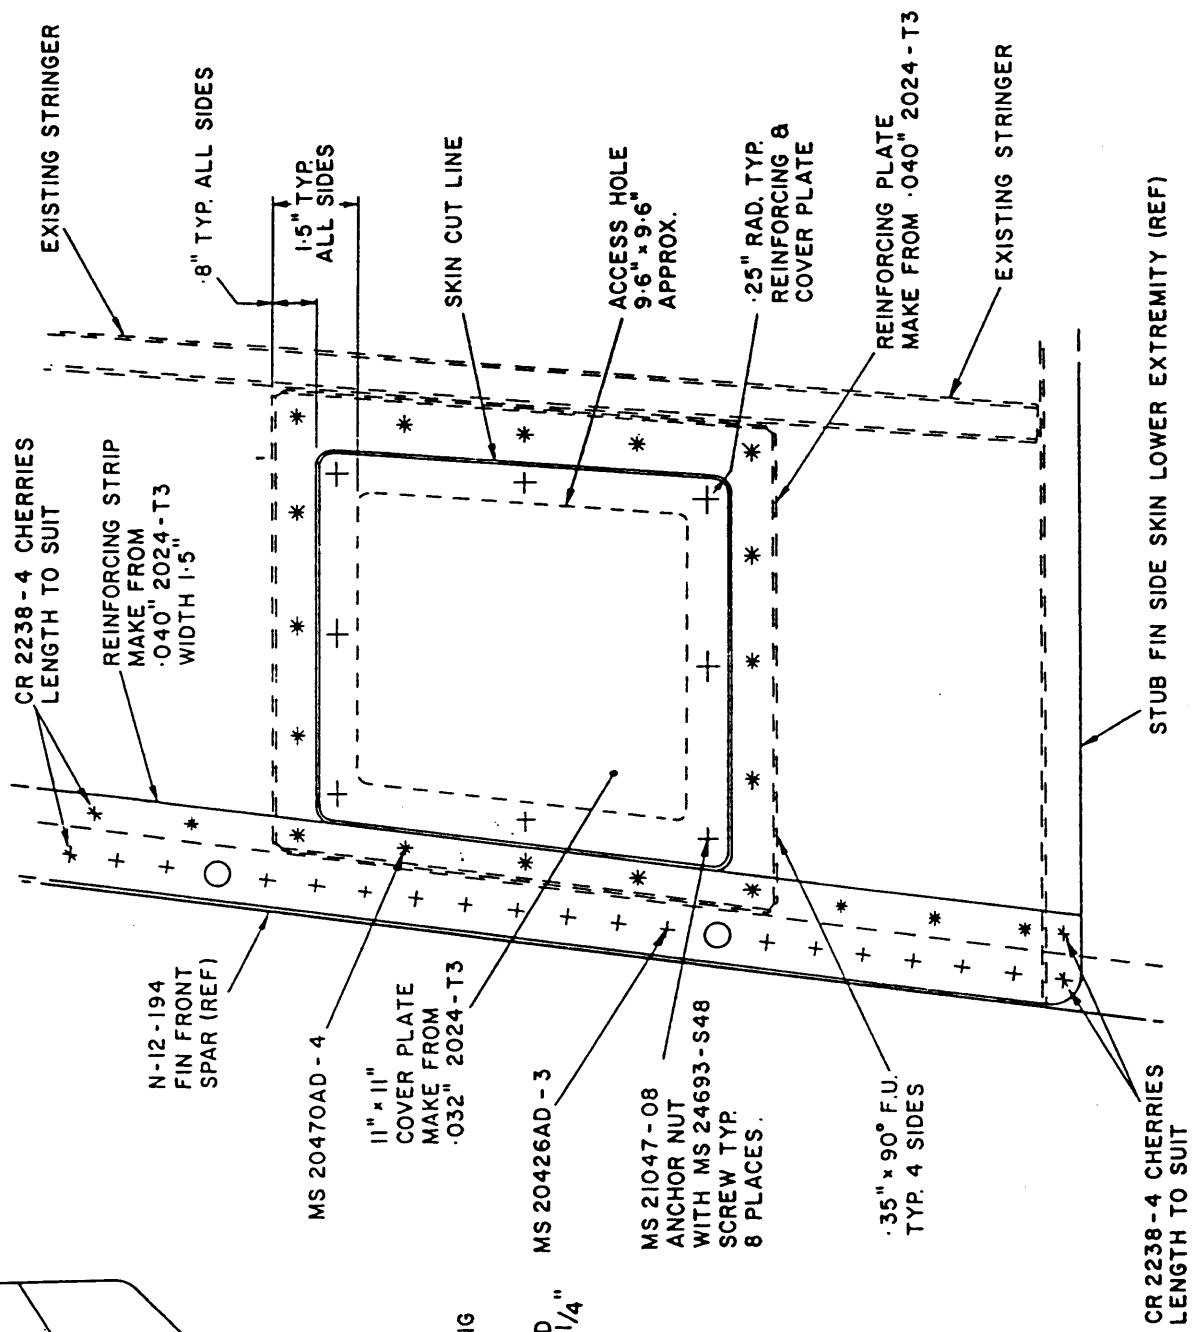
VIEW ON L.H.S. AIRCRAFT (DORSAL REMOVED)

DE-RIVET ALONG SPAR
 FLANGE LINE - ATTACH
 REINFORCING STRIP PICKING
 UP EXISTING HOLES.
 INSTALL 15 EQUALLY
 SPACED RIVETS IN SECOND
 ROW, MIN EDGE DISTANCE 1/4"

- Part 3.
- a. Rework left side of stub fin to provide access panel (Ref. Fig. 1).
 - b. Remove countersunk rivets where side skins attach stub fin forward spar (on both sides of fin). Attach reinforcing strips to rivet line of side skins at stub fin forward spar using rivets as detailed in Fig. 1.
 - c. Using torch and mirror carry out visual inspection of internal stub fin structure. In particular inspect vertical stringer emanating from rudder lower hinge doubler.
 - d. Vertical stringers: Replace or repair in accordance with Structural Repair Manual 53-10-11 Fig. 2.
 - e. Manufacture and install "Z" stiffener as detailed in Fig. 2.
