Service Bulletin

Repair to Tailcone Side Skin

Serial Number GA8-05-088 and GA8-01-008

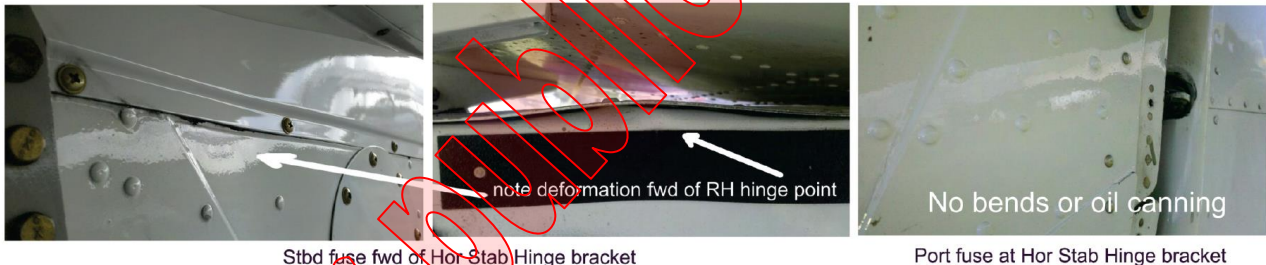
This Service Bulletin documents the procedure for the repair of the tailcone side skin of the affected aircraft after damage. The damage to the tailcone structure is typically incurred following the horizontal stabiliser impacting an external object. This repair is only applicable if the damage is within the limits described and is confined to the tailcone side skin immediately forward of the Horizontal Stabiliser brackets. For Aircraft GA8-01-008 the following observations of damage have been noted.
