SB-GA8-2012-67

Service Bulletin

Flap and Aileron Hinge Wear Repair

All GA8 and GA8-TC 320 aircraft.

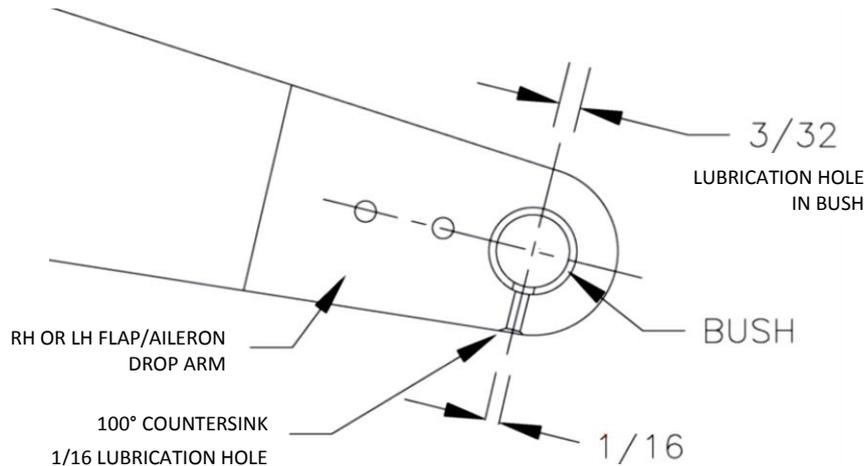
Figure 1 – Lubricating hole

1. Carry out a general inspection of the aileron and flap drop arms.
2. If the hinge bolt hole in the aileron and/or flap drop arm is worn or damaged follow the procedure below, otherwise skip to Step 3:
 - a. Remove the affected aileron or flap in accordance with GA8 Service Manual;
 - b. Drill a 1/16 inches lubrication hole in the aileron or flap drop arm, countersink at 100° and deburr. See Figure 1 as reference;

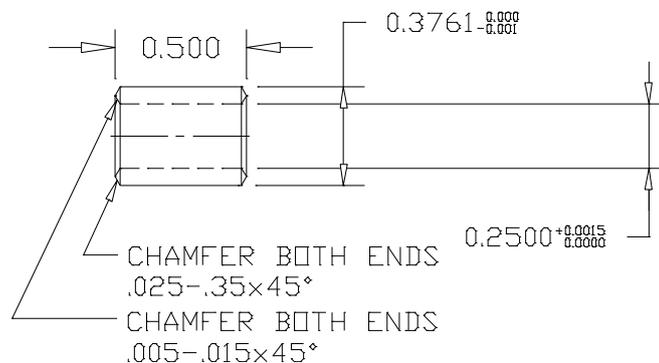
Figure 2 – Bushing manufacturing details (Alum. Bronze AMS 4631)

- d. Drill a 3/32 inches lubrication hole through the centre of a NAS76-04-016 plain bushing and deburr. If the NAS76-04-016 bushing is not available a bushing can be manufactured as per Figure 2.

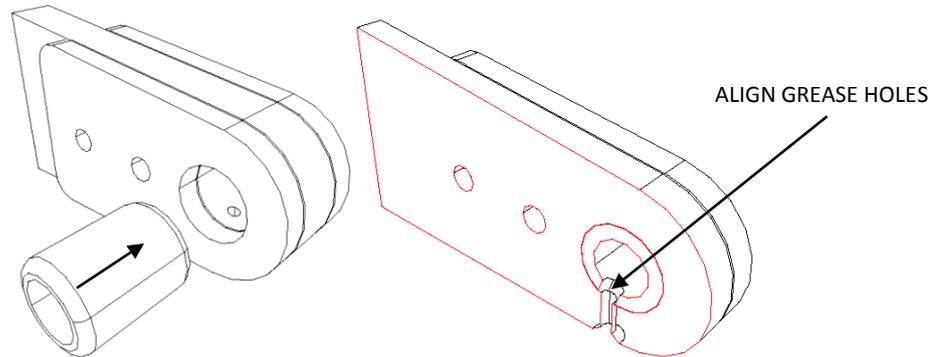
Figure 3 – Bush Installation detailed.

- e. Apply Loctite ® 680™ (or an equivalent high strength bonding compound designed for bonding of cylindrical parts) to the bush and carefully press it into the aileron or flap drop arm ensuring that its lubrication hole aligns with the lubrication hole in the aileron or drop arm, as shown in Figure 3.
