SB-GA8-2013-99

Service Bulletin

Inspection and modification of Strut Pick-up ribs – Rib no. 5 and Rib no. 6

All GA8 series aircraft

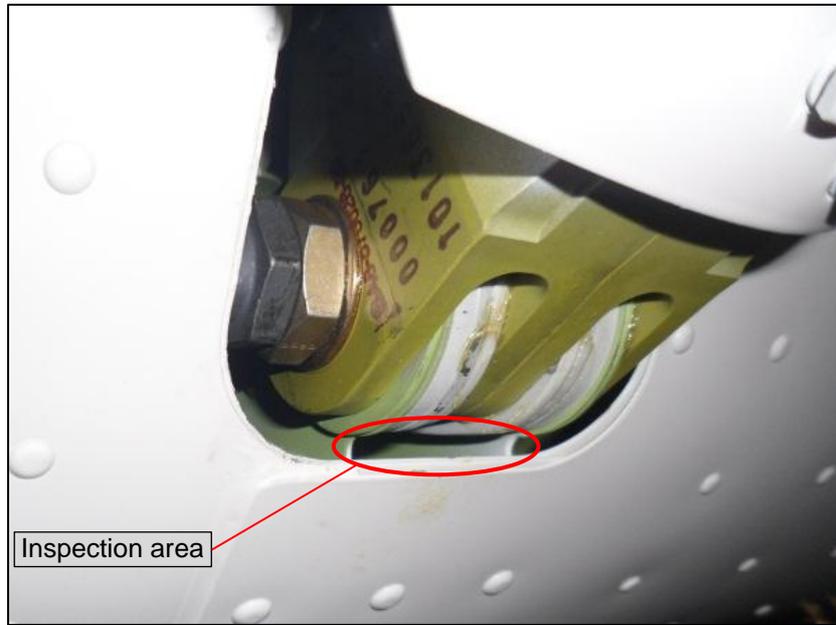
Figure 1: Inspection Region on Strut Pickup Ribs

1. Before any of the procedures prescribed in this service bulletin are carried out, ensure that the aircraft is secured on stable ground, preferably a hanger.
2. Unscrew and remove the strut/fuselage fairings (GA8-570017-013 and GA8-570017-015).
3. Inspect the strut pick-up ribs at the point just below the connection between the wing strut and the fuselage. Refer to Figure 1 below

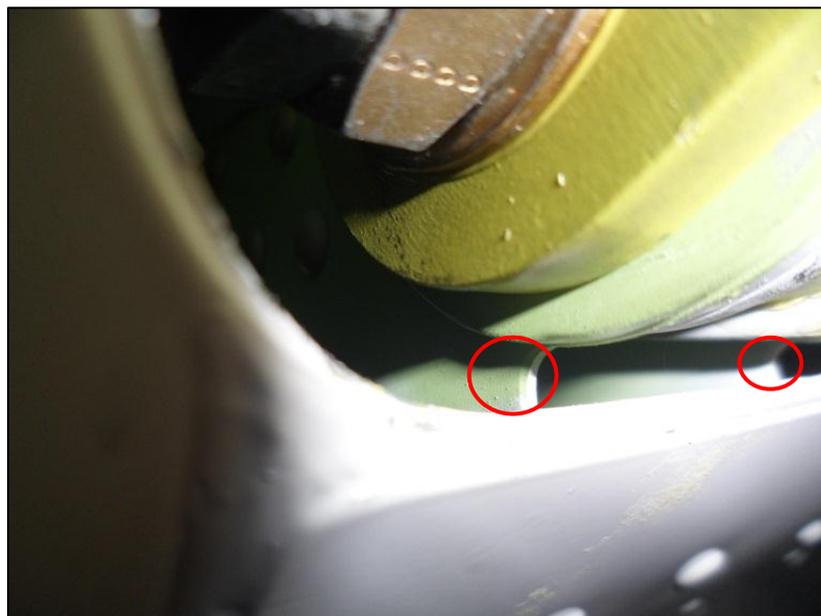
Figure 2: Region of potential crack development

Cracks on Rib no. 5 and Rib no. 6 have been detected on several aircraft during routine inspection. This service bulletin aims to provide instructions on modifying the affected area in order to prevent propagation of any crack.

4. If a crack is found on any of the ribs within the region shown by red circles in Figure 2, proceed to step 5, otherwise skip to step 12.
