Service Bulletin

Conversion of aircraft from CASA certificated FAR23 Amendment 54 status to FAA certificated FAR23 Amendment 54 status.

SB-GA8-2003-05	Issue: 1	Date of Issue: 11 April 2003	Page 4 of 4
----------------	----------	------------------------------	-------------

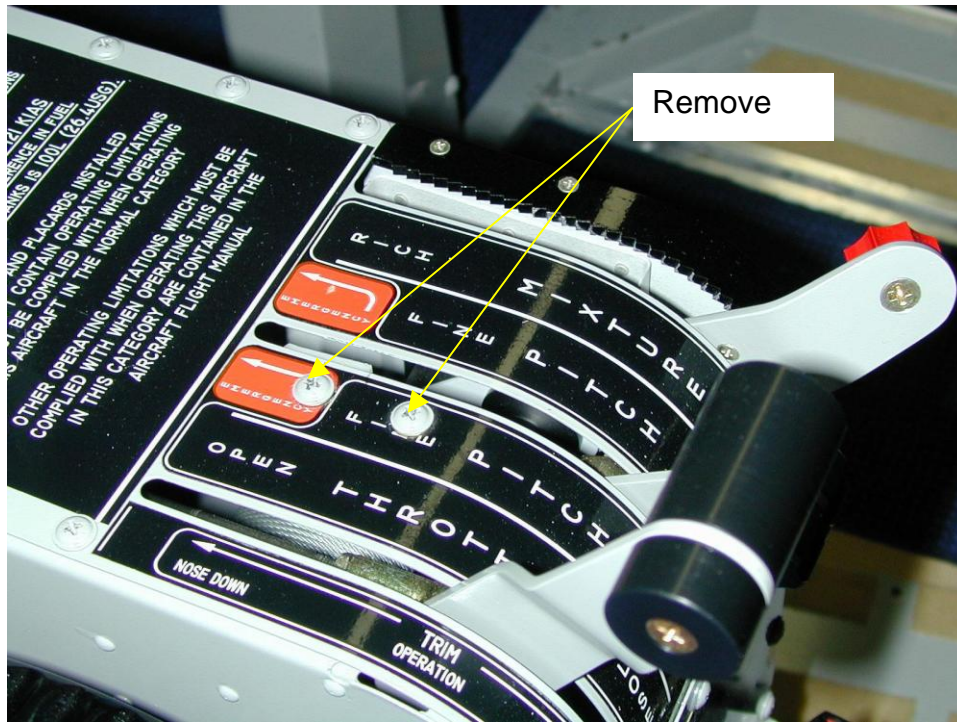
Figure 1 – Pitch stop attachment

To meet noise requirements under the ICAO test method accepted by CASA, the aircraft features a pitch stop to limit propeller speeds to 2500 rpm for normal operations with an emergency bypass to 2700 rpm.

The FAR 36 noise test method accepted by the FAA results in no limits on propeller speed below the maximum allowable value of 2700 rpm, and so the pitch stop can be removed.

1. Gain access to the throttle quadrant by removing the access panel on the left hand side of the centre console.
2. Unfasten the two screws attaching the pitch stop and backing plate to the throttle quadrant cover. Discard these parts.
