# Service Bulletin

Horizontal Stabiliser Trim Indicator Inspection

GA8 serial numbers GA8-00-004 through GA8-06-100.

Document: Service Bulletin SB-GA8-2006-35

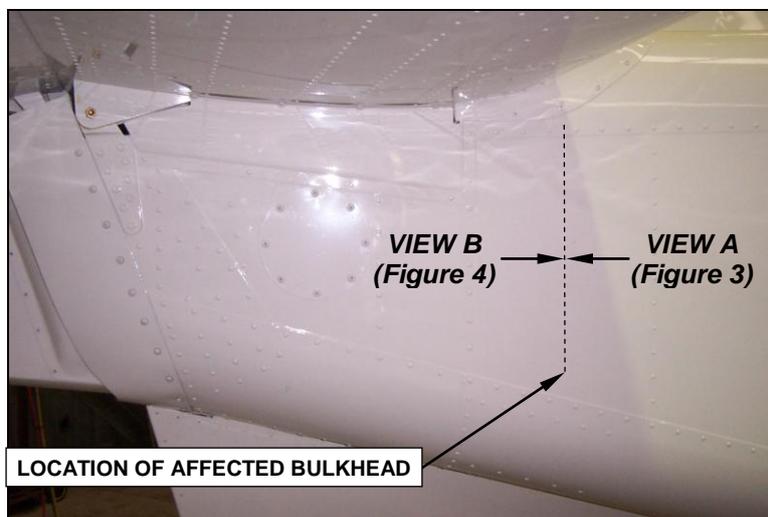
Figure 2

Situations have arisen where the trim position indicator reaches the end of its travel before the horizontal stabiliser is adjusted to the full leading edge down (i.e. nose up trim) position. When this occurs, further movement of the trim wheel may possibly lead to damage of the trim cable clamp mount, attaching bulkhead and associated hardware.

- 1.4. If deflection of the trim indicator cable mount occurs with the horizontal stabiliser trimmed to the full leading edge down position, an inspection for cracking and other damage of the bulkhead and cable mount is required. To adequately inspect the bulkhead (location indicated in figure 2), remove the large access panel on the lower tail cone skin and inspect the forward face of the bulkhead around the trim indicator cable mount attaching fasteners (refer to figure 3). If defects are found, contact Gippsland Aeronautics. If no defects are found, perform the adjustment to the trim indicator cable in accordance with section 2 of this Service Bulletin (Rod End Adjustment Procedure).

For all applicable aircraft, inspect the horizontal stabiliser trim indicator clamp mount and the attaching bulkhead (refer to figure 2) in accordance with the inspection procedure detailed in section 1 of the instructions contained in this Service Bulletin at the next 100 hour/annual inspection after 30 April 2006.
