Service Bulletin

Solenoid box breaker modification

All GA8 serial numbers up to S/N GA8-06-098

Document: Service Bulletin SB-GA8-2008-50

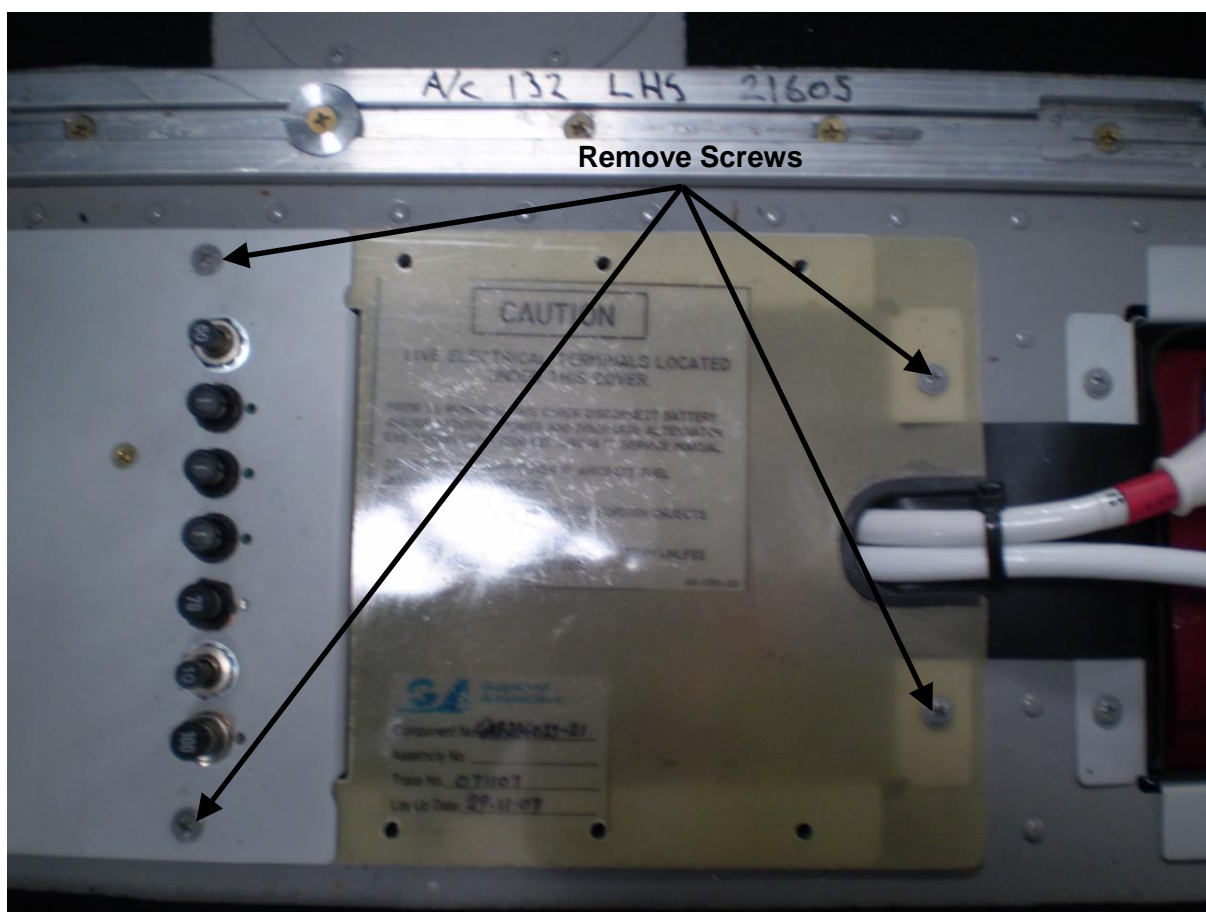
Figure 1 - Screws to be removed to gain access to internal assembly of the solenoid box

1. Remove the pilot seat and gain access to the solenoid box. Take off the fibre glass battery cover.
2. Gain access to the battery box. Disconnect the positive terminal connected to the battery from the aircraft as a precautionary measure. Refer to the GA8 Service Manual Section Chapter 24.
3. Gain access to the internal components of solenoid box by removal of screws as noted in Figure 1. Take care not to damage the heads of the screws when undoing them. Remove the fibre glass sheet. Refer to the GA8 Service Manual Section Chapter 24 taking specific note of the warning in Section 24-00-00.

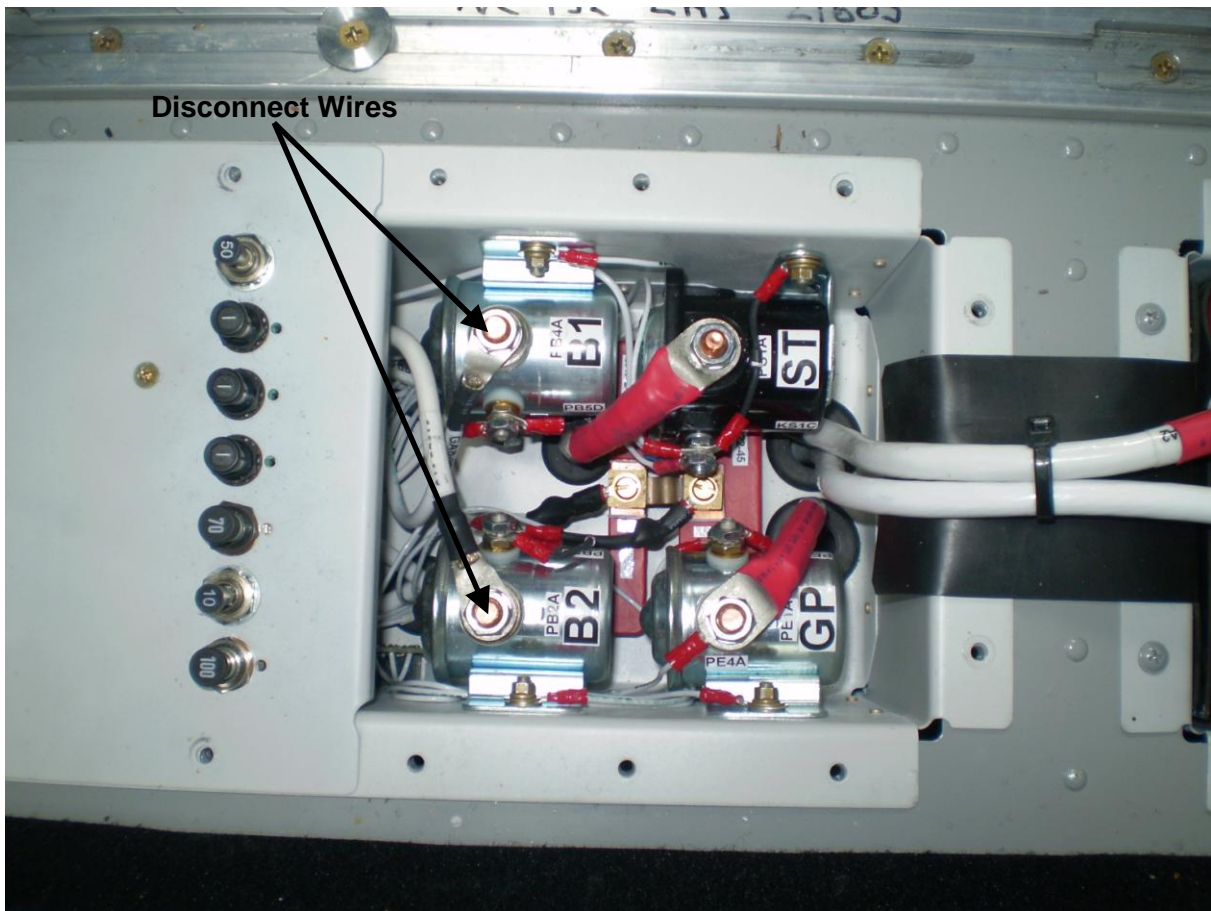
Figure 2 - Showing the first two wires to be disconnected

- Gain access to the Circuit Breaker Assembly and remove this from the main solenoid box assembly. This will require disconnecting of wires PB4A8, PB4B8, PB2A6, PB2B6 to ease the modification of the circuit breaker panel. Refer to Figure 2. Remove the existing 1A breakers from the assembly and discard. Retain the bus bar (GA8-311022-33) for reinstallation.

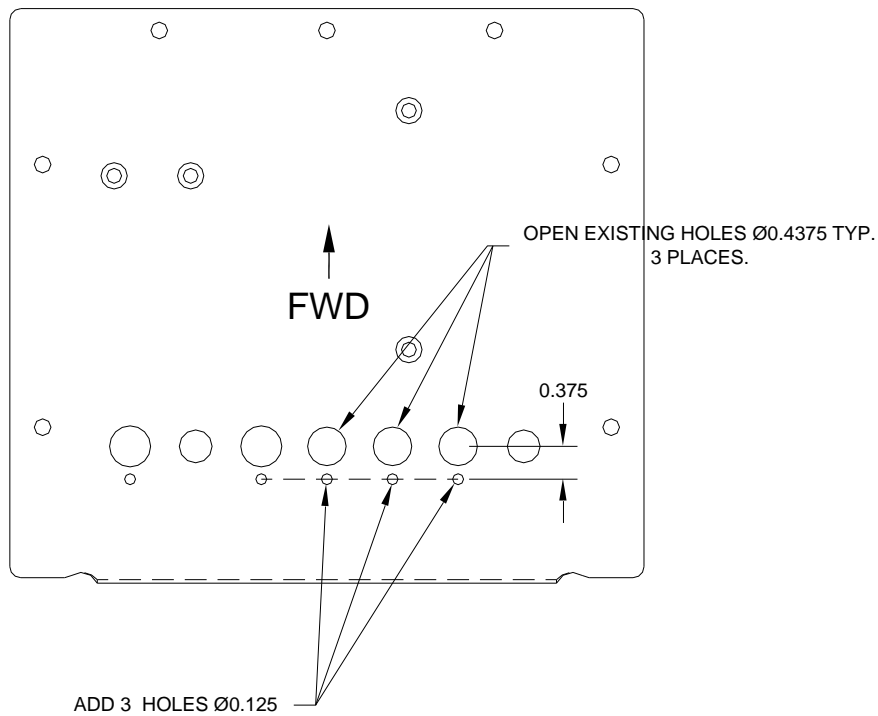
Figure 3 - Modification to Breaker Panel, viewed from above when fitted into aircraft

5. Modify the Breaker Panel as detailed in Figure 3. Each new breaker requires the existing mounting hole to be enlarged to 0.4375 inches diameter and the addition of a 0.125 inch diameter hole per location. Remove all swarf.

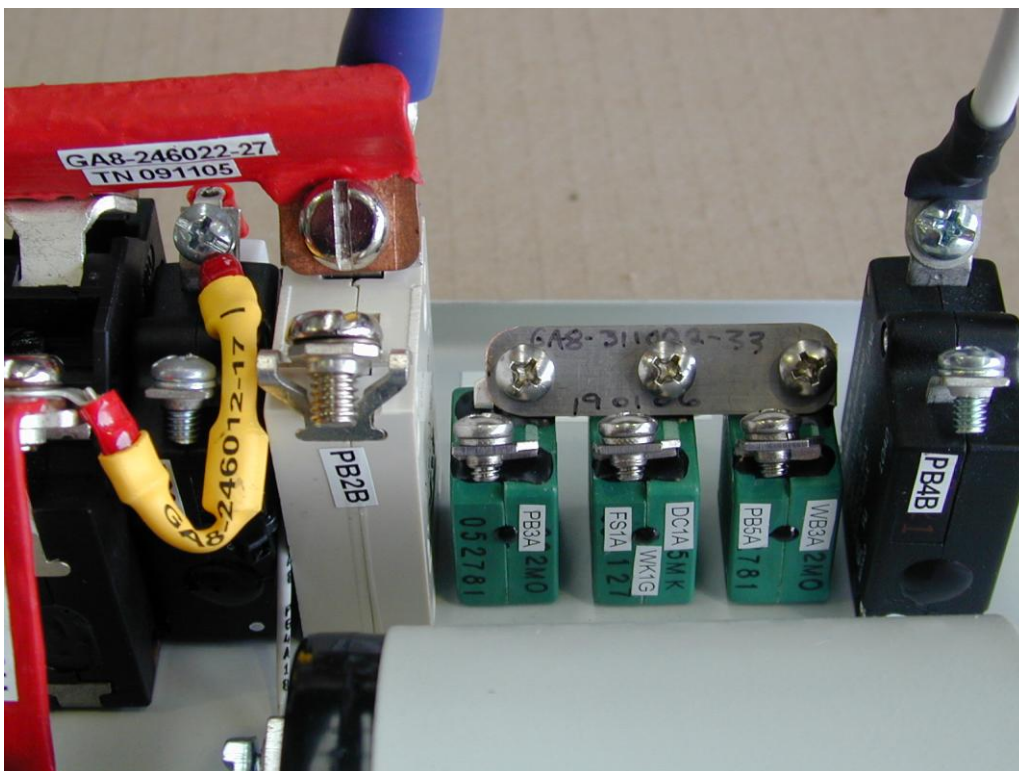
Figure 4 - Modified Breaker Assembly

6. Replace the 1A circuit breakers with 2TC2-1 breakers. Reinstall Bus Bar. Refer to Figure 4.

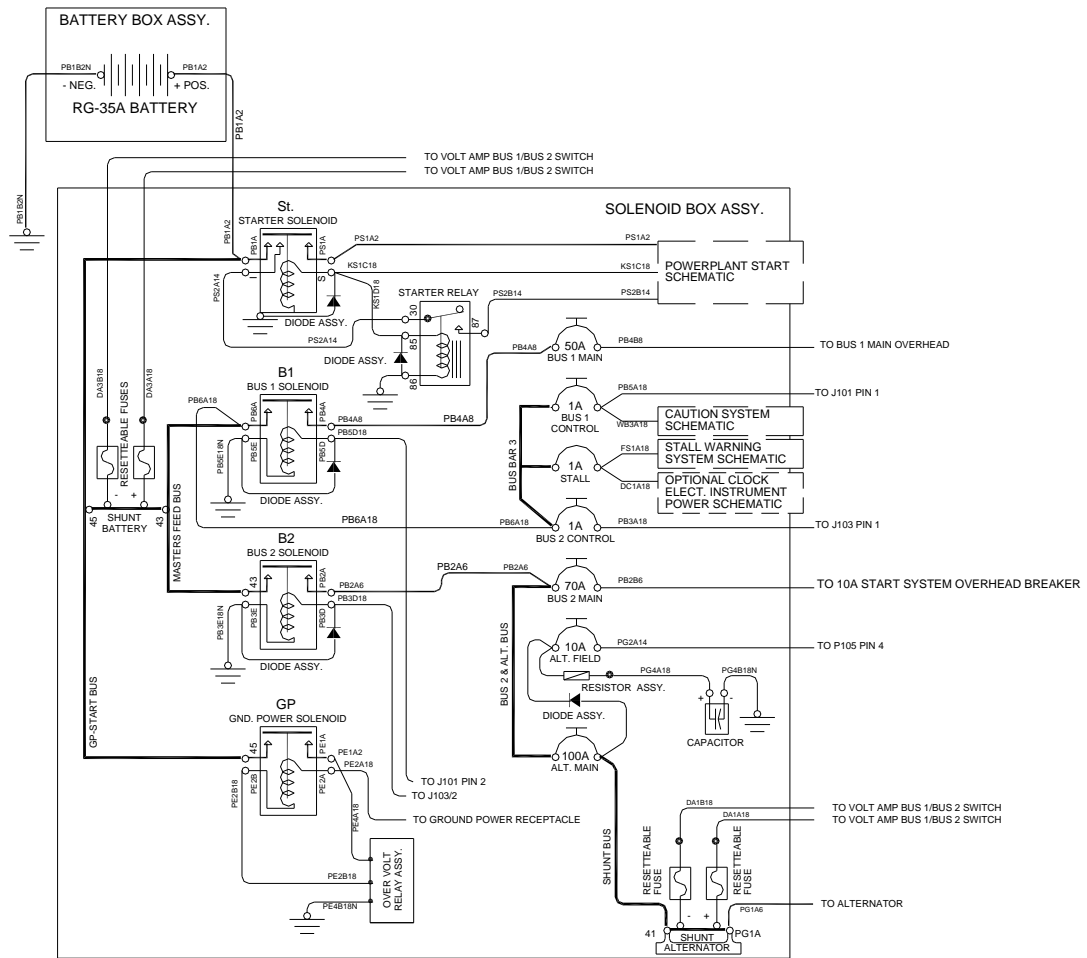
Figure 5 - Partial wiring schematic showing underfloor circuit breakers.

- Refit the Circuit Breaker Assembly to the solenoid box. Refer to Figure 5 for the wiring to circuit breakers. Refer also to Chapter 24, Figure 24-1 of the Service Manual
