Service Bulletin

Pitot heat warning circuit board replacement.

GA8-00-004 to GA8-06-096 with heated Pitot Tube installed.

SB-GA8-2008-51	Issue: 2	Date of Issue: 17 Sep 2010	Page 2 of 4
----------------	----------	----------------------------	-------------

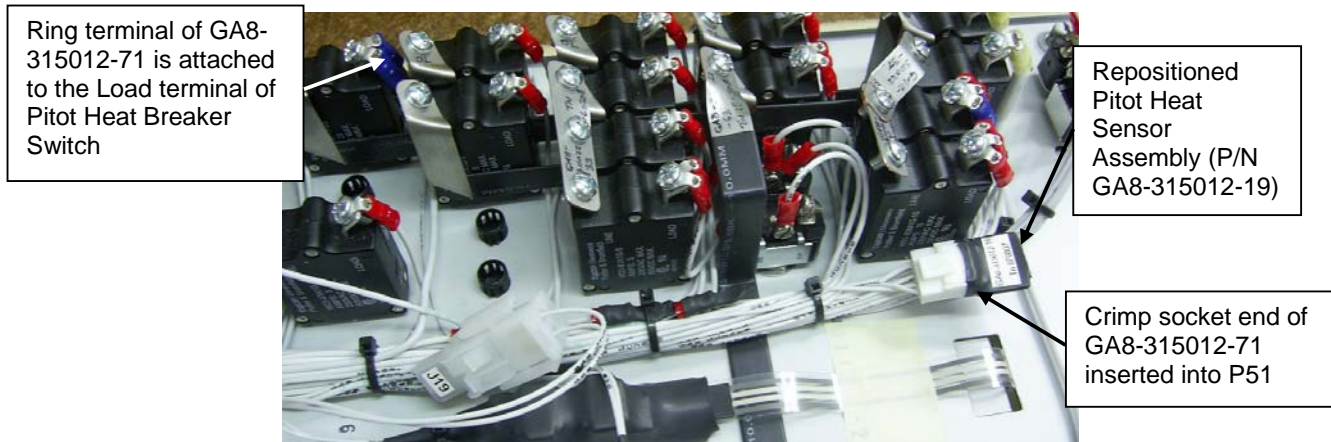
Figure 1. Correct installation of the relocated pitot heat sensor assembly and wiring

Breaker location may vary due to other optional equipment.

- 1.3. Locate the Pitot Heat Sensor Assembly attached to the terminal of the Pitot Heat breaker switch and remove the Pitot Heat Sensor Assembly.
- 1.4. Attach the ring terminal of the Pitot Heat Sensor Wiring Harness – Retrofit (P/N GA8-315012-71) to the breaker switch. Refer to Figure 1.

- 1.5. Insert the socket crimp end of wiring harness (P/N GA8-315012-71) into pin 2 of the existing plug P51.
- 1.6. Plug the new Pitot Heat Sensor Assembly (P/N GA8-315012-19) to Plug P51 and secure with cable ties to the wiring loom centrally on the panel adjacent to the electro luminescent panel light power supply. Ref Figure 1.
