ALERT SERVICE BULLETIN

Reference No 219

**FUSELAGE - STUB FIN - INSPECTION FOR DEFORMATION
OF STUB FIN FRONT SPAR**

FUSELAGE - STUB FIN - INSPECTION FOR DEFORMATION OF STUB FIN FRONT SPAR

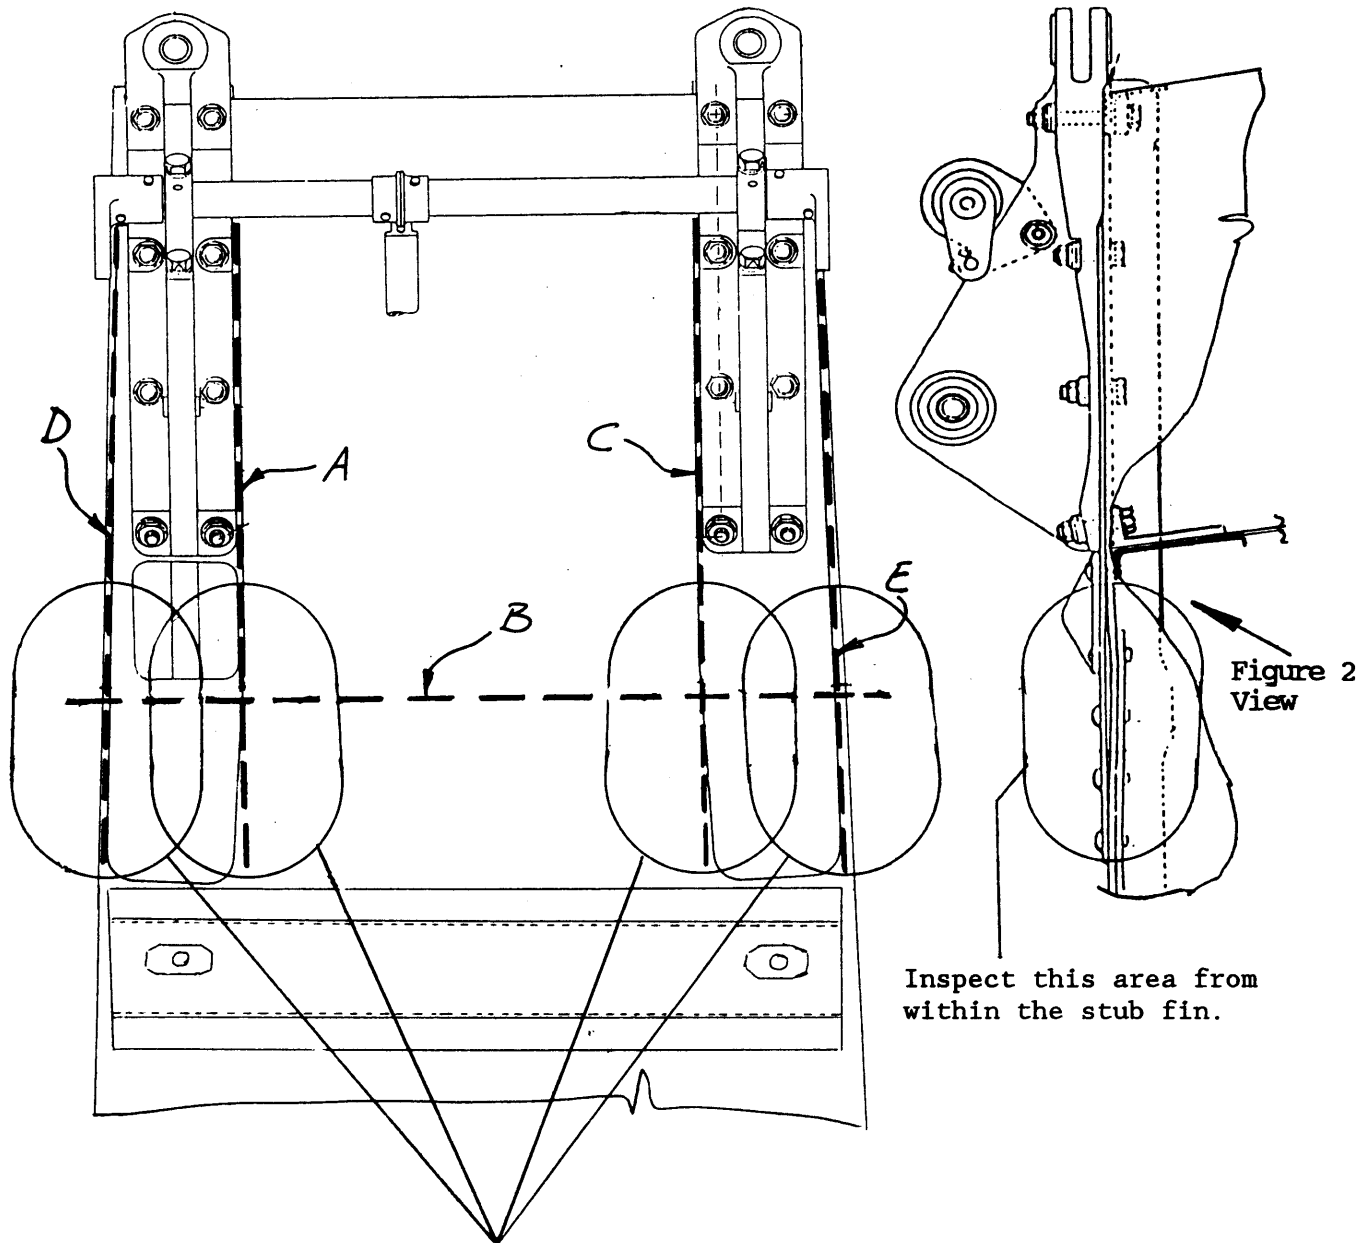
Figure 1 View on Forward Face of Stub Fin
(Shown with Mod N600 Installed)

Inspection of a number of aircraft has revealed the presence of "dishing" of the stub fin front spar face on the starboard side beneath the lower horizontal stabiliser stop plate. Such "dishing" is a symptom of deformation of the stub fin starboard spar boom angle and is unacceptable. On two aircraft inspected, the "dishing" was accompanied by cracking of the horizontal brackets which support the spar, this is also unacceptable.

NOTE: Clearances in excess of the following limits will require the stub fin to be repaired prior to further flight.

1 Aircraft incorporating Mod N600A or N600B (Service Bulletin NMD-53-5) - Maximum allowable clearance is 0.061 inch.

2 Aircraft not incorporating Mod N600A or N600B - Maximum allowable clearance is 0.011 inch.

Place a straight edge along each line 'A', 'B', 'C', 'D' and 'E' in turn and measure deformation in these areas using a feeler gauge.

Maximum allowed - 0.061 inch (Post Mod N600A or N600B)

- 0.011 inch (Pre Mod N600A or N600B).

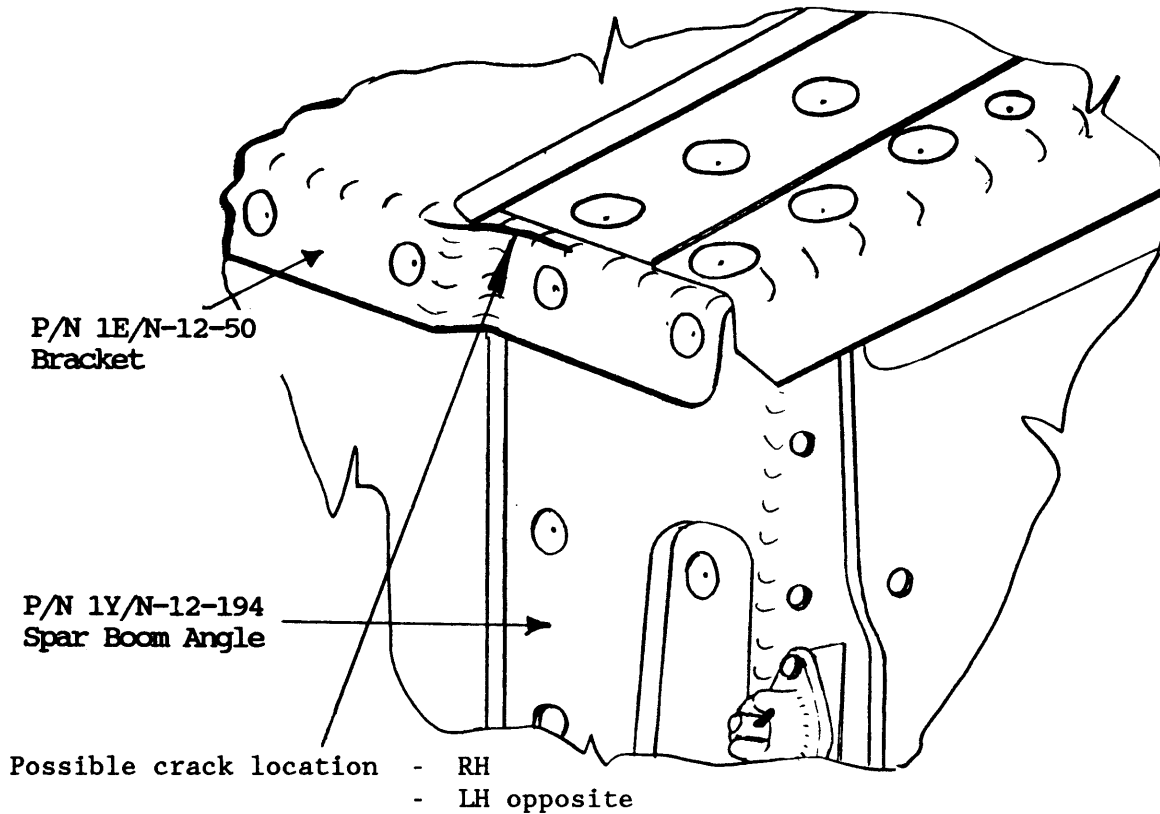
Figure 2 View Inside Stub Fin Looking Through Inspection Panel

- (4) Remove the access panel from the port side of the stub fin and examine the rear face of the spar for damage, pay particular attention to the flange of the horizontal bracket where cracking has been seen on some aircraft (Ref Fig 2).
- (5) Repair any damaged spar boom angle in accordance with the procedure shown in Part 2 and replace Bracket P/N 1E/N-12-50 as required.
- (6) Remove the horizontal stabiliser rigging bar.
- (7) Install the dorsal fin (Ref MM 55-30-00).
- (8) Replace the access panel on the port side of the stub fin.

Cracking in flange of bracket per Figure 2.

- (28) Remove fuselage side skin and stub fin side skins, deburr holes and check inside stub fin for cleanliness.
 - (29) Using a drill bush with an outside diameter to match the diameter of the existing holes and 3.5 mm inside diameter (refer to Figure 2), drill the two bolt holes in the third row from the top and using a reamer open up to 0.265 inch. Temporarily bolt RH fin/horizontal stabiliser attachment bracket to stub fin using existing bolts.

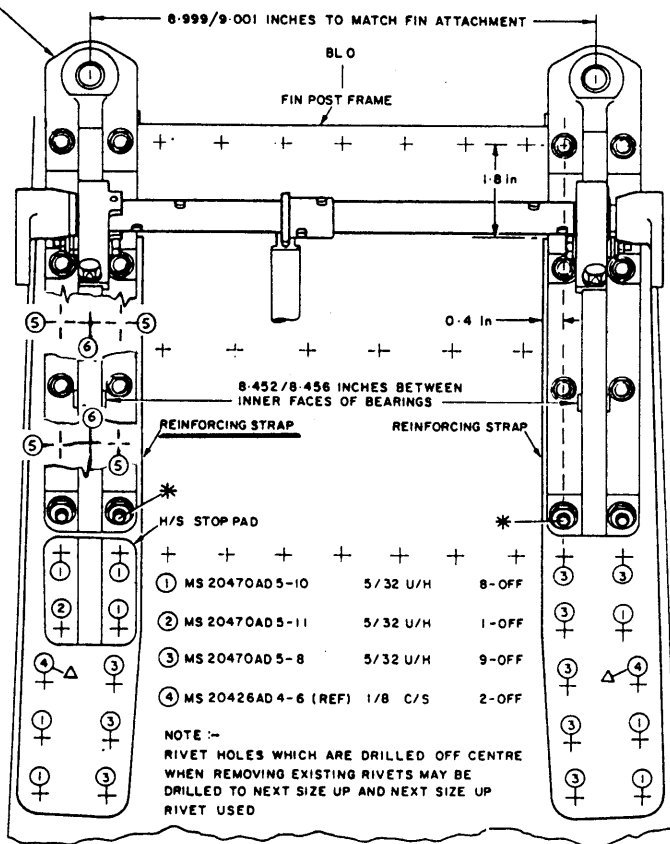
Figure 4 Mod N600 Reinforcing Strap

- ⑤ MS20426AD3
Through Diaphragm and Angle (hidden)
- ⑥ MS20426AD3
Tack rivet through reinforcing strap

- (20) Locate RH Reinforcing Strap P/N 1/N-12-380 (if fitted by Mod N600A or N600B, refer to SB NMD-53-5) on RH stub fin web. Align with existing RH stub fin web holes using existing bolts removed from fin/horizontal stabiliser attachment bracket. Drill two 2.4 mm holes in centre of reinforcing strap through web, countersink holes in aft face of web and forward face of strap and tack rivet together. Refer to Figure 4 and step 31.

- (31) Refer to Figure 4. Remove RH fin/horizontal stabiliser attachment bracket and reinforcing strap (remove tack rivets installed in step 20). Drill 3.3 mm diameter holes in angle to match countersunk rivet locations beneath reinforcing strap, drill (2.5 mm diameter) tack rivet hole right through and completely rivet reinforcing strap. Install RH fin/horizontal stabiliser attachment bracket using bolts listed in step 30.
