# Nomad ALERT SERVICE BULLETIN

## FUSELAGE REAR SECTION - STUB FIN - INSPECTION

Rev 2 18 March 98

# ANMD-53-16

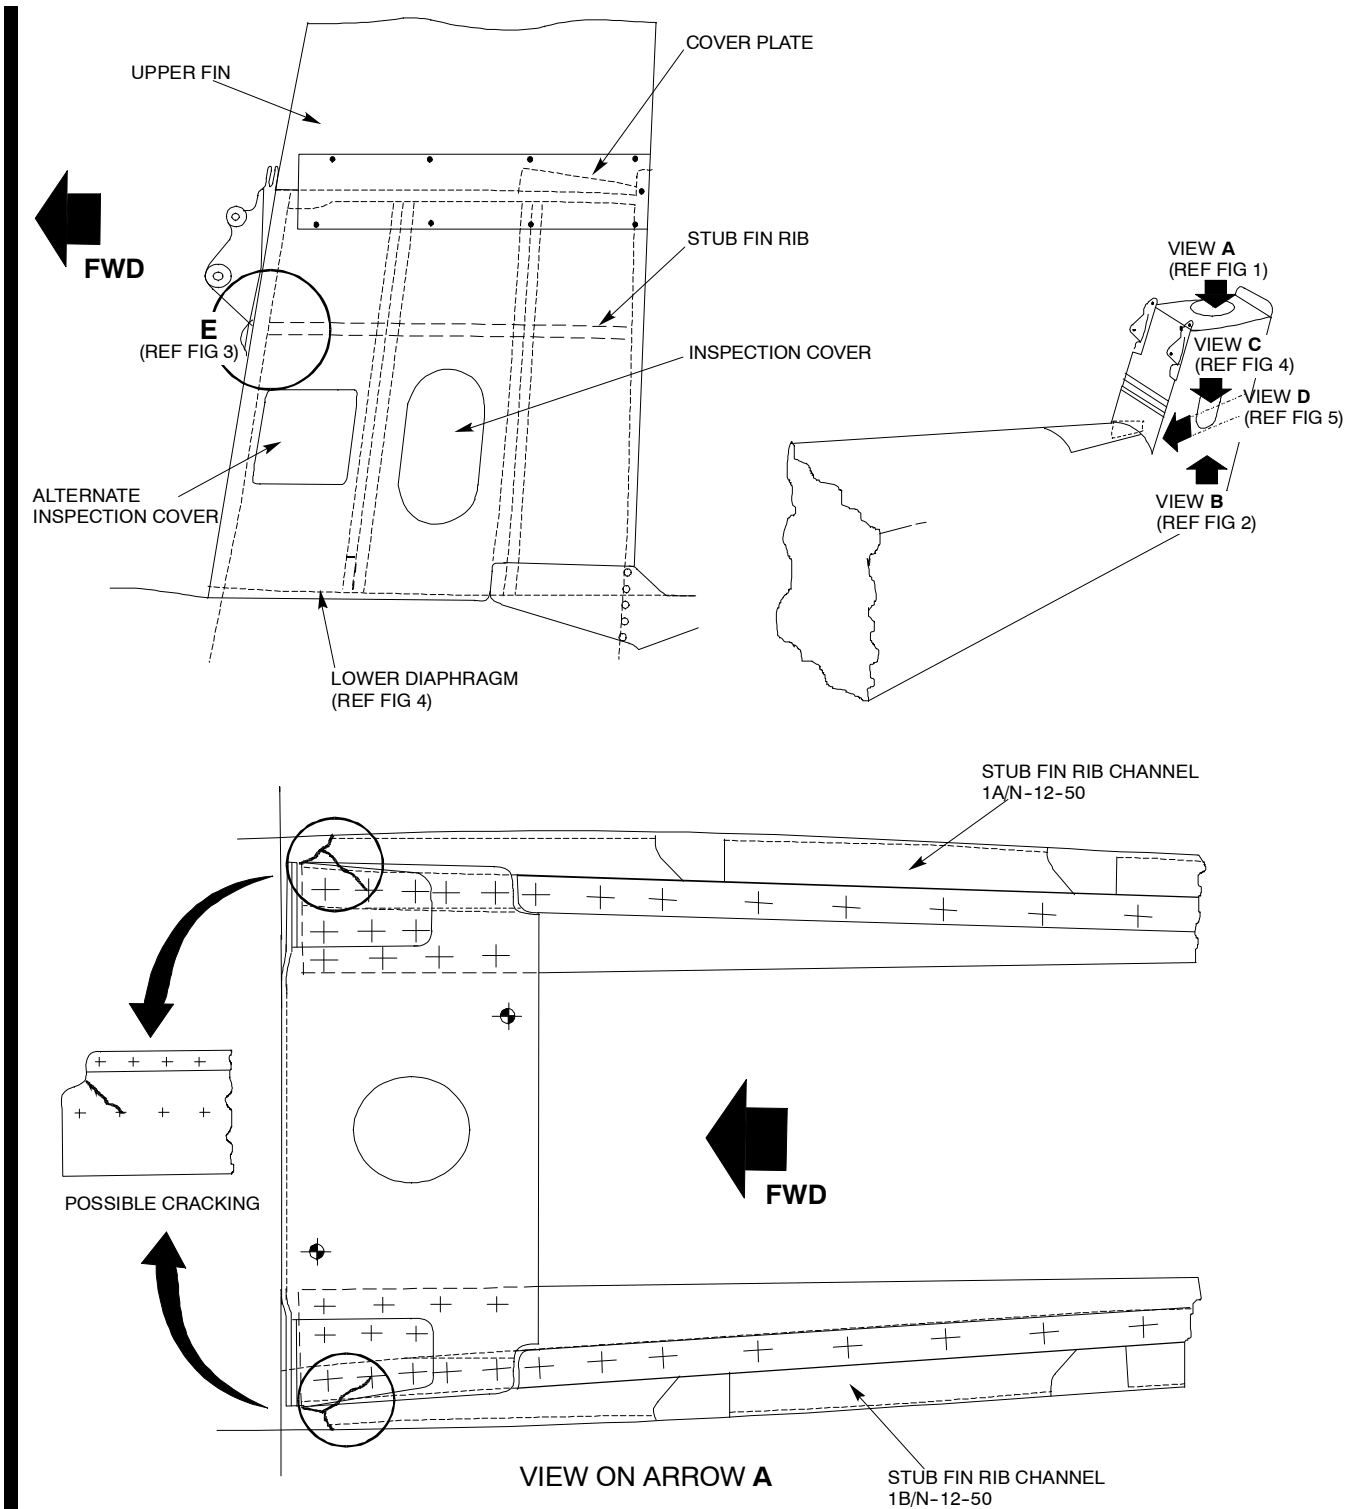
**Figure 1 Possible Fatigue Cracking - Stub Fin Rib**

- (10) Repair all cracked components by replacement.

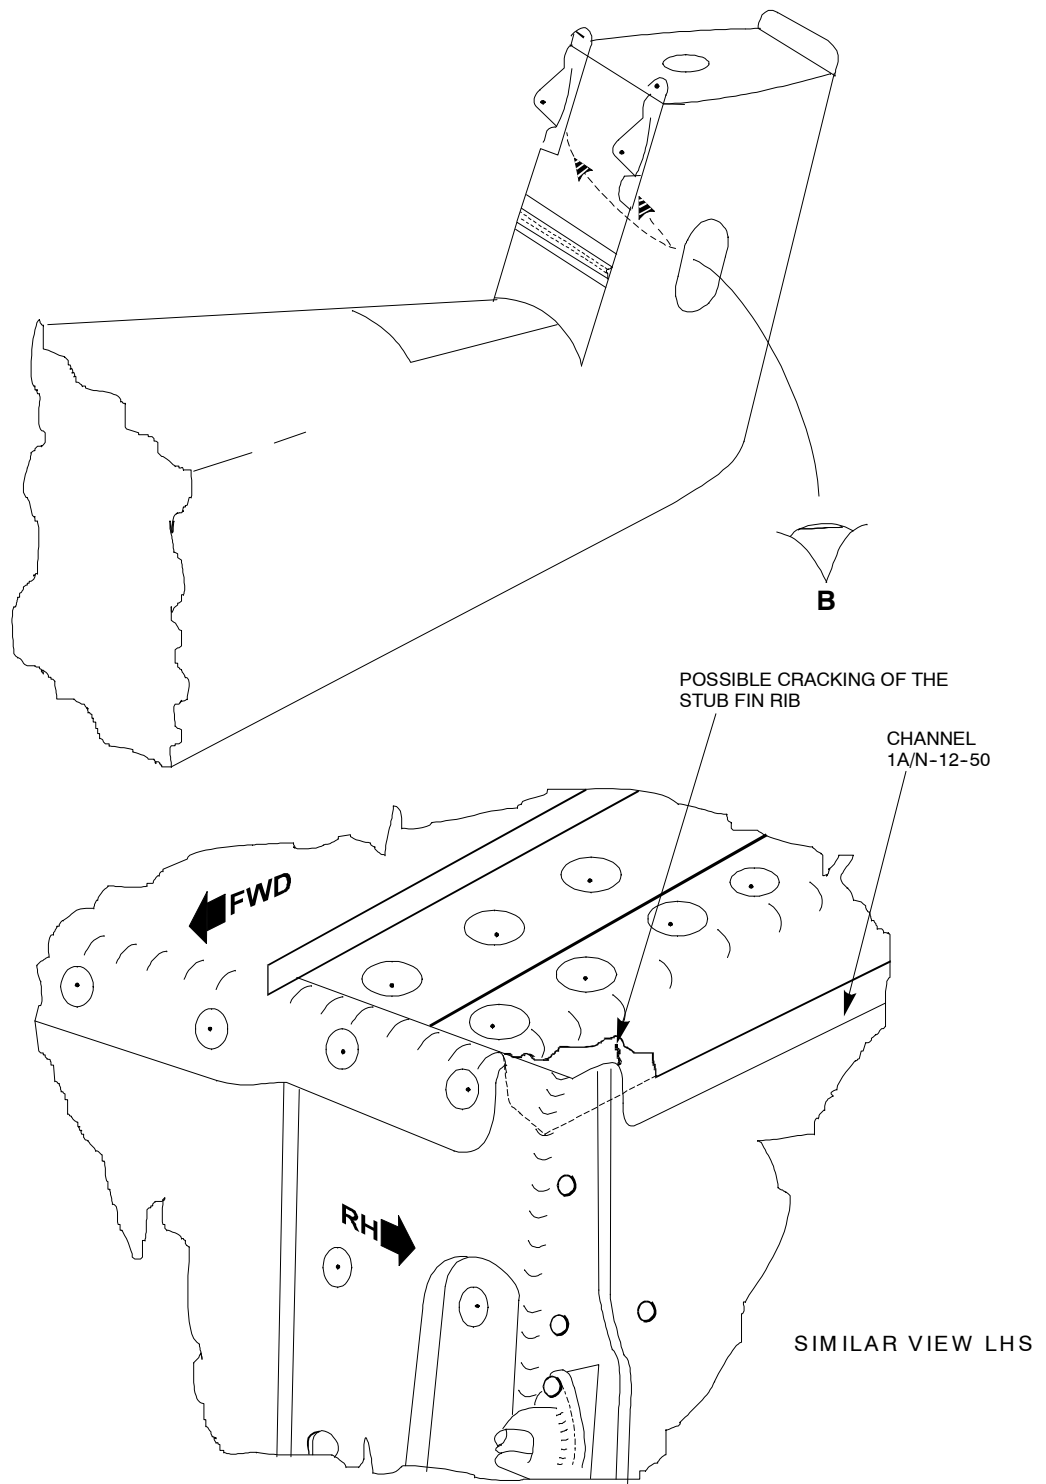
VIEW ON ARROW B  
Figure 2 Possible Fatigue Cracking - Stub Fin Rib

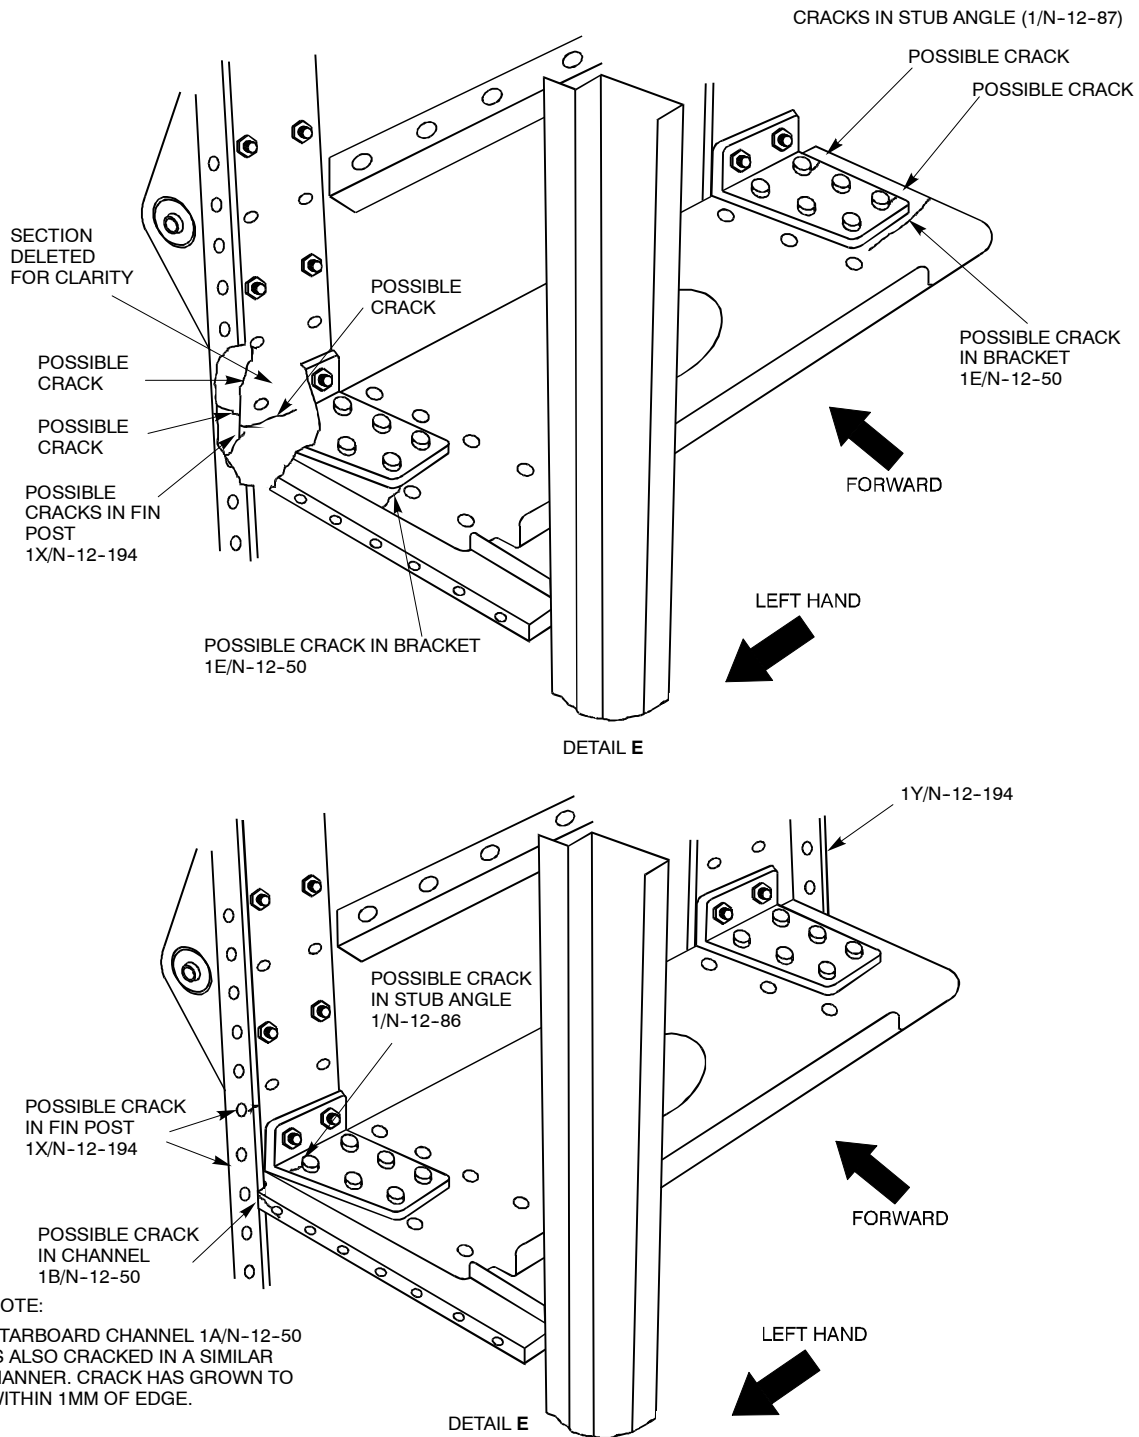
The Stub Fin structure in the tailplane resonance test has experienced fatigue cracks in various members of the sub-structure as shown in Figure 3.

- (6) Visually inspect bracket PN 1E/N-12-50 for cracking in the area around the rear of the stub angles both LH and RH sides (Ref Fig 3).
- (7) Visually inspect the fin posts PN 1X/N-12-194 and 1Y/N-12-194 for cracking in the area adjoining the stub angles PN 1/N-12-86 LH and PN 1/N-12-87 RH (Ref Fig 3).

**Figure 3 Possible Cracking as Identified on Fatigue Test**

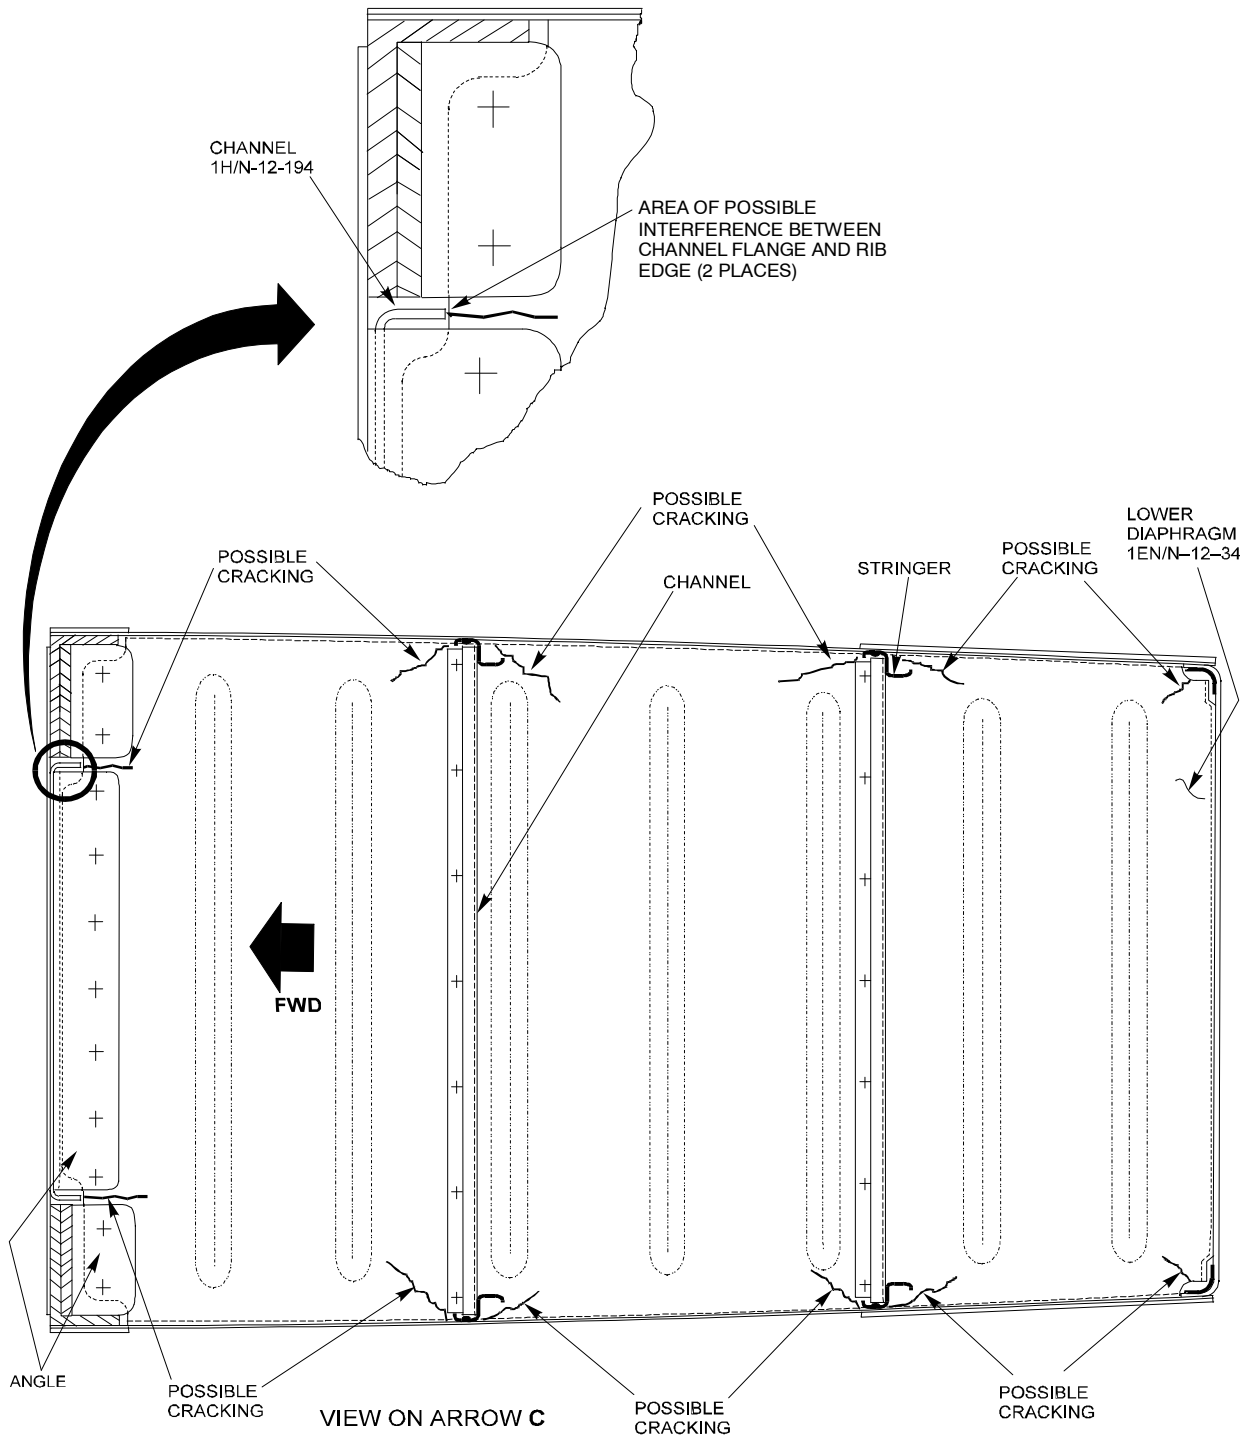
An operator has identified a crack at the forward end of the stub fin lower diaphragm. Tailplane resonance testing also indicated possible cracking of the stub fin front corner posts below the stub fin lower diaphragm.

- (8) Visually inspect the lower Diaphragm for cracking, in the vicinity of the lower end of the vertical stringers and cross channels, and also paying particular attention to the forward end of the stub fin. Check for any interference between forward end of the lower Diaphragm and the angles on the rear face of the stub fin front spar, and report in Annex A (Ref fig 4).

**Figure 4 Possible Fatigue Cracking - Lower Diaphragm**

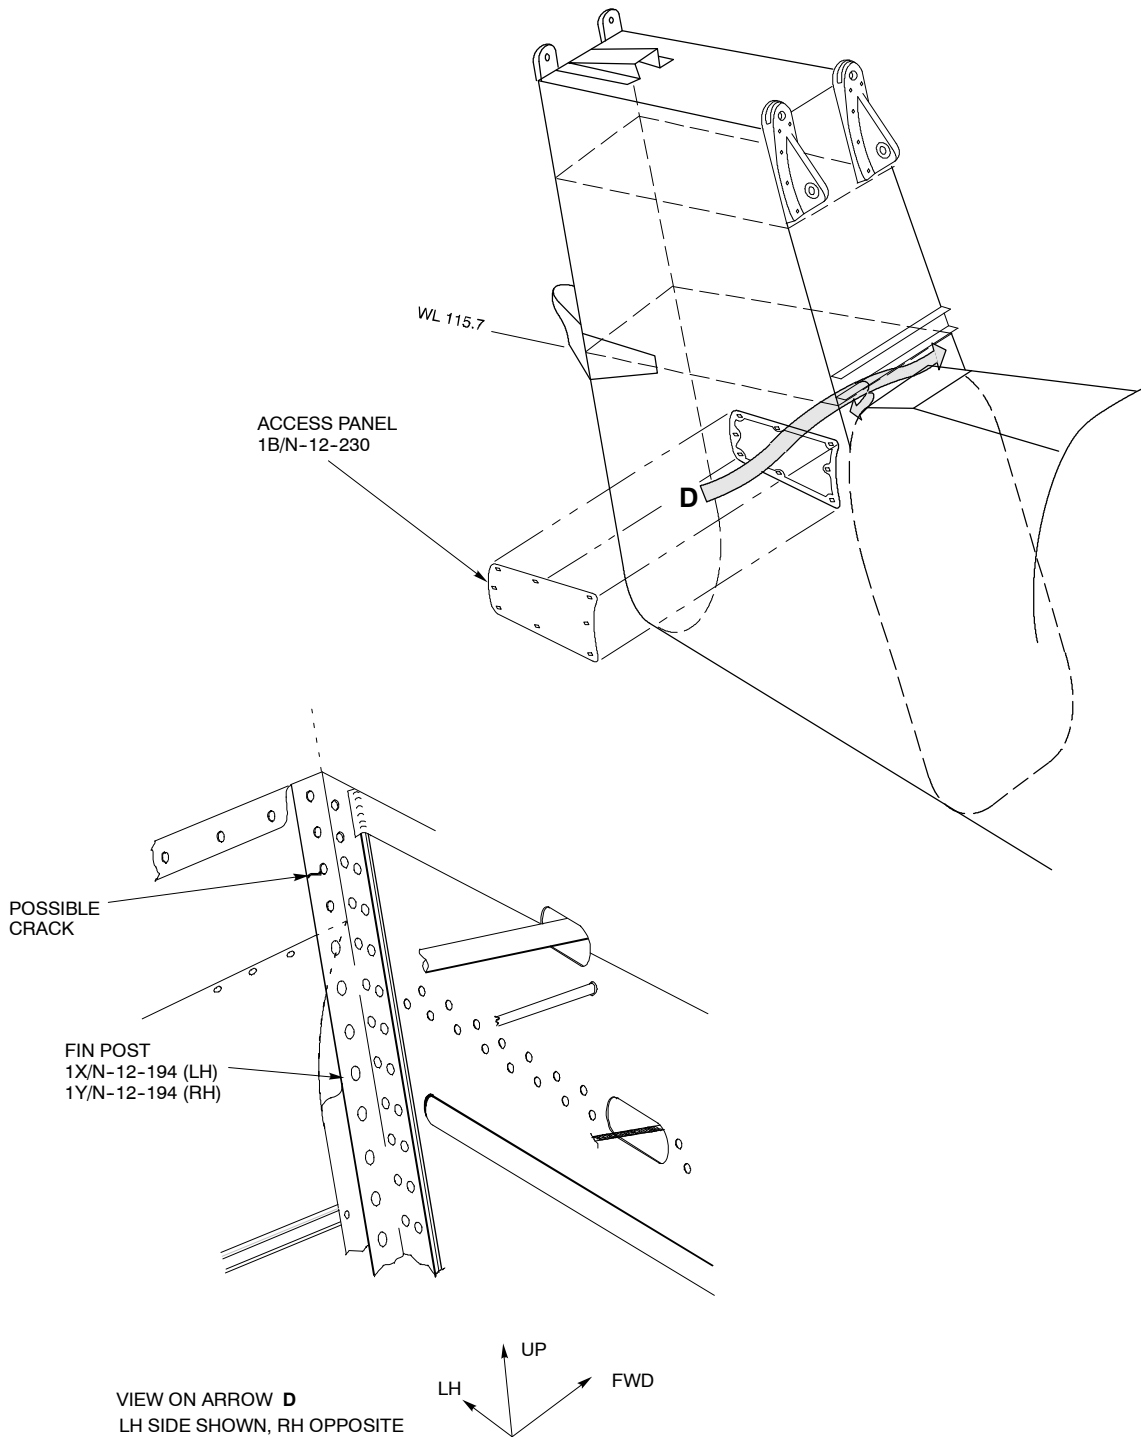
- (9) Using a strong light source and a mirror, visually inspect stub fin front corner posts PN 1X/N-12-194 and 1Y/N-12-194 for cracking around the rivet holes just below the stub fin lower diaphragm (Ref Fig 5).

**Figure 5 Possible Cracking as Identified on Fatigue Test**
