ALERT SERVICE BULLETIN

**TRANSMITTAL LETTER
FOR
ALERT SERVICE BULLETIN ANMD-53-19**

FUSELAGE REAR SECTION – STUB FIN – UPPER FIN REAR ATTACHMENT POINTS – INSPECTION

ANMD-53-19

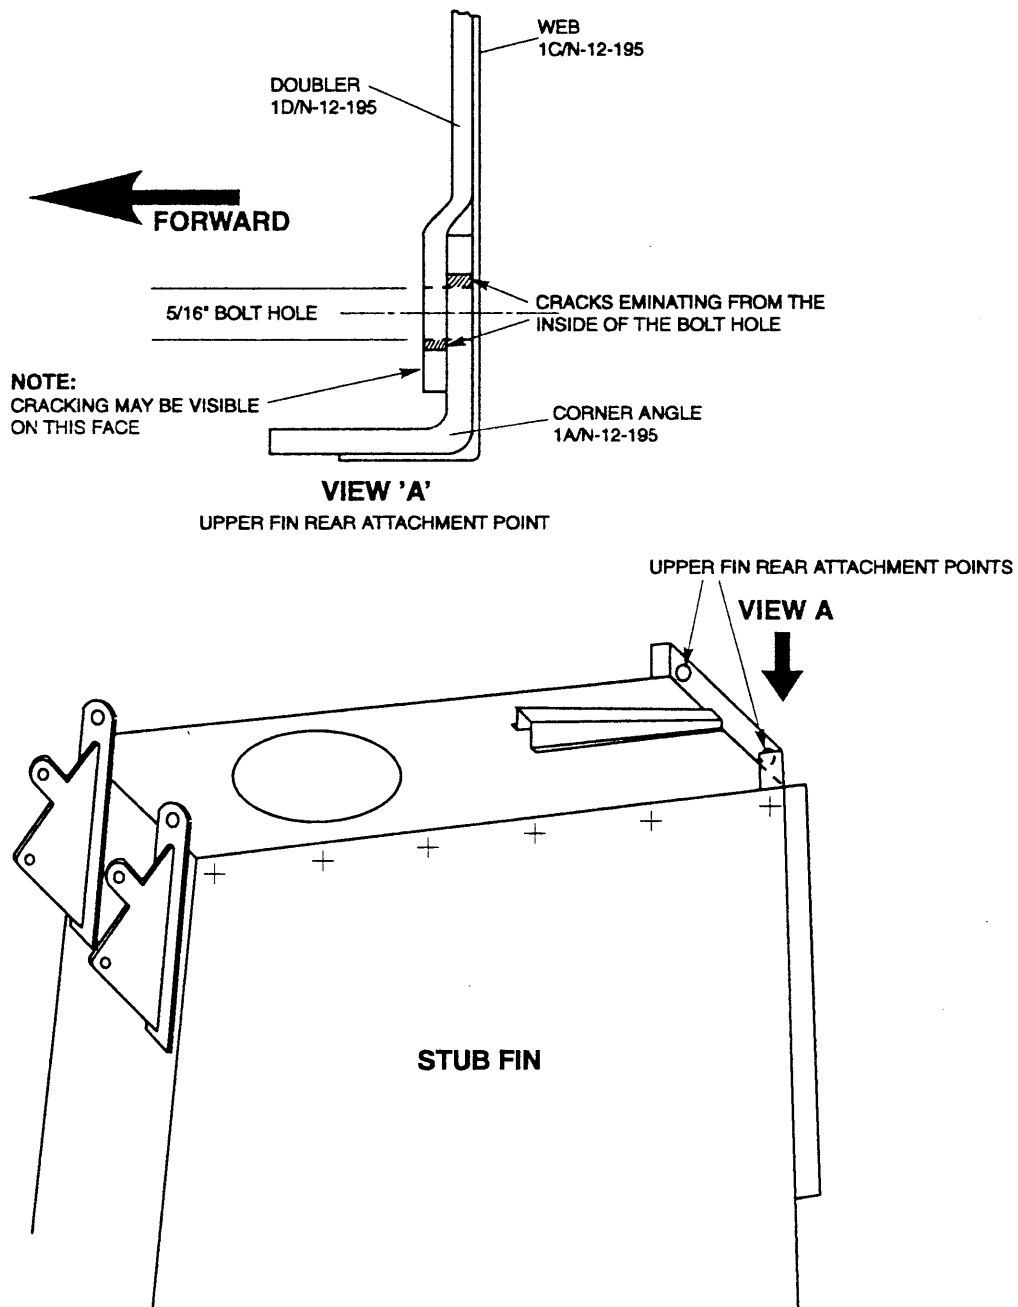
Figure 1 – Upper Fin to Stub Fin Attachment

A detailed visual inspection is to be performed to inspect for cracks radiating outwards from the inside of the rear fin attachment bolt holes in the Stub Fin rear face (Ref Fig 1) using one of the methods described in Part 1.

- (b) Taking care not to allow the bolt to rotate, remove the nut and 2 washers from only one bolt and, still without rotating the bolt, carefully push it out.
- (c) Using a Borescope inspect the bolt hole for horizontal cracking in the 3 layers of metal plate (Ref Fig 1).
- (d) Following the inspection, install the removed bolt in accordance with MM Chap 55-30-00.

- (a) Remove the Rudder (Refer MM Chap 55-40-00), Dorsal Fin and Upper Fin (Refer MM Chap 55-30-00)
- (b) Using a X10 magnifying glass and strong light, inspect the rear attachment bolt holes for horizontal cracking in the 3 layers of metal plate (Refer Fig 1).
- (c) Visually inspect the area surrounding the bolt holes for evidence of fretting and/or any other damage.

- (1) If cracks, fretting and/or any other damage is found either in the corner angle (PN 1A/N-12-195), the doubler (PN 1D/N-12-195) or the web (PN 1C/N-12-195) ASTA Defence is to be contacted for a repair scheme.
