ALERT SERVICE BULLETIN

SUBJECT: RUDDER - INSPECTION AND MODIFICATION OF INTERCOSTALS AND TRIM
TAB CONTROL ROD. (MODIFICATION N437)

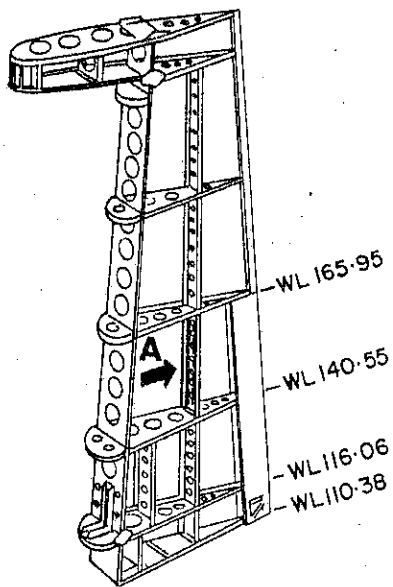
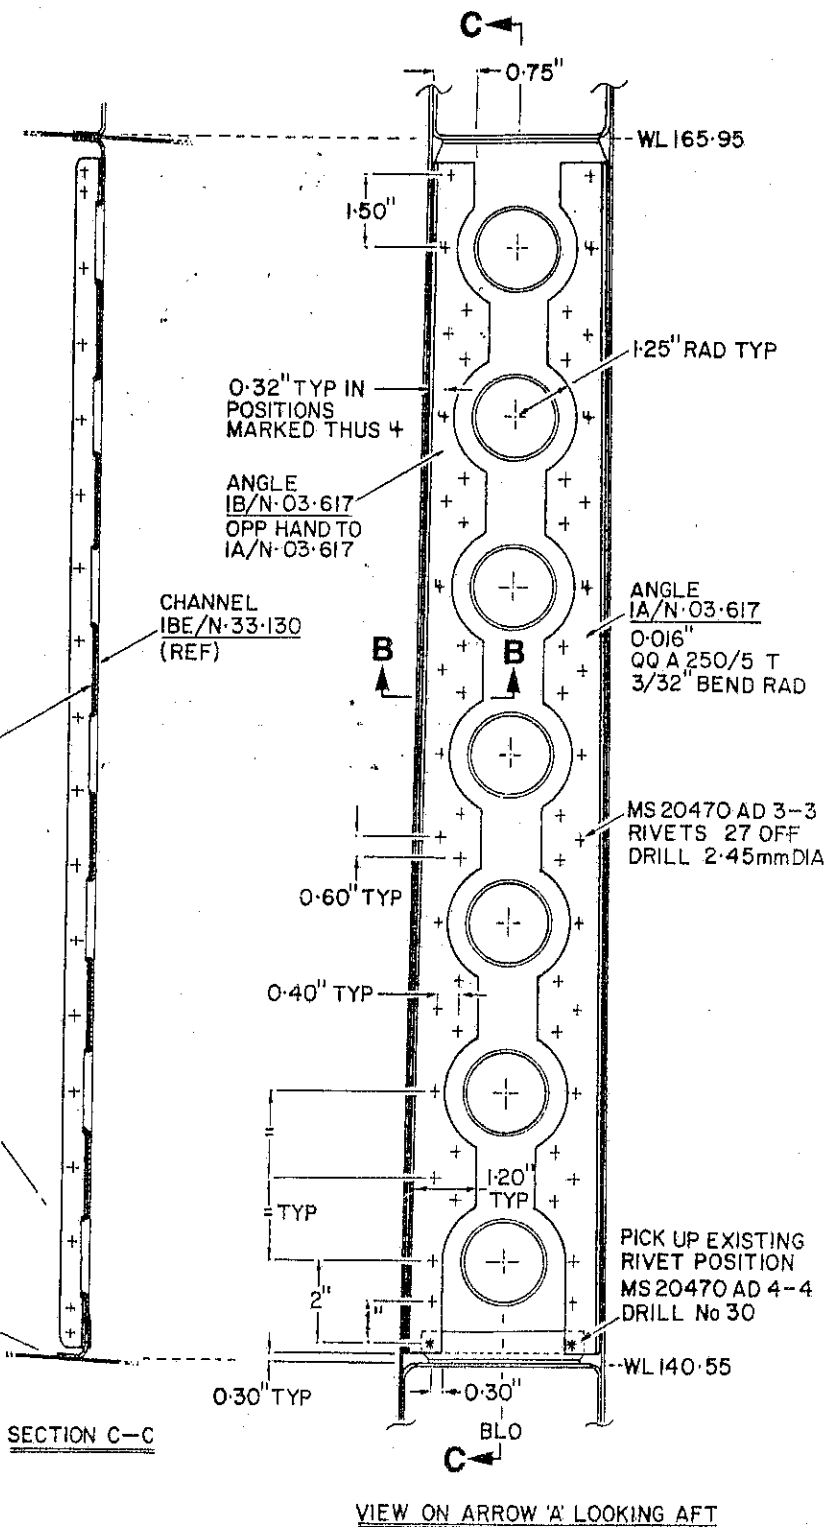
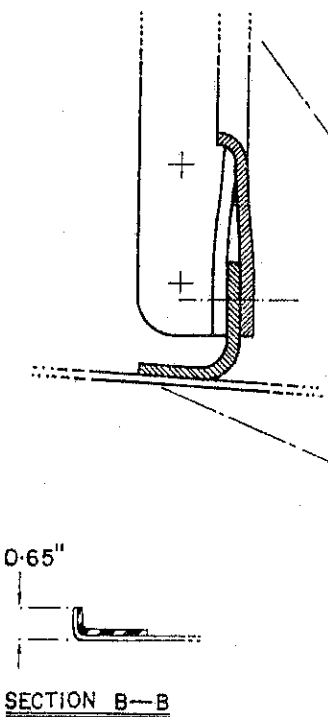
FIG 1

Instances have been reported of partial failure of an intercostal and chafing of the trim tab control rod during aircraft operation.

- A. Inspect intercostal between WL 140.55 and WL 165.95 (Ref detail A fig 1 for intercostal location) for working/loose rivets. If more than 3 consecutive rivets are found working/loose they are to be replaced before further flight with AGS 2050 () pop rivets.
- B. Place a straight edge (12 inch steel rule) across flutes along the intercostal rivet line.

- A. Remove rudder from aircraft (Ref M.M. 55-40-00).
- B. Suitably trestle rudder to obviate distortion. De-rivet and remove right-hand side skin between WL 110.38 and 165.95.
- C. Remove intercostal P/N IBE/N-33-130 (ref detail A fig 1 for location).
- D. Inspect intercostal for signs of cracks. No cracks are permissible.
- E. If no cracks are evident, reinforce both flanges of intercostal in accordance with fig 1; or replace with intercostal locally manufactured (heavier gauge without lightening holes) in accordance with figure 2.

Locally manufactured intercostals from heavier gauge do not require the additional flange reinforcing detailed in figure 1.
