Nomad

SERVICE BULLETIN NO: ANMD-55-27

TITLE: Stabilisers - Horizontal Stabiliser -
Pivot Bearings and Brackets -
Inspection for Side Play

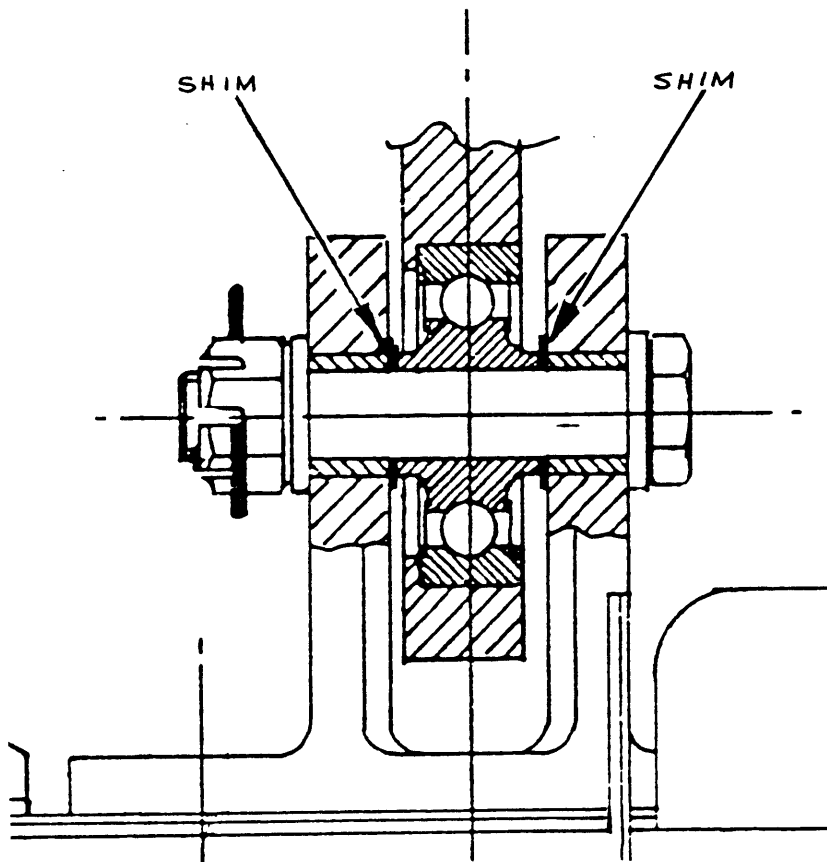
FIGURE 1

Excessive stress may be placed on the tailplane pivot brackets by tightening the nuts on the pivot bolts, if insufficient shims are inserted between each side of each pivot bracket and the bearing in the pivot brackets on the stub fin.

LOCATION OF SHIMS BETWEEN HORIZONTAL STABILISER PIVOT BEARINGS
AND HORIZONTAL STABILISER PIVOT BRACKETS

- B.
1. Install shims as required between the pivot bearings and the horizontal stabiliser pivot brackets to give between 0.000 and 0.002 inch end float of the horizontal stabiliser. Shims should be equally distributed between both pivot bearings.
 2. Tighten the pivot bolt nuts finger tight and install split pins.
