Nomad ALERT SERVICE BULLETIN

WINGS — FLAP OPERATING LIMITATIONS

ANMD-57-18

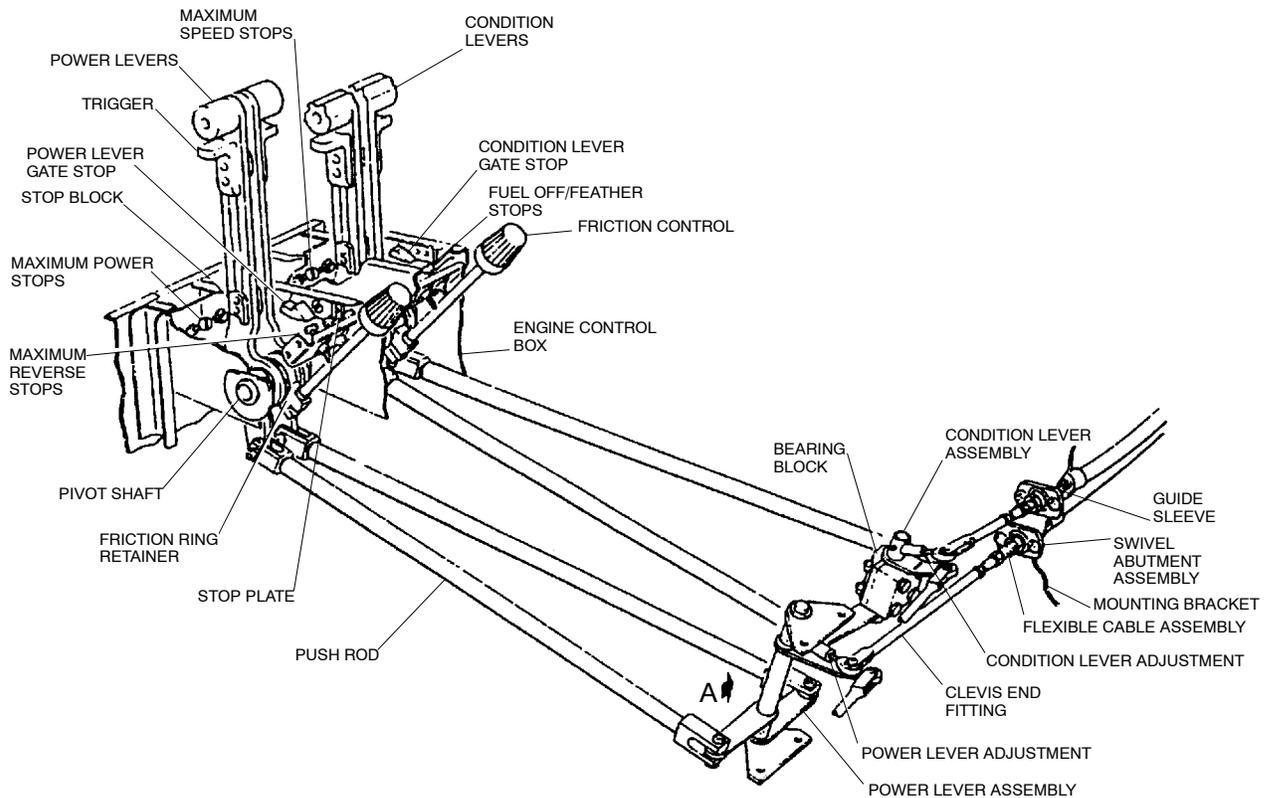
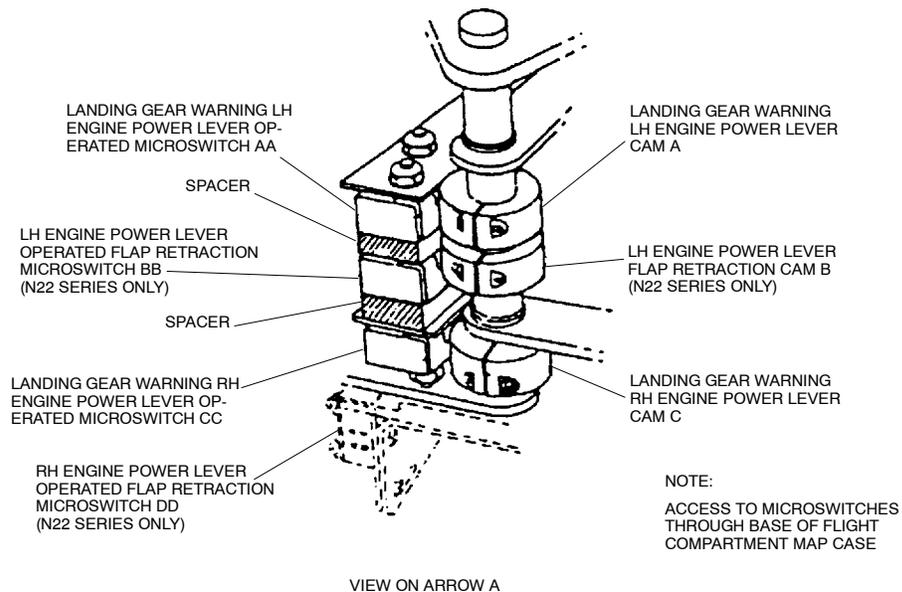
Figure 1 Engine Power lever Aural Warning Microswitches

B. **Part 2 - Adjustment of Engine Power Lever Actuated Landing Gear 'UP' Aural Warning Microswitches (Ref Fig 1)**

- (3) Check that over-travel of AA and CC microswitches is between 0.020 in to 0.030 in. If necessary, adjust as follows:
 - (a) Loosen nuts on the microswitch mounting rods.
 - (b) Adjust microswitch position accordingly.
 - (c) Lock mounting rod nuts when over-travel adjustment is complete.
- (4) Confirm that all microswitches, when operated, have between 0.020 in and 0.030 in over-travel remaining.
- (5) Set both power levers to full forward.
- (6) Connect continuity tester across terminals C and NO of top microswitch AA.

- (7) Retard LH power lever to marked position corresponding to a torque pressure of 28.0 to 31.0 psi.
- (8) Adjust cam A by loosening two locking screws on the cam. If the continuity tester indicates continuity, rotate cam A until continuity is broken. Adjust cam A until continuity is just indicated and lock the cam adjusting screws.
- (9) Reset the LH power lever to full forward.
- (10) Retard the RH power lever to the marked position.

- (11) Adjust cam C by loosening two locking screws on the cam. If the continuity tester indicates continuity, rotate cam C until continuity is broken. Adjust cam C until continuity is just indicated and lock the cam adjusting screws.
- (12) Reset the RH power lever to full forward.
- (13) Disconnect the continuity tester.
- (14) Re-confirm the over-travel setting of each of the microswitches.

Check that over-travel adjustment of flap retraction microswitch BB, operated by LH engine power lever, remains within the limits 0.020 in to 0.030 in when operated. Also check that microswitch switch BB is activated at a torque pressure of 60 ± 5 psi (engine protractor angle $76^\circ \pm 2^\circ$). Lever operated flap microswitch DD for RH engine power is not affected by the adjustments.
