Nomad **ALERT SERVICE BULLETIN**

**TRANSMITTAL LETTER
FOR
SERVICE BULLETIN ANMD-71-8**

**POWER PLANT — ELECTRICAL HARNESS — STARTER CIRCUIT
FIREWALL STUD — INSPECTION AND REPLACEMENT (MOD N789)**

ANMD-71-8

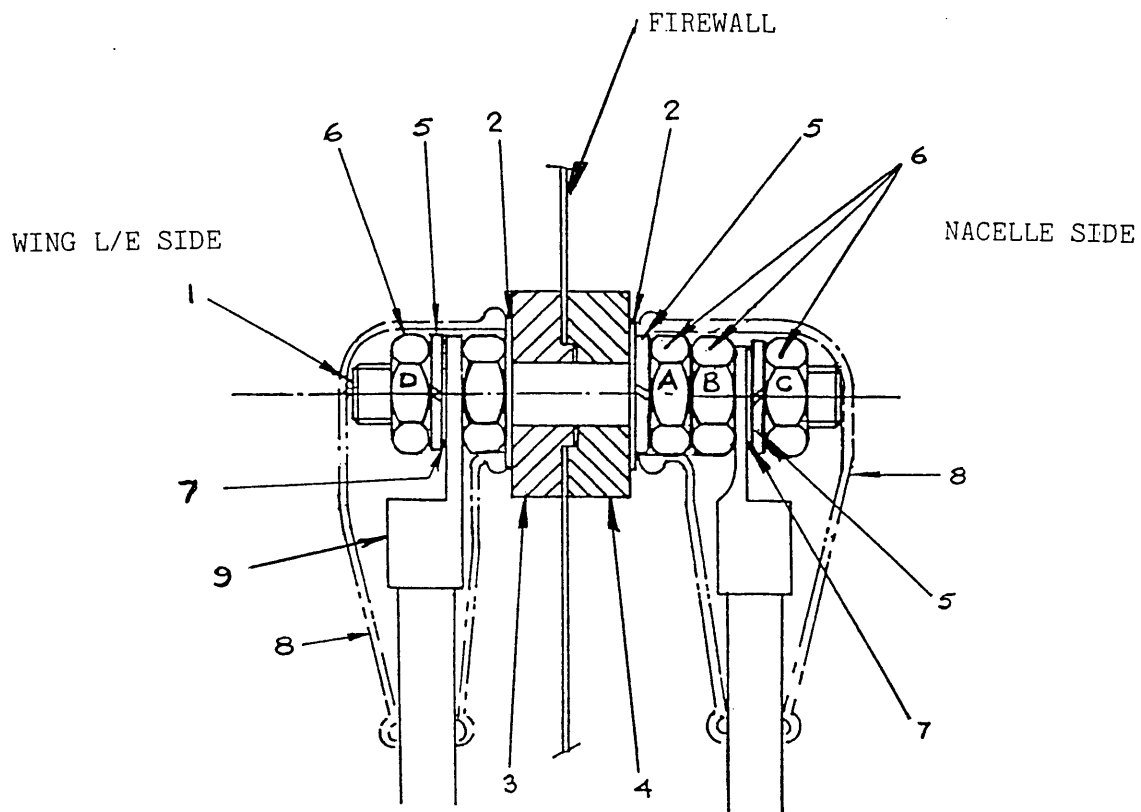
Figure 1 Starter Cables and Stud Assembly

Instances have occurred where the terminal lug on the starter circuit cable, at the engine firewall, has been severely damaged by overheating. The firewall stud has also shown signs of heating (blueing) and arcing (pitting). The incorporation of Mod N789 overcomes this hazard. Mod N789 is identical to Mod N724 (Service Bulletin ANMD-24-5) which applies to the generator circuit only.

Incorporation of Mod N789. The existing steel studs, PN 1/N-81-424, are replaced with copper studs, PN 1/N-81-925. The attaching hardware and cable lugs are also replaced.

- 1 Onto the longer end of the stud (1) place special washer (2) and insulating washer (3).
- 2 Insert stud through firewall from the wing leading edge side.
- 3 Place insulating washer (4), special washer (2), spring washer (5) and nut (6A) onto stud.

- 4 Torque tighten nut (6A) to 20 in lb.
- 5 Assemble locknut (6B) and torque tighten against nut (6A) to 80 in lb.
- 6 Connect cables K1B2 and K2C2 to respective studs, washer (7), spring washer (5) and nut (6C).
- 7 Torque tighten nut (6C) to 60 lb in and replace protective cover (8).

- 8 On the inboard side of the firewall connect cables K1A2 and K2B2 to respective studs, washer (7), spring washer (5) and nut (6D).
- 9 Torque tighten nut (6D) to 60 lb in and replace protective cover (8).
- (g) Reconnect battery and at the next engine start check Starter operation in accordance with 'Starting Procedure', Section 3 of the relevant Flight Manual.
