Nomad SERVICE BULLETIN

TRANSMITTAL LETTER
FOR
SERVICE BULLETIN NMD-21-1

AIR CONDITIONING - DISTRIBUTION — PLENUM CHAMBER FLAPPER VALVE ASSEMBLY REPLACEMENT (MOD N774)

AIR CONDITIONING - DISTRIBUTION - PLENUM CHAMBER FLAPPER VALVE ASSEMBLY REPLACEMENT (MOD N774)

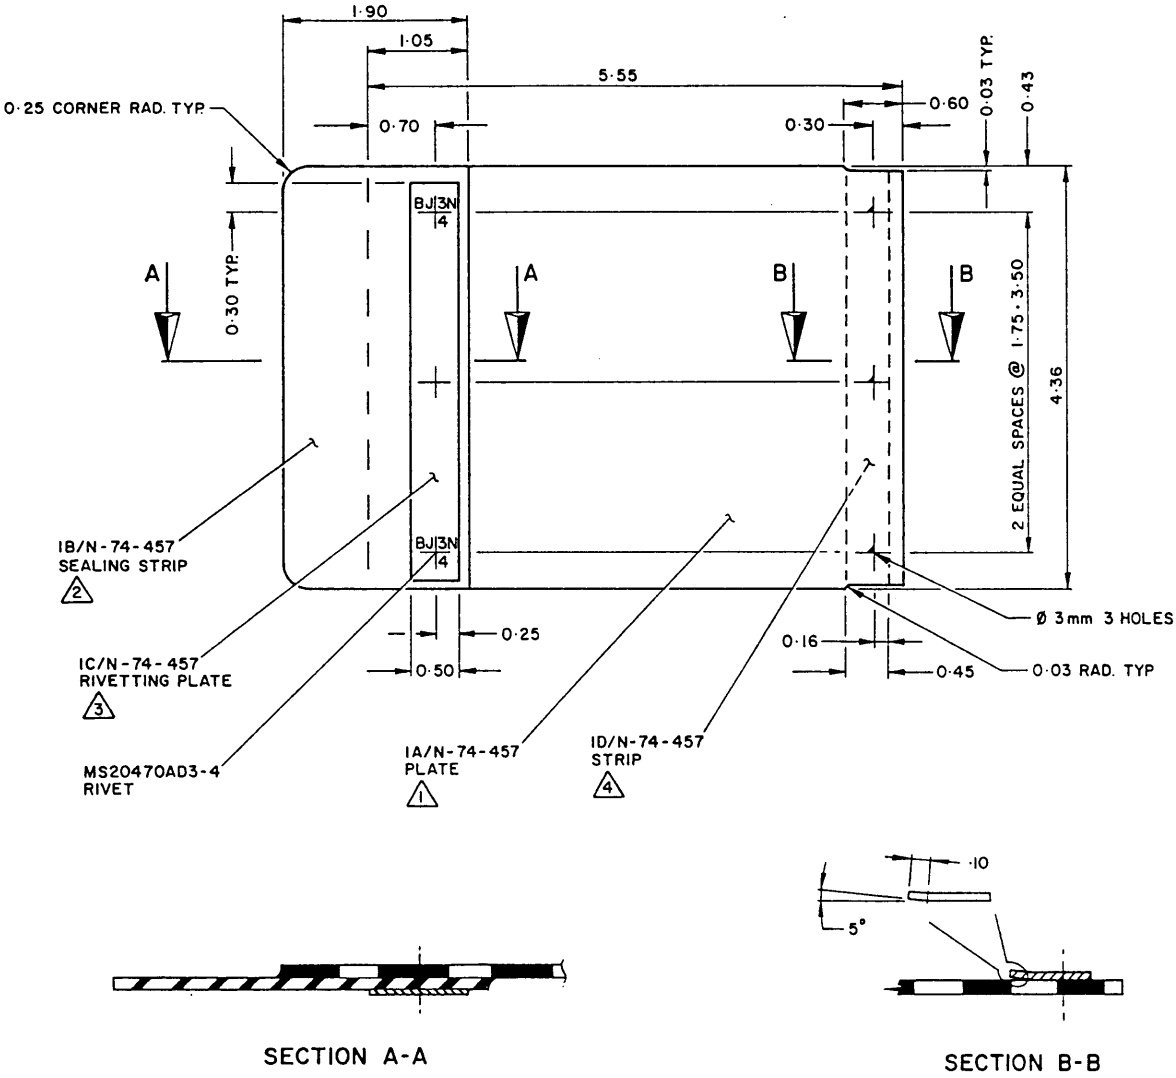
Figure 1 Flapper Assembly — Manufacture

To overcome high flapper assembly failures by strengthening the flapper assembly and improving in-service reliability.

A new Flapper Assembly PN 1/N-74-457 is manufactured and installed in lieu of Flapper Assembly PN 1/N-74-409. The flapper plate is increased in thickness from 0.040 to 0.080 in and a 0.040 in thick reinforcing strip added.

A. Manufacture new Flapper Assembly PN 1/N-74-459 as follows (Ref Fig 1):

- (1) Manufacture Plate PN 1A/N-74-457.
- (2) If available, use a superseded Plate PN 1A/N-74-409 to back-drill the three holes in the strip and the three rivet holes in the plate. If not refer to Figure 1. Deburr all edges and holes.
- (3) Alodine plate and epoxy prime (one coat).
- (4) Manufacture Sealing Strip PN 1B/N-74-457. Use Plate PN 1A/N-74-457 as a template to cut three sealing strip holes.
- (5) Bond sealing strip to plate using Araldite AW106/HV953U (Ref Fig 1 Sect A-A).
- (6) Manufacture Riveting Plate PN 1C/N-74-457. Deburr all edges and holes.
- (7) Alodine plate and epoxy prime (one coat).
- (8) Rivet riveting plate to flapper assembly (Ref Fig 1 Sect A-A).

Ensure rivet heads are on riveting plate side of assembly. Do not over compress rubber sealing strip.

- (9) Manufacture Strip PN 1D/N-74-457 (Ref Fig 1).
- (10) Bond strip to flapper plate using Araldite AW106/HV9534. Ensure holes in strip are aligned with flapper plate holes.
