GOVERNMENT AIRCRAFT FACTORIES

SUBJECT: NOMAD SERVICE BULLETIN NMD-32-10 REVISION 1

SUBJECT: ELIMINATION OF OPENINGS IN NOSE LANDING GEAR ACTUATING MECHANISM HOUSING (MODIFICATION N345)

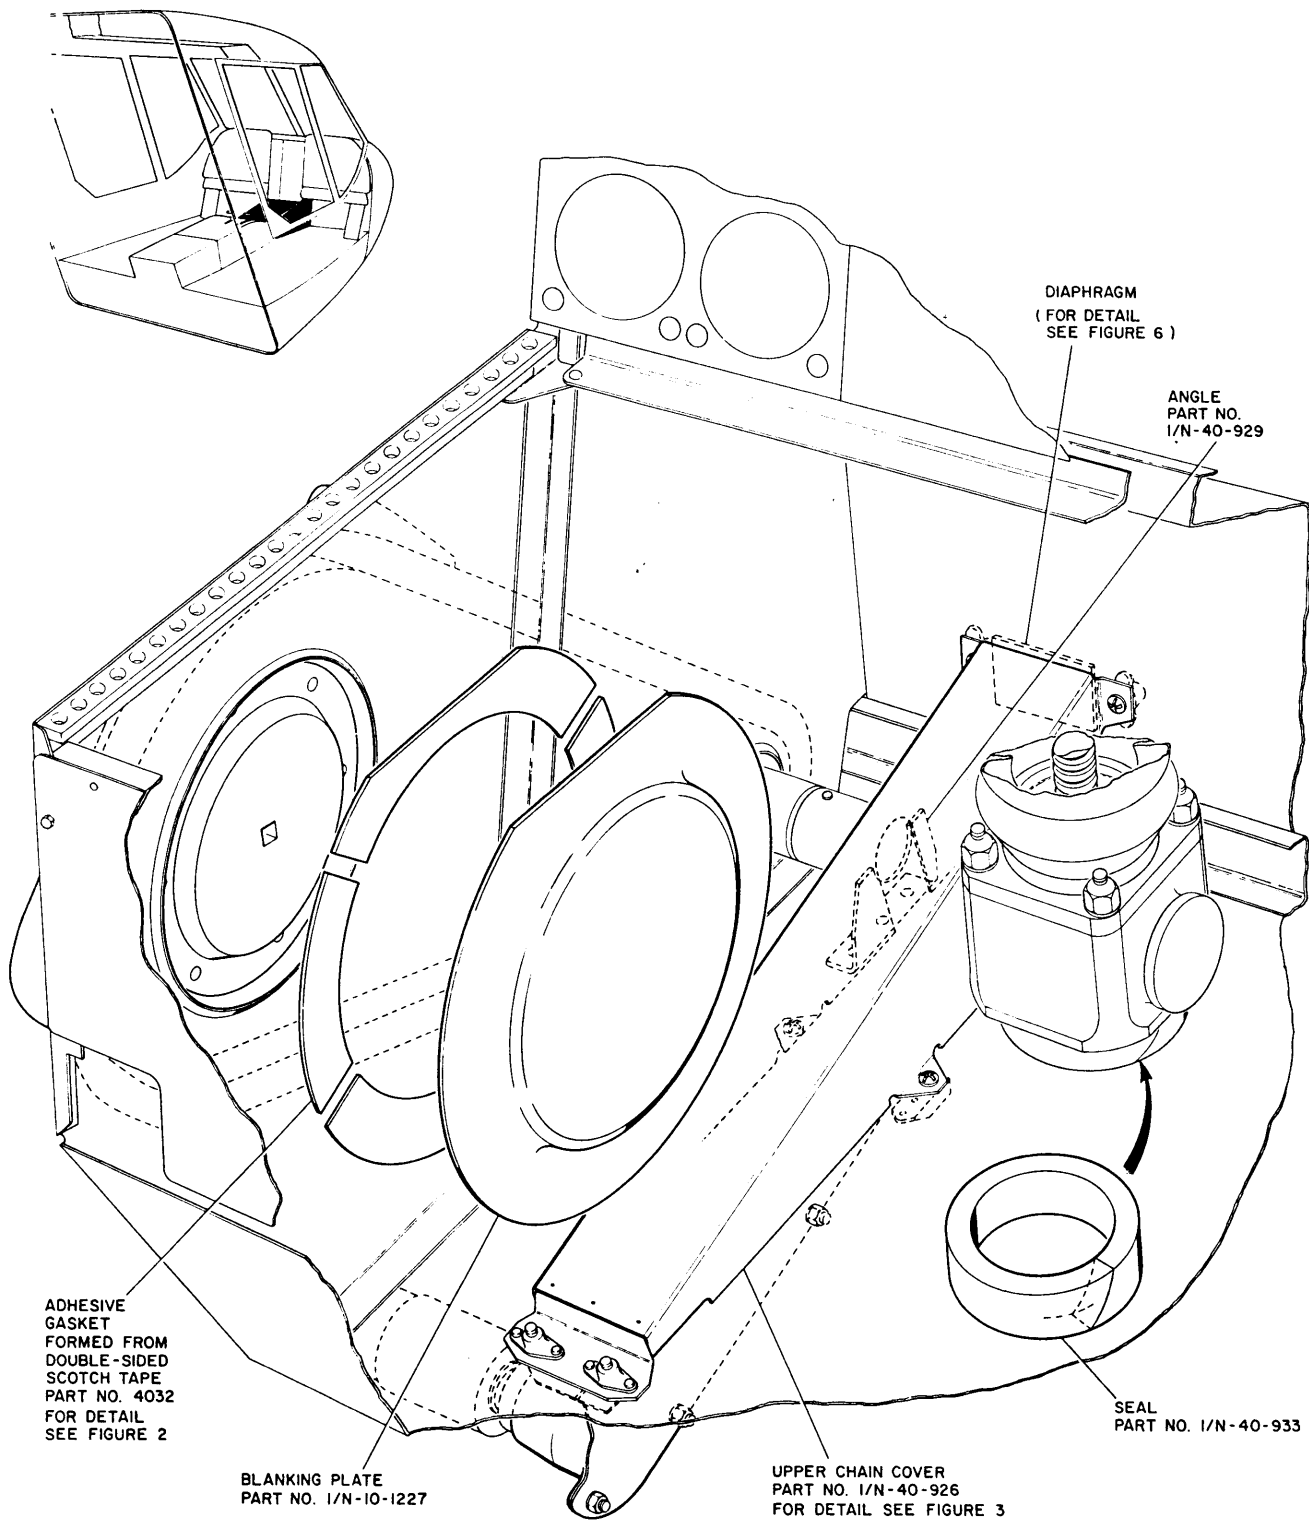
Installation of Mod N345
Figure 1

Under certain operating conditions it is possible that foreign objects could pass into chain drive areas of the nose landing gear actuating mechanism located within the centre console and possibly cause malfunction of the landing gear.

A five inch diameter lightening hole in the left hand side panel of the centre console is covered by a blanking plate, and the upper chain cover has been redesigned to enclose the chain completely.

- C. Fit blanking plate P/N 1/N-10-1227 over five inch diameter lightening hole in left hand side panel of the centre console (Ref Figure 1).
- (1) Thoroughly clean mating surfaces with a degreasing solvent such as trichlorethylene.
 - (2) Secure blanking plate to left hand side panel using double-sided Scotch tape P/N 4032 (3M Co.) cut as illustrated in Figure 2.
- D. Remove nose gear screw actuator chain drive cover assembly, discard upper chain cover and four self-locking nuts and retain lower chain cover, side cover plate and the remaining attaching parts (Ref Figure 3).

G. Install seal P/N 1/N-40-933 between the screw actuator and the wheel well top panel (Ref Figure 1).

(2) Make an angled cut through the seal (Ref Figure 1).

(4) Fit the seal to the screw actuator, ensuring that the upper and lower edges of the seal are in firm and uniform contact with the screw actuator and wheel well top panel, respectively, and that the cut in the seal is fully closed by the adhesive.

(1) Locate angle P/N 1/N-40-929 in position against upper chain cover (Ref Figure 1) and drill 0.1285 inch diameter hole in wheel well top panel to suit.
