GOVERNMENT AIRCRAFT FACTORIES

Nomad

SERVICE BULLETIN

SUBJECT: REVISED AIRSPEED INDICATOR LIMIT MARKING (V_Y) FOR
N24A SERIES AIRCRAFT

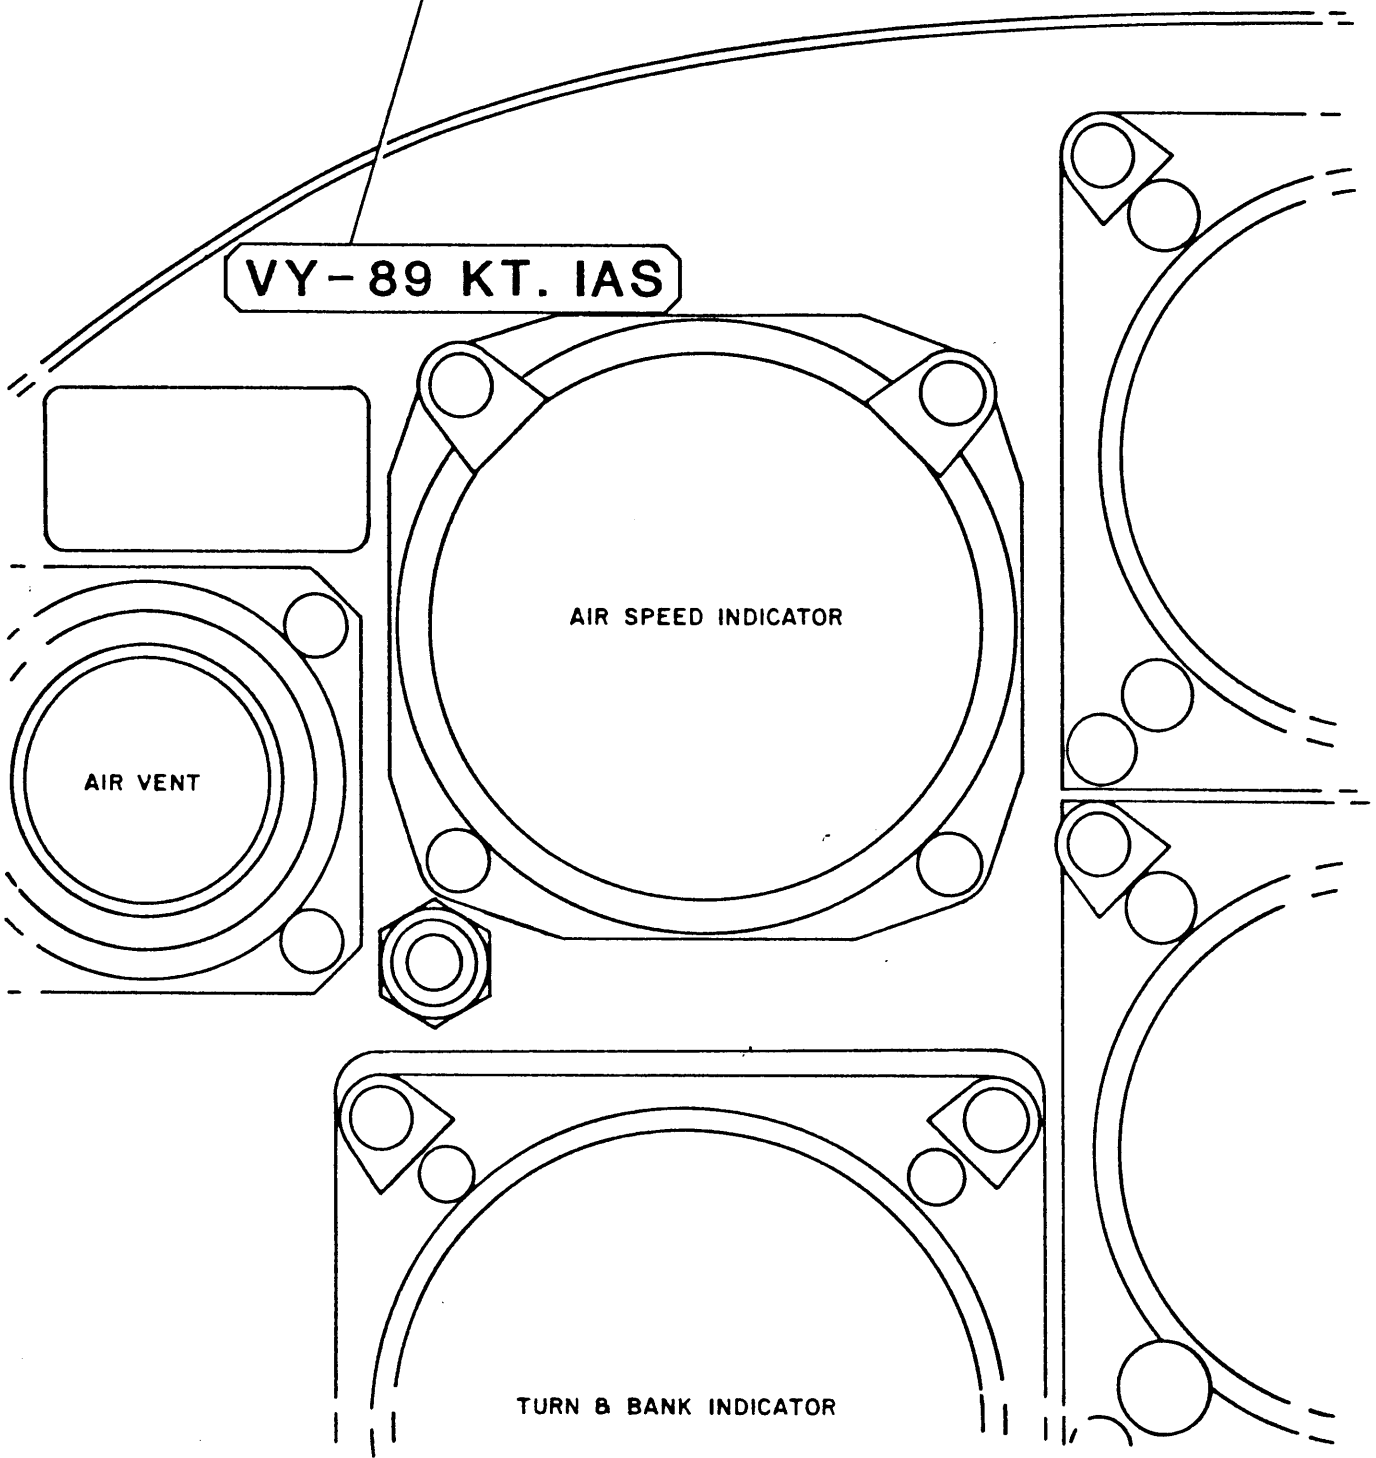
**V_y Placard Affixed as Shown
(RH Similar)
Figure 1**

PLACARD (I/N-00-913)
ALTERNATIVE -
METAL LABEL OR EQUIVALENT
(SILVER OR WHITE LETTERS ON BLUE BACKGROUND)

- A. Affix a placard with the caption, as shown in Figure 1, adjacent to the LH ASI in the location shown.
- B. When an optional ASI is fitted in the RH instrument panel affix a similar placard as in item A above.
