# ALERT SERVICE BULLETIN

SUBJECT: OPERATION OF EMERGENCY EXIT IMPEDED  
BY INTERIOR TRIM PANEL

All Nomad N22 Series and N24 Series aircraft whose log books do not already record the embodiment of Mod N627 or compliance with Alert Service Bulletin ANMD-52-6.

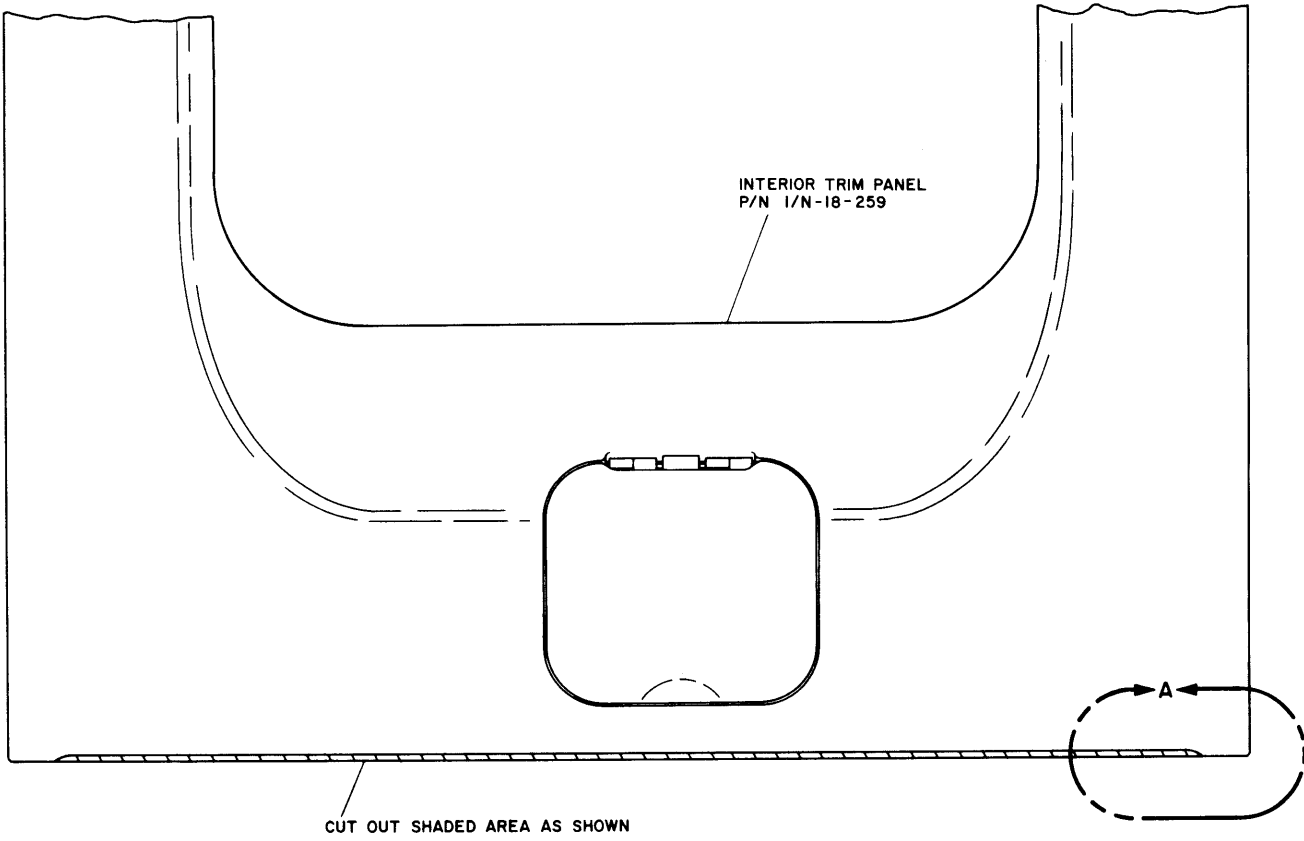
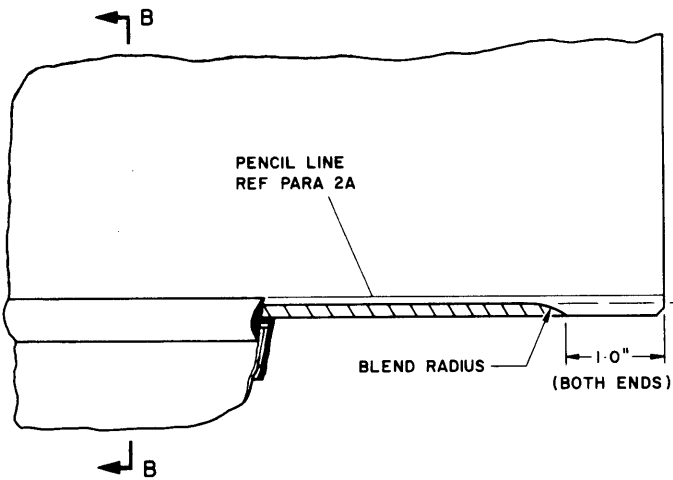
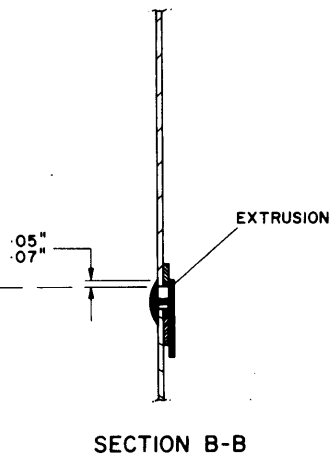
Rework of Emergency Exit Interior Trim Panel  
Figure 1

Reports of excessive force being required to push the emergency exit clear of the aircraft.

The lower edge of the trim panel is relieved to provide minimal engagement in the trim retaining extrusion and to clear the emergency exit surround in the fuselage.

- A. With the emergency exit door complete with interior trim panel installed in the fuselage, mark the trim panel along the lower edge retaining extrusion using a sharp medium hardness pencil.
- B. Remove the interior trim panel from the emergency exit door (Ref MM 25-20-00 and 52-20-00).
- C. Draw a line .05 to .07 inches below and parallel to the line drawn in step A (Ref Figure 1) and extending to within one inch of each side of the panel.
- D. With the exception of those sections one inch from each side of the panel, cut out the shaded area of the panel (Ref Figure 1) so that .05 to .07 inches of engagement with the lower trim retaining extrusion will be achieved when the panel is fitted to the door.
- E. Refit the trim panel to the emergency exit door (Ref MM 25-20-00).
