TRANSMITTAL LETTER FOR SERVICE BULLETIN NMD-52-12

DOORS — ENTRANCE — UTILITY STEPS (CO G100) — REINFORCEMENT (Mod N732)

NMD-52-12

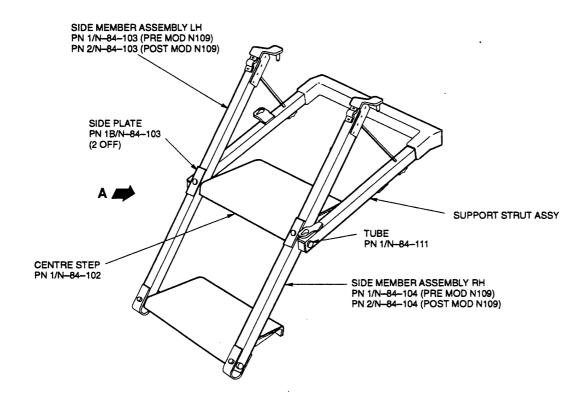
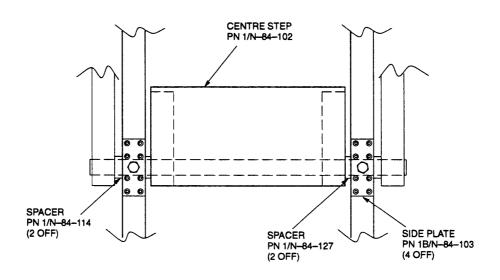
Figure 1 Utility Steps (CO G100) Pre Mod N732

To prevent cracking of the side member assemblies of the utility steps in the vicinity of the support strut attachment.

- (1) Derivet centre step PN 1/N-84-102 (Ref Fig 1). Support tube PN 1/N-84-111 and punch out two pins PN 1/N-84-113. Discard pins.
- (2) Grind off the peened end of the two bolts securing tube PN 1/N-84-111. Remove nuts, washers and bolts and scrap. Withdraw tube completely.
- (3) Scrap spacers PN 1/N-84-114 (2-off) and PN 1/N-84-127 (2 off). Derivet and remove four side plates PN 1B/N-84-103 from the LH and RH side members (Ref Fig 1). Punch out rivet tails from the side members. Scrap side plates.
