SERVICE BULLETIN

Reference No. 32

SUBJECT: MAIN UNDERCARRIAGE POD - INCREASED RIGIDITY

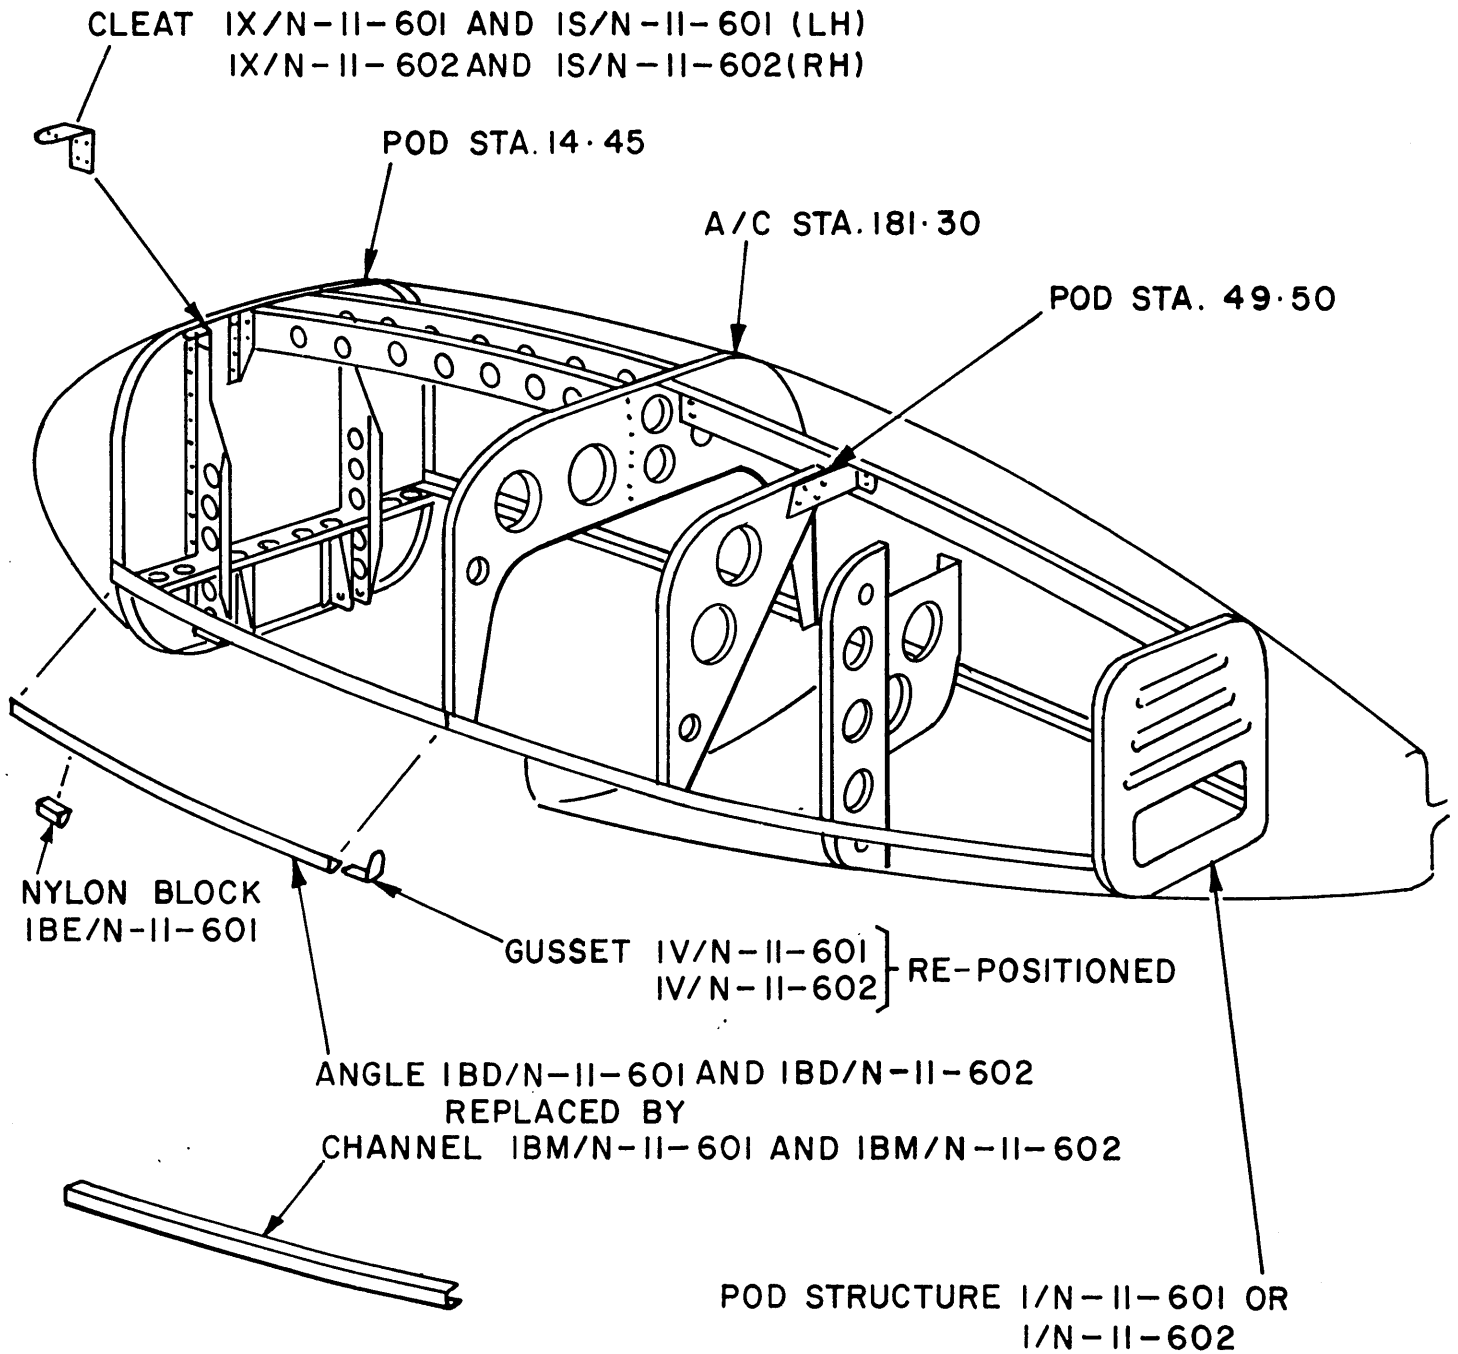
FIGURE 1 SB N 22-53-1

When subjected to heavy landings the undercarriage pod has been found to distort, especially the L.H. Battery pod. The result is for the forward door Assy to remain partially open and so prevent operation of "landing gear up" indication when fully retracted.

Part A. Stiffening of Door Opening (Ref. Fig. 1 and Fig. 2)

Part B. Stiffening of Bulkhead Pod STN. 14.45 (Ref. Fig 1 and 3)

Part C. Stiffening of Pod Frame STN 49.50 (Ref. Fig. 1 and 4)
