# SERVICE BULLETIN

SUBJECT: INSPECTION OF STUB WING UPPER FRONT SPAR CAP  
FLANGES OUTBOARD OF LANDING GEAR SCREW ACTUATOR BAYS

**NMD-53-6**

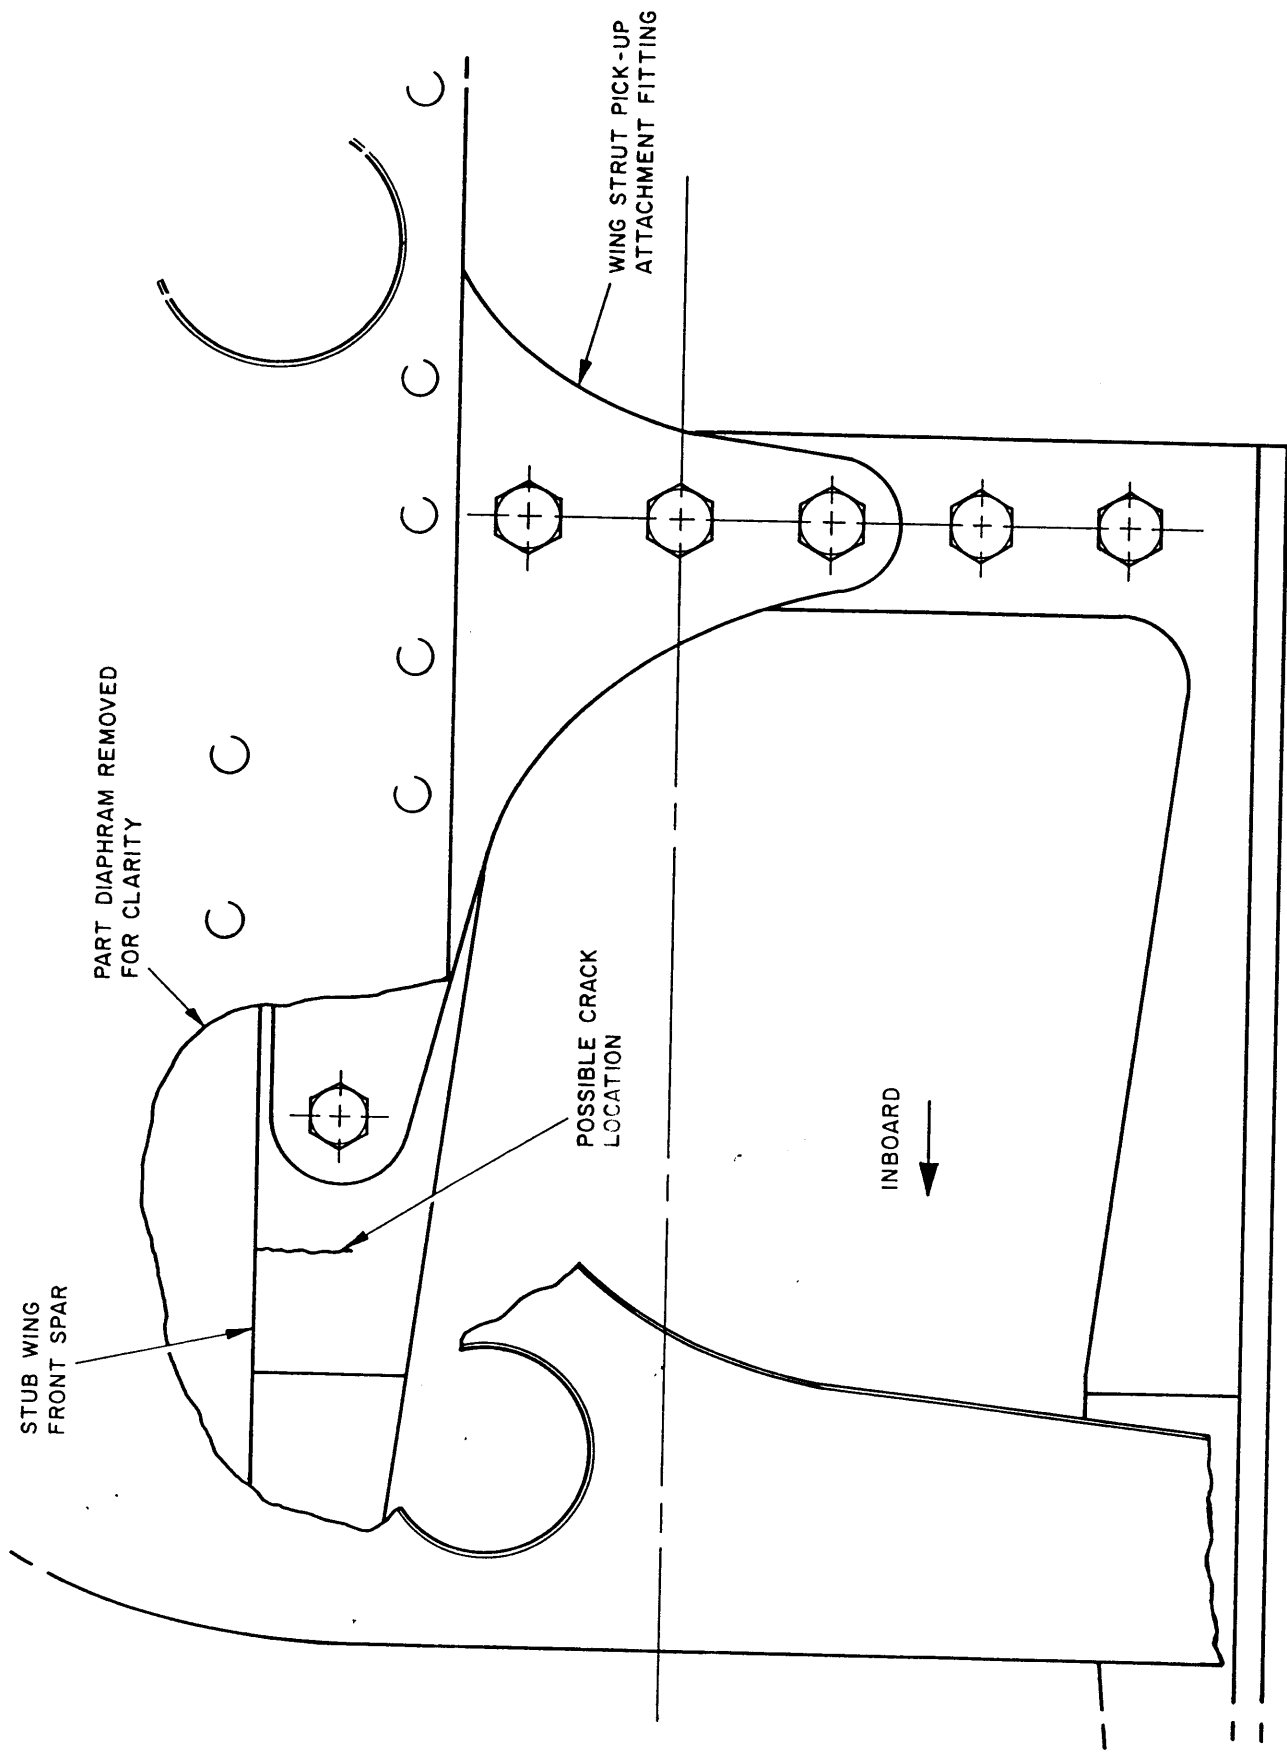
FIGURE 1 STUB-WING INSPECTION LOCATIONS

The stub wing upper front spar cap and flanges require inspection visually, and by the eddy current method, in the area of Buttock Line 47.6 (outboard of the main landing gear screw actuator bays). If defects are revealed by the eddy current inspection, further inspection will be required to determine the extent of the defect.

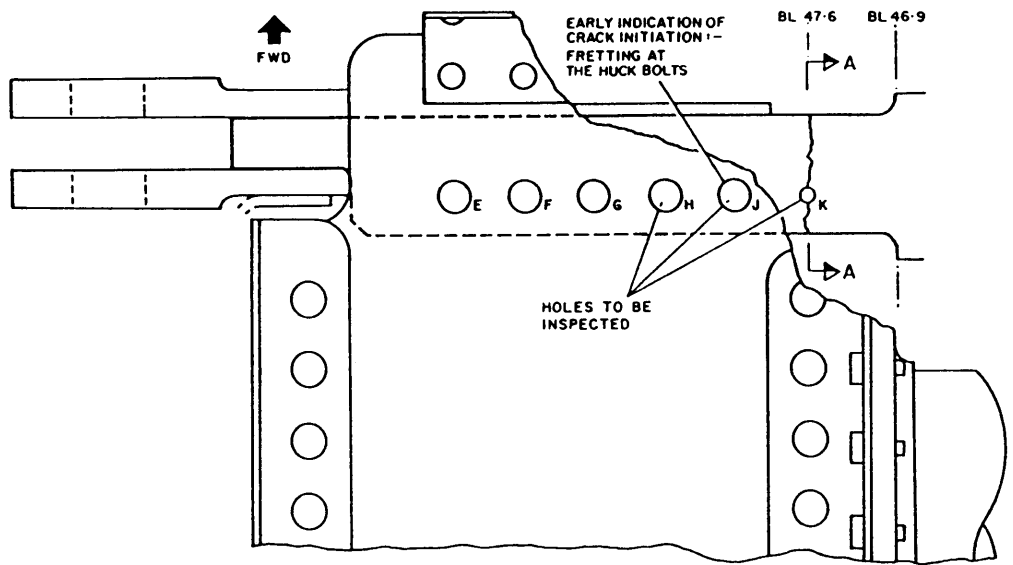
FIGURE 5 EDDY CURRENT INSPECTION OF SPAR CAP FLANGE

Scan each of the 6 holes at positions 1,2, & 3 for at least 2 complete rotations and re-zero the probe at each position - Ref Figure 5.

A sharp upscale meter deflection in excess of 20% FSD is reason for further investigation. Indications from cracks are characteristically abrupt upscale meter deflections.

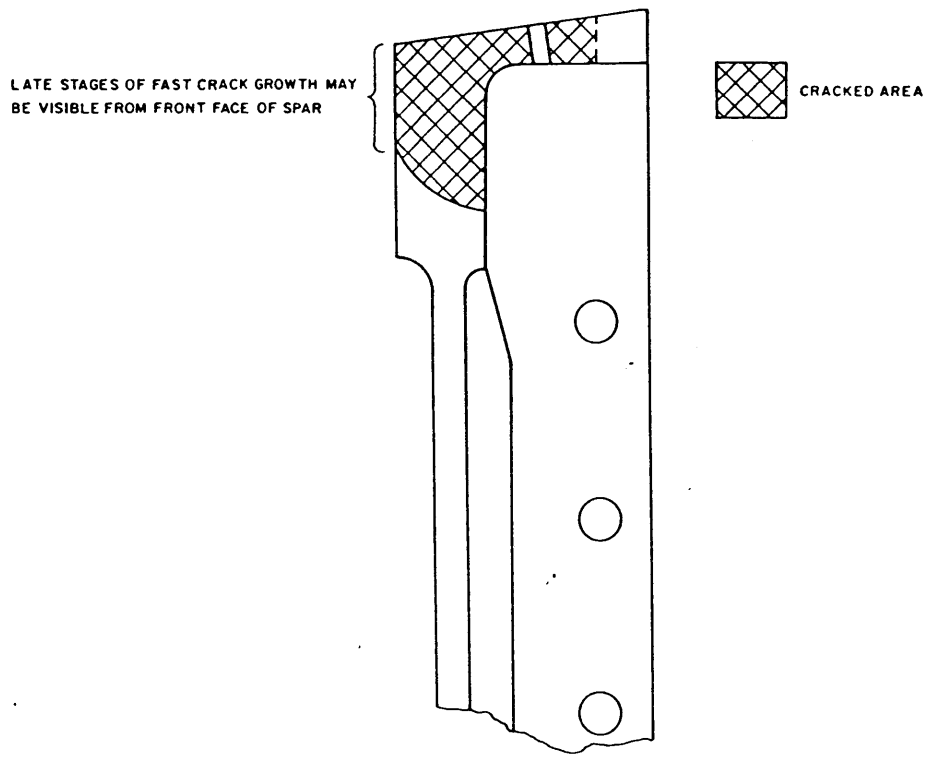
FIGURE 6 STUB WING FRONT SPAR UPPER CAP

- (3) Aircraft may be returned to service with a crack from the forward side of the hole, provided that the crack does not extend more than halfway into the fillet radius at the intersection of the spar flange and the spar cap (Ref Figure 7). In this case more frequent inspections will be necessary, and GAF must therefore be advised in order that a revised inspection interval may be established.
