MANDATORY

Service Bulletin

Cargo Door Forward Slide, operating rod and handle.

AIRCRAFT	SERIAL NUMBER(s)
GA8 & GA-TC320	All GA8 Serial Numbers

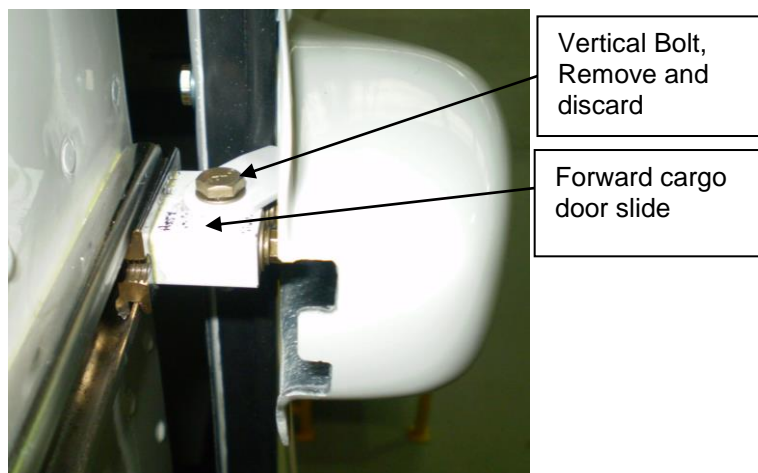
Figure 1: Forward Cargo Door Slide with door swung open.

1. Open the door handle so that the door swings out to gain access to the Forward Cargo Door Slide Assembly, see Figure 1 below.

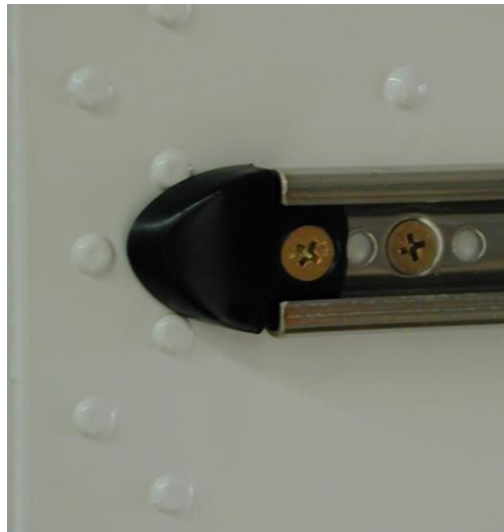
Figure 2: Nylon Track End

2. Remove the Forward Cargo Door Slide, by removing the vertical bolt and sliding the slider out of the track. On earlier versions of the Airvan it would be necessary to remove the Nylon Track End as shown in Figure 2 below to be able to remove the slider.

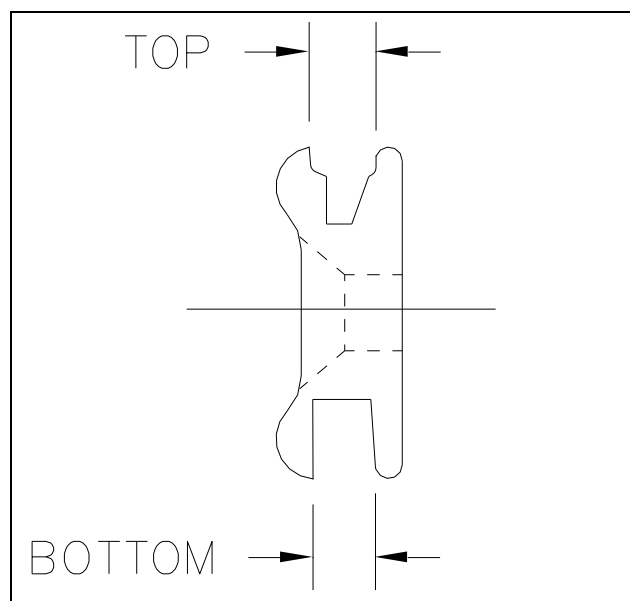
Figure 3: Worn slider indicating where to measure.

4. Measure the groove width and if the groove is wider than 0.145" at any point along the slider or if the part is cracked or excessively worn a new slider, Item 1, must be fitted.
5. Irrespective of Item 1, Items 2 to 7 MUST be fitted as shown in Figure 4 and listed in below.

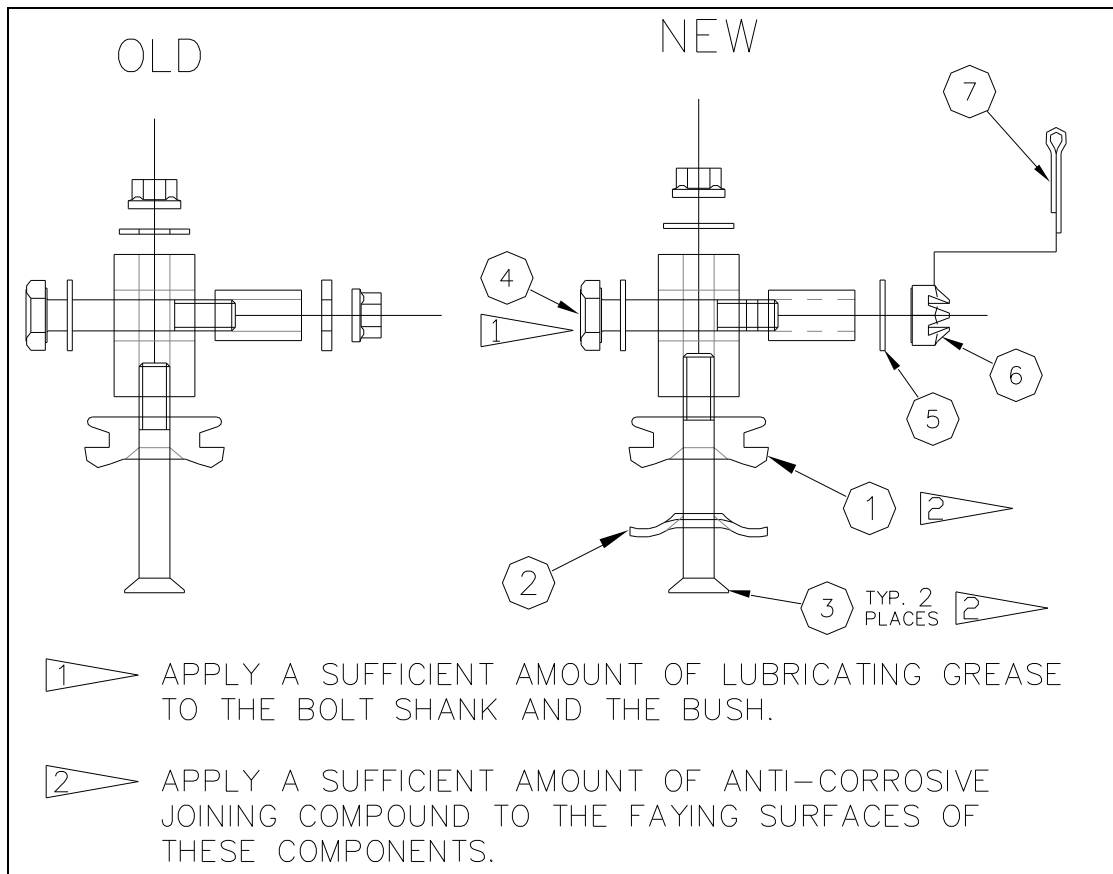
Figure 4: Old (left) and New (right) Forward cargo door slide.

ITEM	OLD ASSEMBLY	NEW ASSEMBLY	QTY
1	GA8-521022-149	GA8-521022-149 (If old part is worn)	1
2	-	GA8-521022-151	1
3	MS24694-S64	MS24694-S65	2
4	AN3-10A	AN3-11	1
5	AN960-10	AN960-10L	1
6	MS21042-3	AN310-3	1
7	-	MS24665-132	1

- Reinstall new slider assembly and refit the Nylon Track End if it was removed.

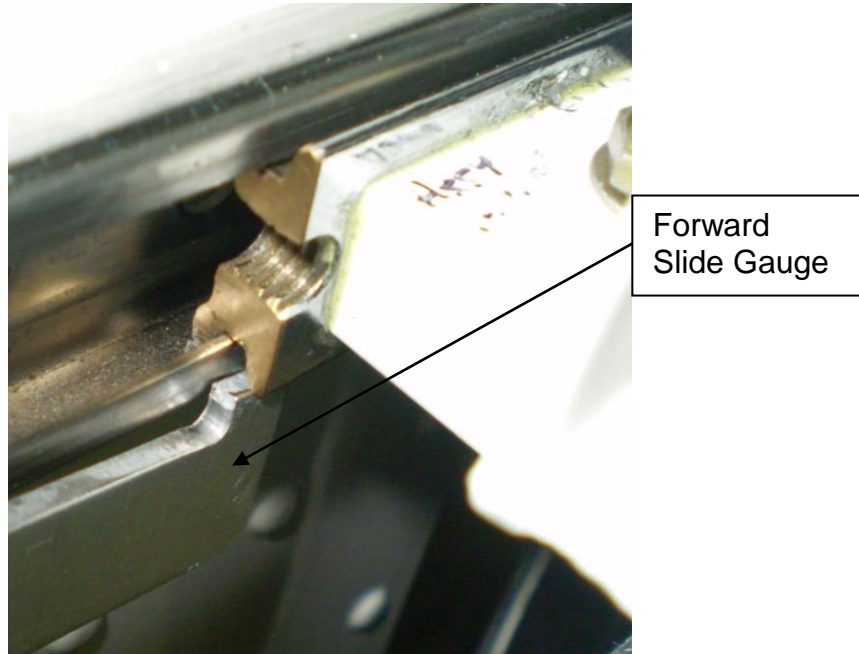
Figure 5: Checking with the Forward Slide Gauge (all four corners require checking)

1. Open the door handle so that the door swings out to gain access to the slider (see ACTION 1, Para 1)
2. Try to insert the Forward Slide Gauge (Item 8, Table 2) between the slider and the track as shown in Figure 5 and Figure 6 below. Standard Feeler gauges made up to 0.098" (0.023"+0.024"+0.025"+0.026") may also be used.

3. If it is possible to fit the Forward Slide Gauge or feeler gauge between the track and slider (as shown in Figure 6 above) at any of the four corners carry out ACTION 1 Para 2 to 4.

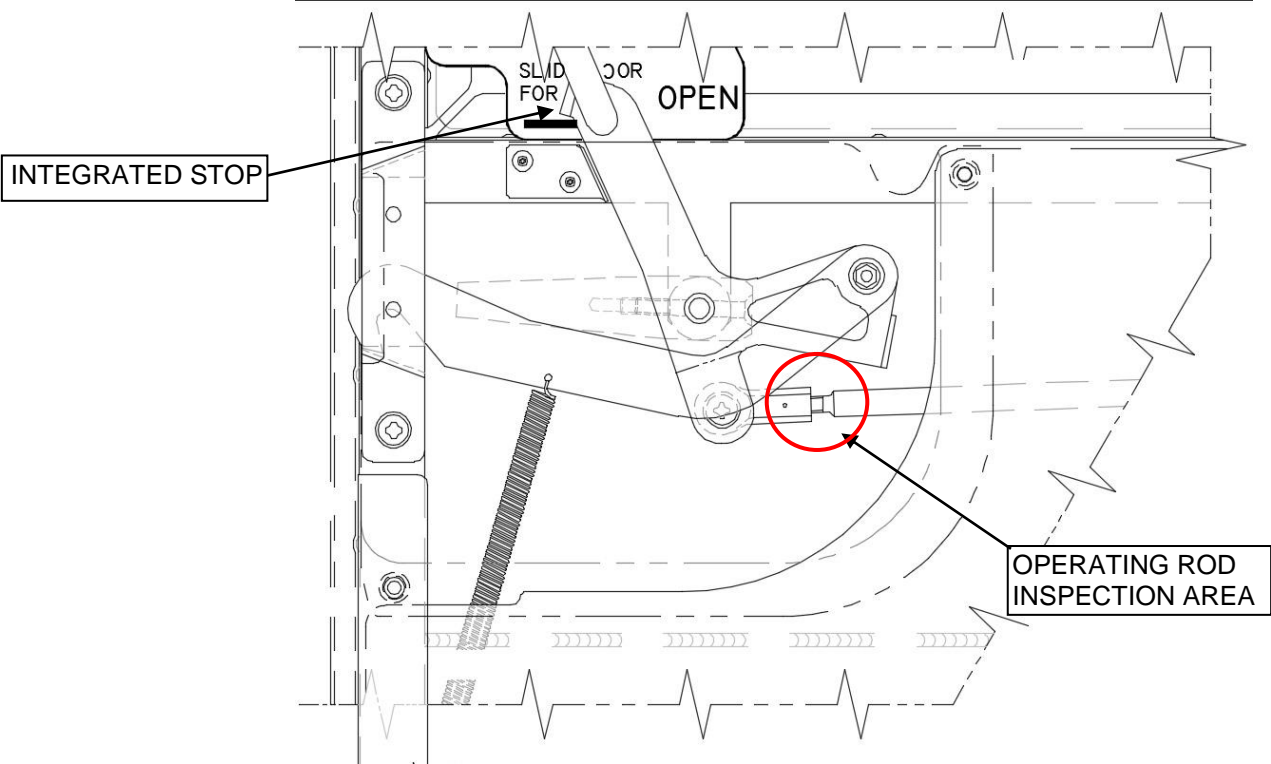
1. Remove Rear Mechanism Cover, refer to Figure 7.
2. Inspect threaded stud at the end of the operating rod, refer to Figure 8. If there is any indication of bending then either replace the operating rod with Item 9 from Table 3 or locally modified rod detailed in Part B2 using the following steps.
3. Disconnect the rod ends from the handle and pivot arm. Remove the forward rod end and pull out the operating rod.
4. Install the operating rod through frame bush prior to installing forward Rod End. Install rod ends and connect to the handle and pivot arm.

Figure 8: Rear Door Handle Mechanism - Inspection Areas

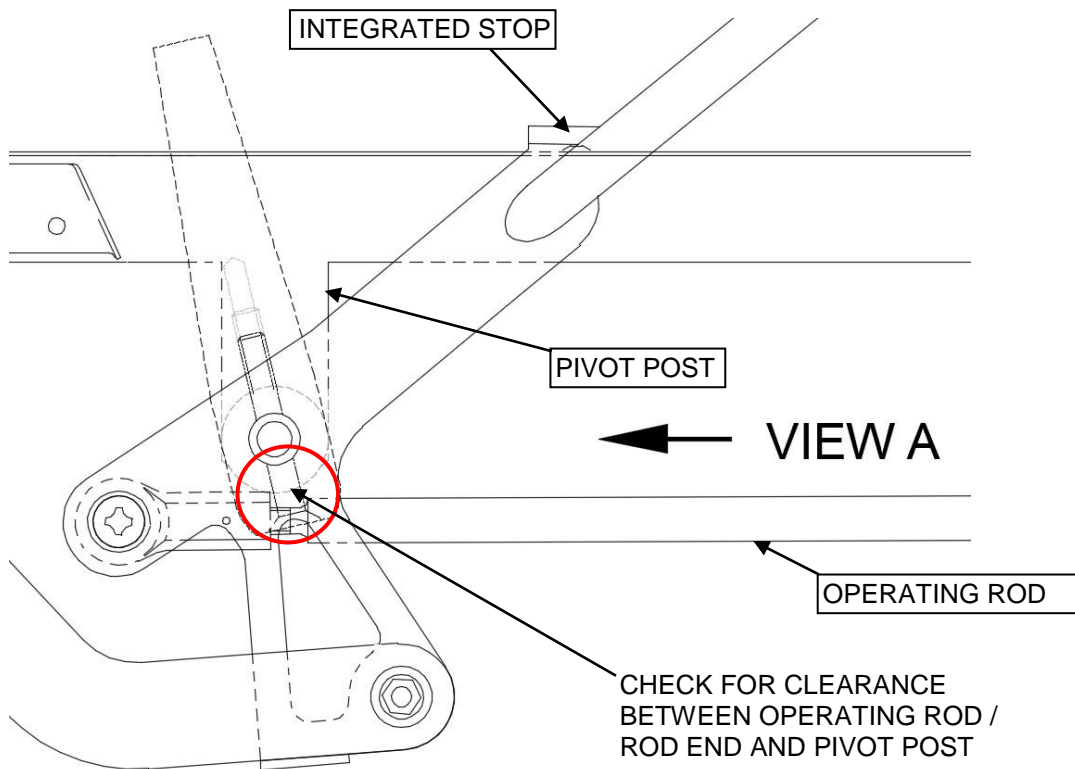
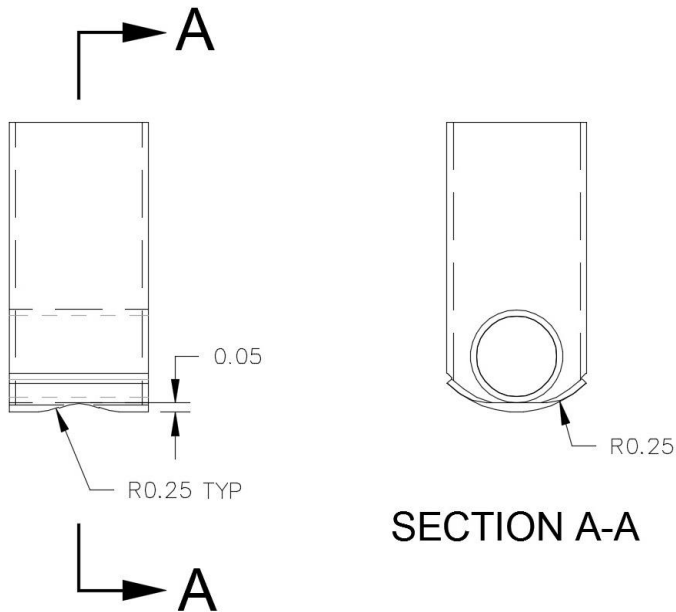
Figure 9: Rear Door Handle Pivot Post – Rework Area

5. With the door handle held fully open / against the stop, check that the operating rod does not hard foul against the rear door handle pivot post, refer to Figure 9. If required rework the rear door handle pivot post.
6. Reinstall the Rear Mechanism Cover, refer to Figure 7.

1. Only Pivot post shown for clarity
2. Rework using blending guidelines of AC43.13-1B Chapter 6 Section 7 and 10
3. Ensure rod end and rod have a min clearance of 0.040in from pivot post
4. Restore surface protection IAW Service Manual

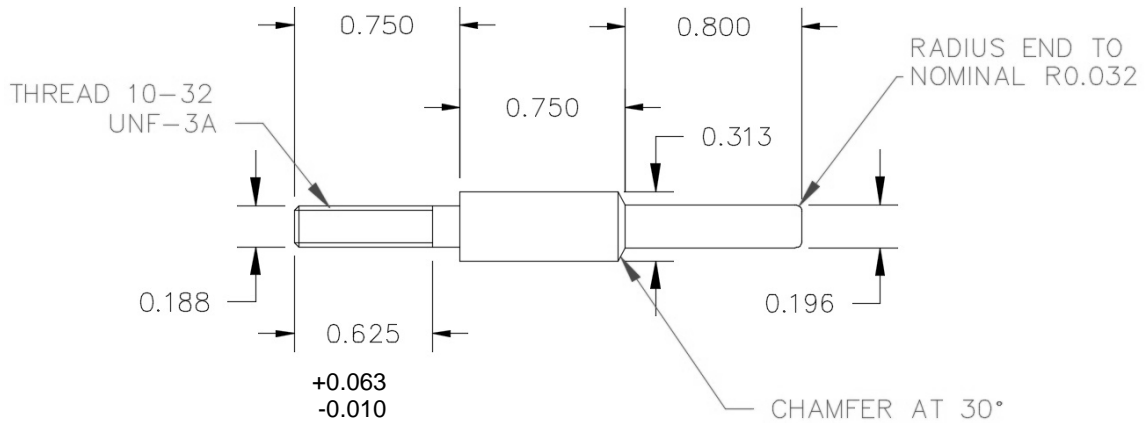
Figure 10: Rod End Repair Plug (P/N: SB-GA8-2005-23-01)

1. From 4130 Rod (MIL-S-67580.0500 manufactures 1 off Rod End Repair SB-GA8-20005-023-01, as shown in Figure 10.
2. Trim 0.75in from the end of the operating rod, chamfer at 30° and drill two Ø0.188in holes, refer to Figure 11.
3. Weld Rod End Repair SB-GA8-20005-023-01 to the trimmed rod, refer to Figure 12.

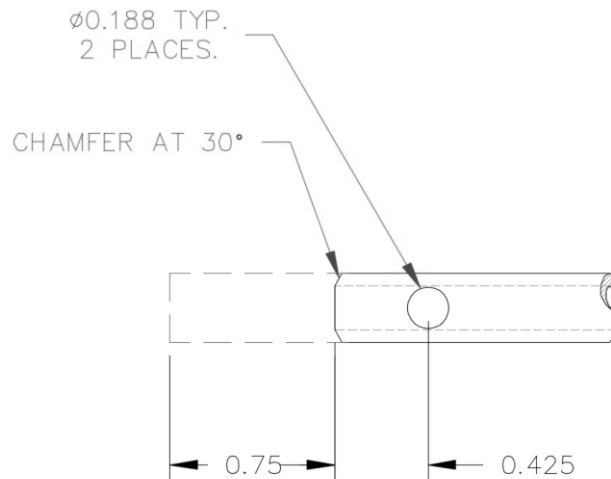
Figure 11: Operating Rod Trim

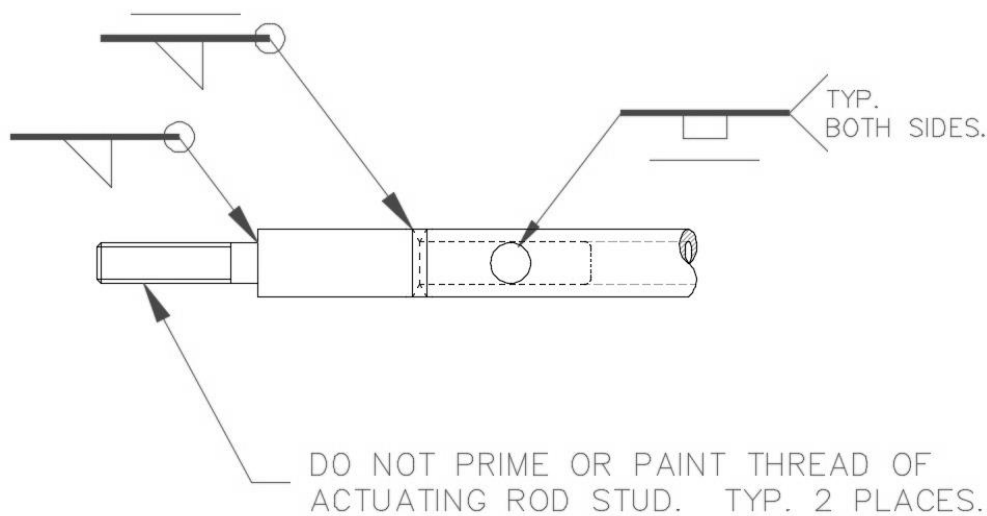
Figure 12: Rod Modification (P/N: SB-GA8-2005-23-02)

1. NOT TO SCALE
2. Weld in accordance with Cahp 51-20-00 of the GA Service Manual. Grind / finish all welds flush. Filler wire / consumable AWS 5.28: ER80S-B2 or equivalent
3. Apply primer 2.0in past the repair area that conforms to MIL-PRF-23377K (or later approved revision) or FEDSPEC-TT-P-1757B (or later approved revision). Apply topcoat of paint that conforms to MILPRF-85285E (or later approved revision) and matches the surround colour.
4. Using indelible ink, permanently part mark the modified operating rod as SB-GA8-2005-23-02
