SB-GA8-2016-163

Service Bulletin

Horizontal Stabiliser Attachment Area Inspection and Reinforcement

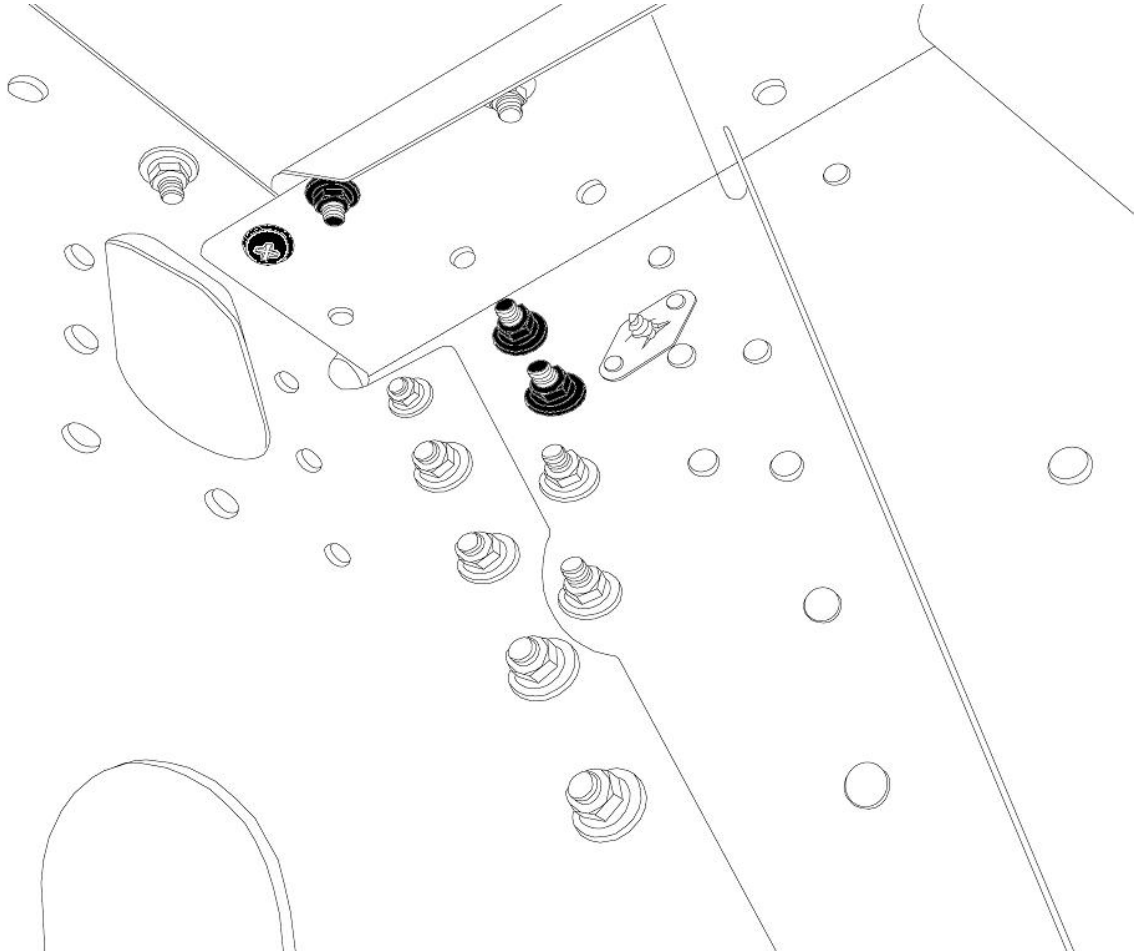
Figure 4 – Inspection Areas

1. Do a detailed visual inspection, using at least a strong light source, of the internal surface of the LHS and RHS Interior Aft Skin Doublers around the fasteners attaching the Horizontal Stabiliser Pivots and Elevator Travel Stiffening Plates. Concentrate inspections around the fasteners highlighted in Figure 4 and look for cracks as shown in Figure 5.
 - 1.1. If cracking is found in the Doublers, note locations and continue to Step 2.
 - 1.2. If no cracking is found in the Doublers, **Part E** of this Service Bulletin **may** be performed as a preventative measure.

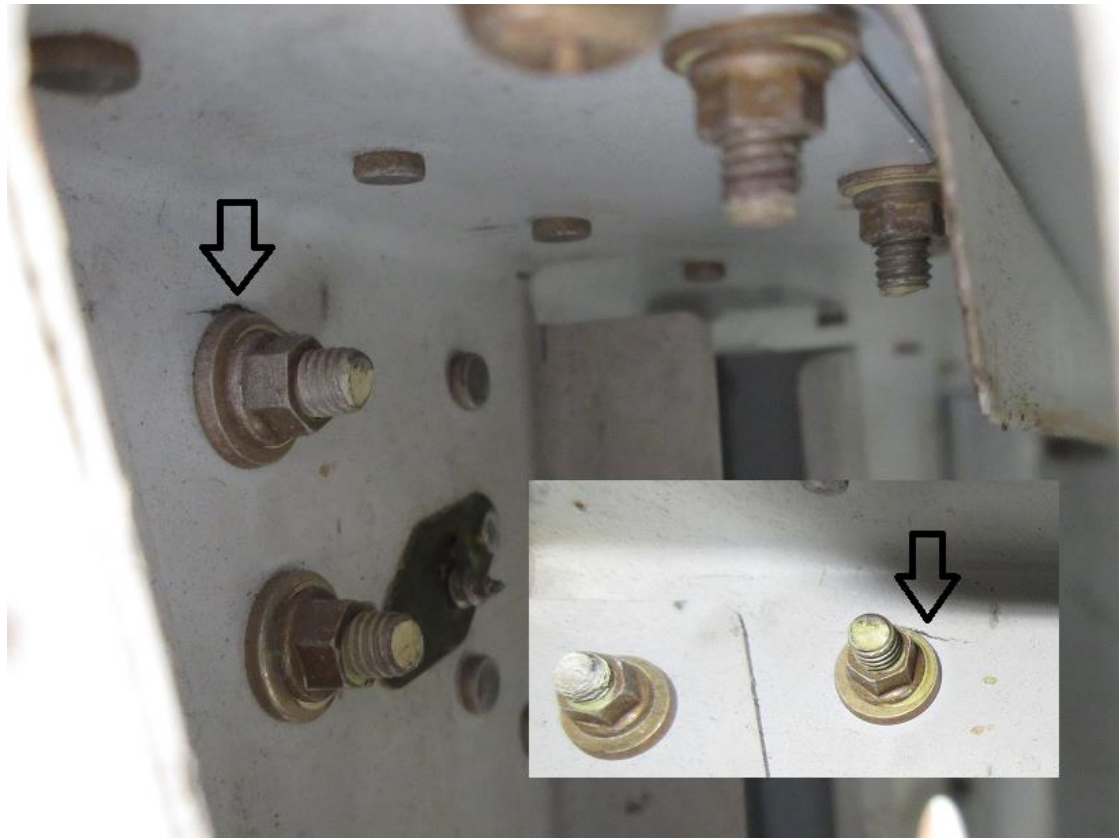
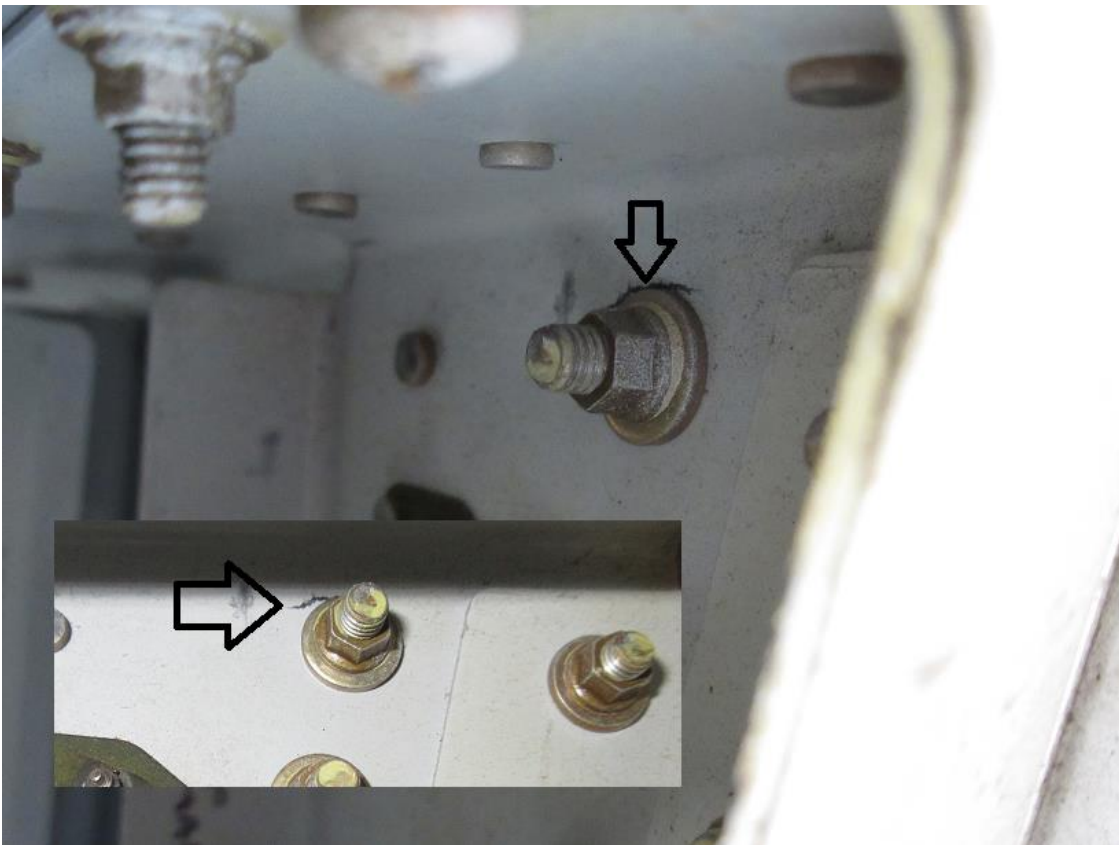
Figure 5 – Typical Cracks

Cracks have been reported in the LH/RH Tailcone Skins, P/N GA8-538021-161/-162 and Interior Aft Skin Doublers, P/N GA8-538021-309/-310 around the attachment of the Horizontal Stabiliser Pivots, P/N GA8-538021-233/-234.

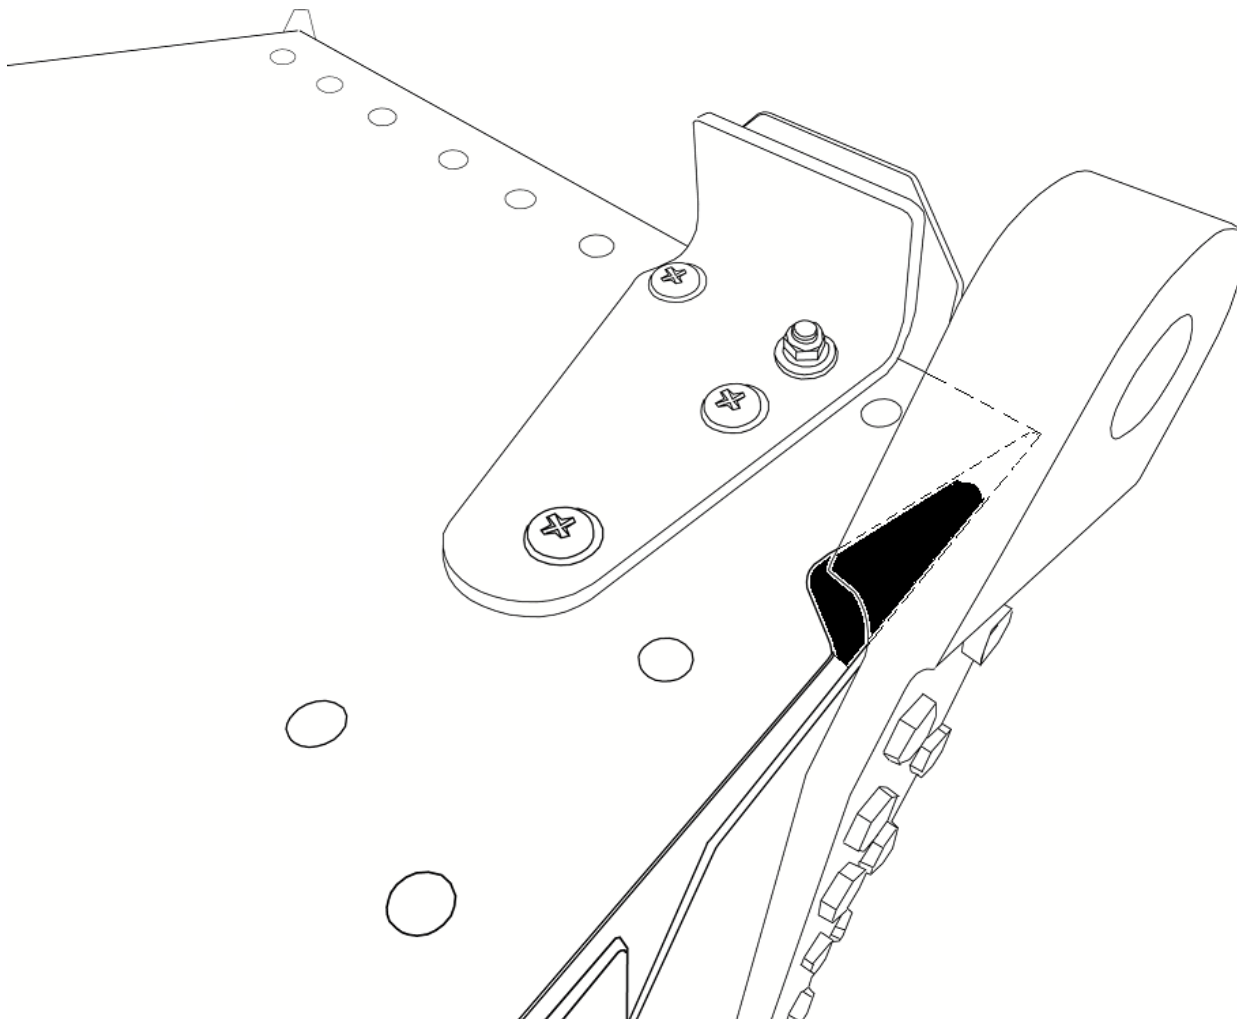
Figure 6 – Tailcone Skin Inspection Area
(LHS shown; RHS typical)

6. Do a detailed visual inspection, using at least 10x magnification and a strong light source, of the external bend radius of the LHS and RHS Tailcone Skins under the Horizontal Stabiliser Pivots as highlighted in Figure 6.

- 6.1. If cracking is found in the Tailcone Skins, note locations and do **Part C, Part D and Part E** of this Service Bulletin.
 - 6.2. If no cracking is found in the Tailcone Skins, do **Part D and Part E** of this Service Bulletin.

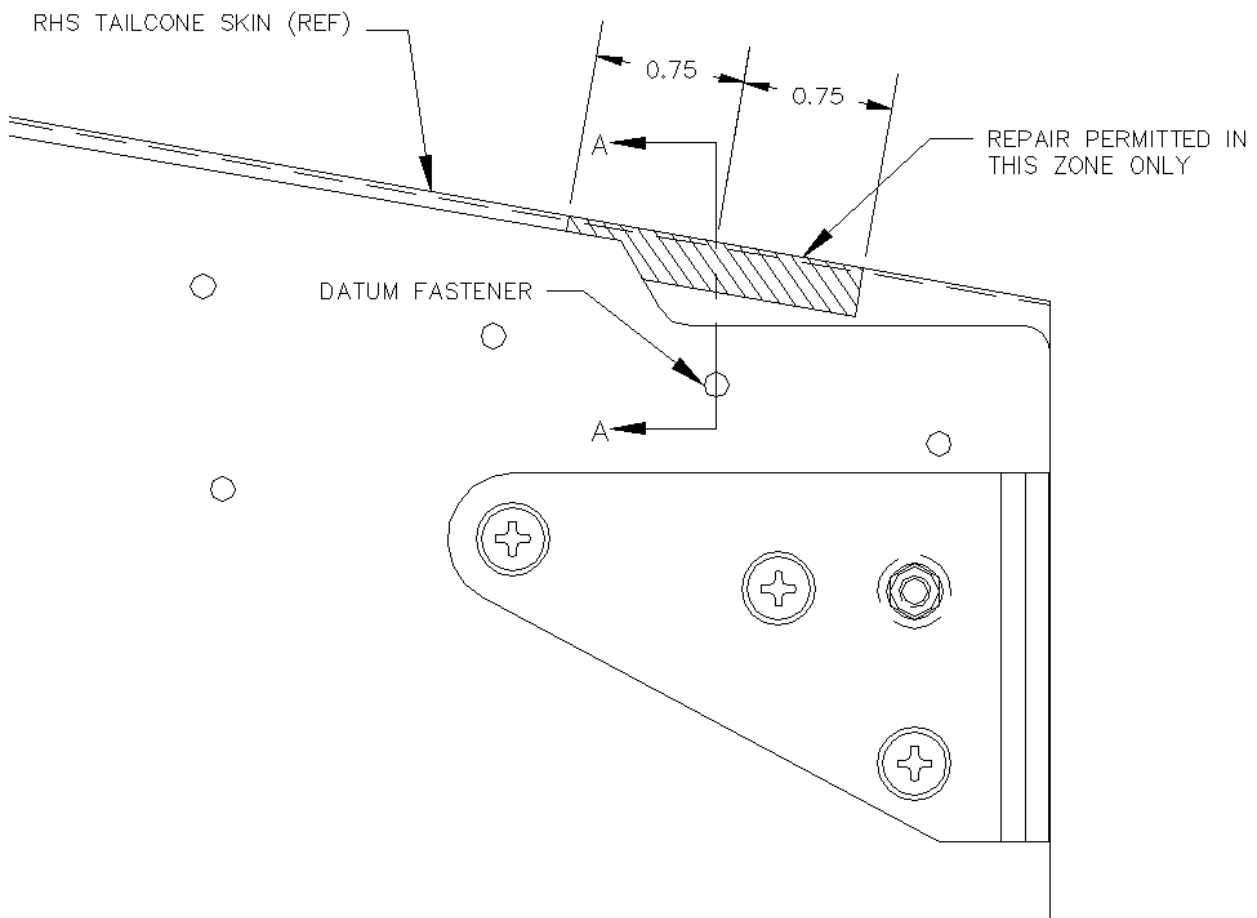
Figure 7 – Repair Zone

2. Determine if the crack is repairable. A repairable crack:
 - has a maximum length of 1.0" (25.4mm); and
 - is within the 1.5" (38.1mm) long repair zone shown in Figure 7; and
 - is within the 0.5" (12.7mm) wide repair zone shown in Figure 8.
