SB-GA8-2017-175

Service Bulletin

Installation of oil pressure transducer and USB download port.

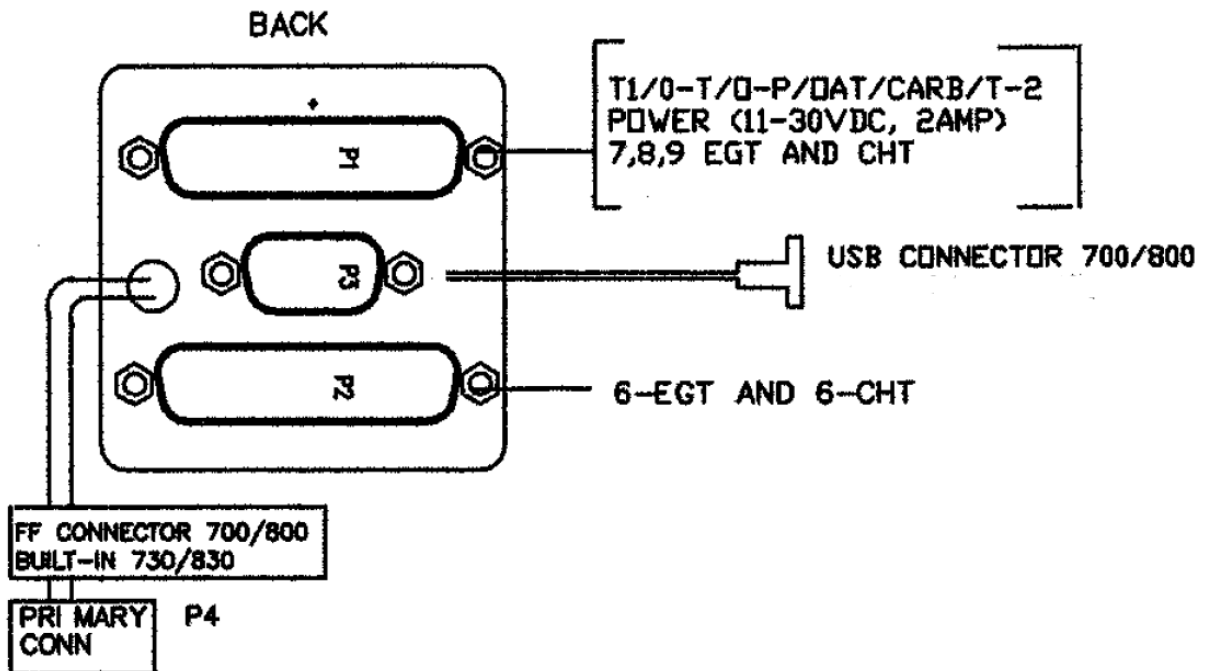
Figure 1 – Rear view of rear indicator

1. Make the aircraft safe for maintenance by pulling all under floor electrical circuit breakers.
2. Check the back of the EDM 800 to see if there is a USB connector tail exiting the rear of the indicator case. Refer to Figure 1.
3. If there is no USB connector, this Service Bulletin cannot be completed until the EDM 800 display unit is returned to JP Instruments for the installation of this feature.

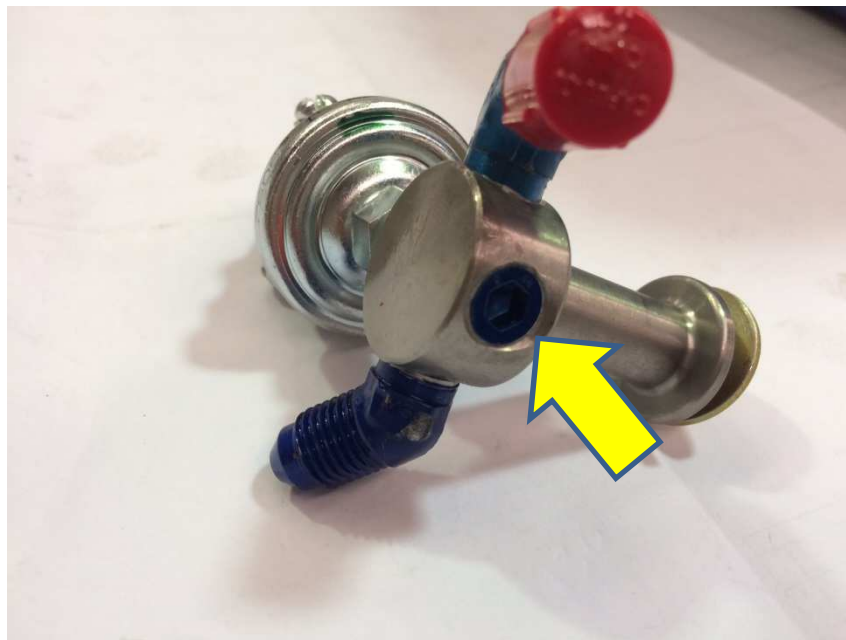
Figure 2 - Oil pressure sensor fitting removed from aircraft.

1. Installation of the JP Instruments oil pressure transducer and harness:
 - 1.1. Refer to document EGT-701 Report 103, "INSTALLING THE EGT-701 SCANNER® 1/20/09" Rev-E to place the indicator into program setup mode.
 - 1.2. Disconnect the existing oil pressure switch from the aircraft's electrical system.
 - 1.3. Remove the oil pressure sensor fitting (P/No. GA8-793021-031), with the oil pressure switch intact, from the aircraft. Place rags under the fitting to catch oil leakage when the unit is removed.
 - 1.4. Apply blanking plugs to both oil lines.
 - 1.5. Remove the blanking grub screw from the oil pressure sensor fitting shown in Figure 2. Heating the fitting with a heat gun may be required.

- 1.6. Ensure the thread of the oil pressure sensor fitting is clean of all contaminants (oil, thread sealant etc.). If required, a 1/8 - 27 NPT tap may be used to clean the threads, without removing any metal from the part.
- 1.7. Fit the JPI transducer to the oil pressure sensor fitting using Loctite 567 thread sealant.
- 1.8. Remove the blanking plugs from the oil lines and reinstall the oil pressure sensor fitting to the aircraft.
- 1.9. Wipe up any remaining oil residue.
- 1.10. Route the 2 transducer wires from the indicator connector J3 to the installed transducer. Refer to Figure 3. Route the wires with existing wire routing running along the fire wall. The routing shall ensure that no chaffing can occur.

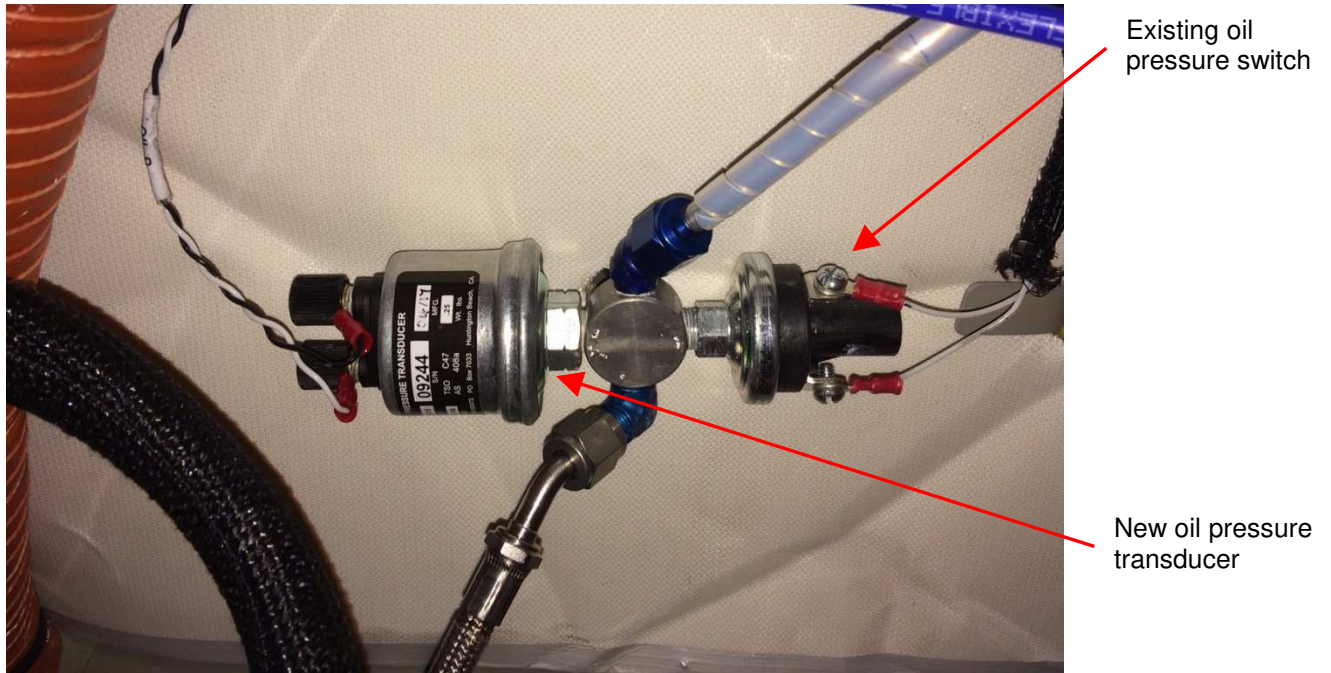
Figure 3 - Installed J.P. Instruments transducer

- 1.11. Terminate the wires with ring terminals supplied with the JPI kit.
- 1.12. Fit the terminated wires to the sensor and firmly tighten the locking nuts to the transducer. There is no polarity on the oil pressure transducer wires.
- 1.13. Place the EDM 800 into program mode in accordance with Installation Manual for EGT 701 Report 103.
- 1.14. Configure the programmable parameter "OIL P" in accordance with Service Manual Supplement C05-96-55 at latest issue.
- 1.15. Power cycle the indicator.
- 1.16. Place the EDM 800 into program mode in accordance with Installation Manual for EGT 701 Report 103.
- 1.17. Set the parameter "O-P" in accordance with Service Manual Supplement C05-96-55 at latest issue. Note the default value from JPI is 20 for this parameter & therefore should not require any change.
- 1.18. Power cycle the indicator.

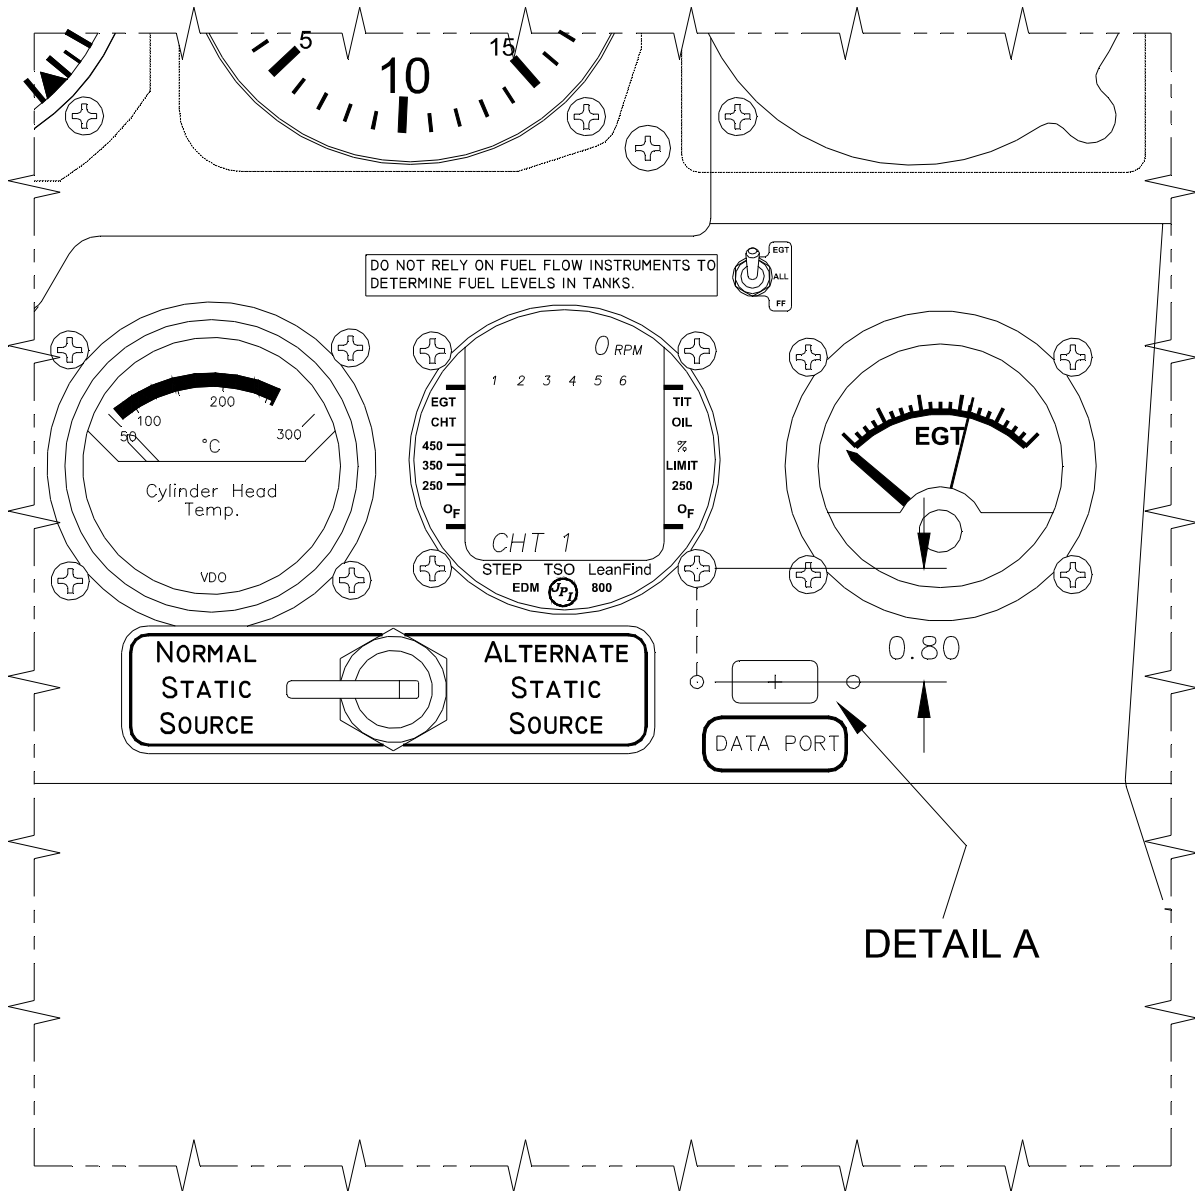
Figure 4 - Location of panel mounted USB port

2.1. Two locations for the USB port are allowed and are given in Figure 4 & Figure 5. Review the existing installation configuration of the aircraft cockpit before proceeding. The location shown in Figure 5 for the USB port may be deviated +/- 1.0" laterally from the location shown. The cut out details are provided in Figure 6. The location as described by Figure 5 will not interfere with the movement of the control column. Figure 4 is viewed looking straight at the instrument faces. Figure 5 is viewed looking at the instrument panel in a horizontal plane.

2.3. Locally fabricate a placard stating "DATA PORT" and fit immediately adjacent to the USB connector as shown in Figure 4 & Figure 5, subject to data port location selected.

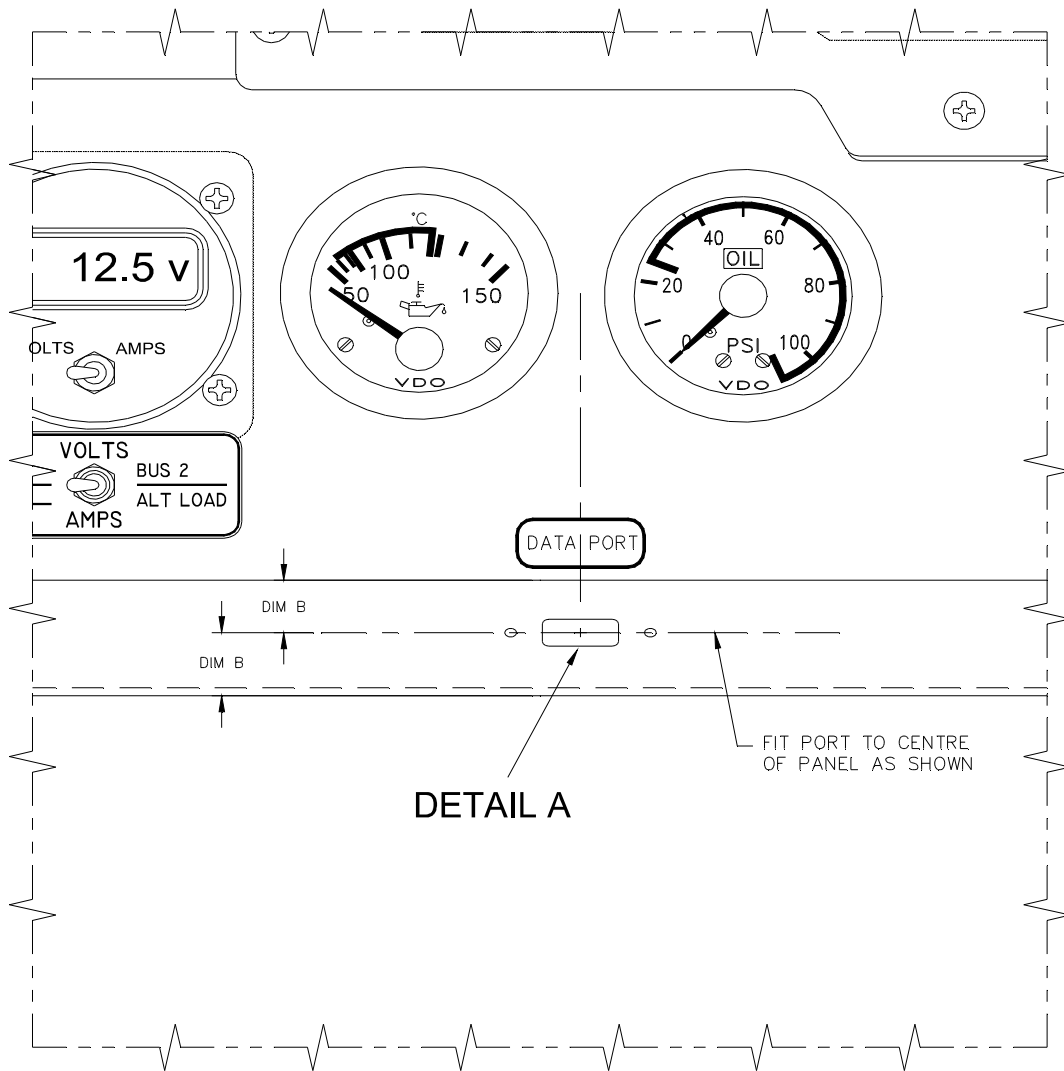
Figure 5 – Location of panel mounted USB port on underside of instrument panel.

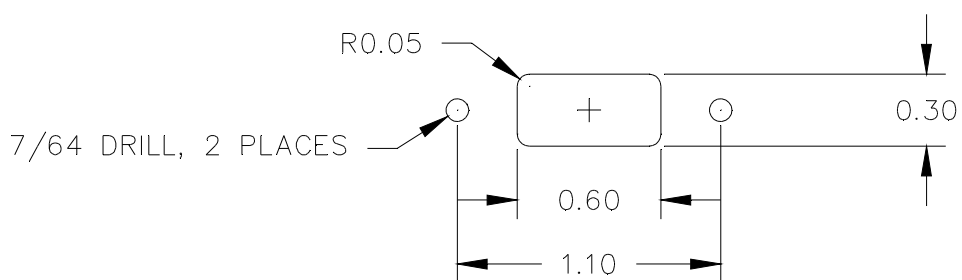
DETAIL A

Figure 6 - Panel cut-out details for USB port, denoted "DETAIL A"
