**SB-GA8-2019-187**

**Issue 1**

# Service Bulletin

Electrical Cover Assembly Sealing

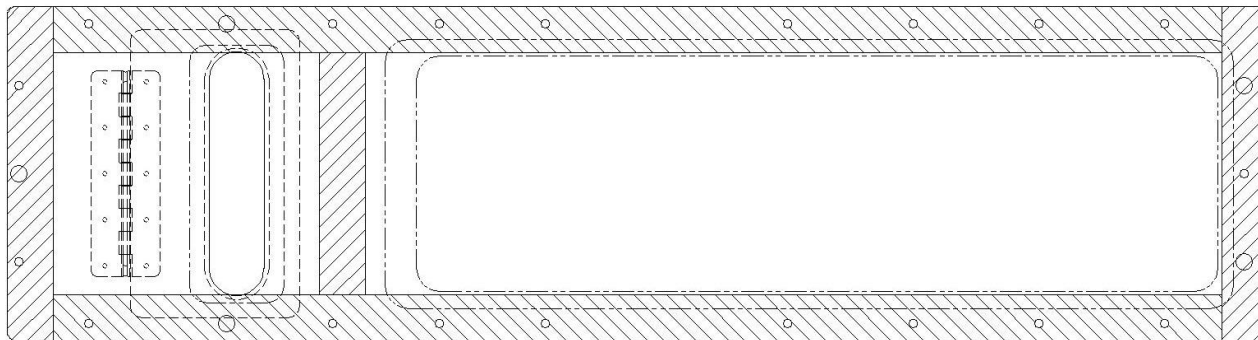
**Figure 1: Vinyl Tape Application  
(View looking at the underside the Electrical Cover Assembly)**

One operator has reported that fluid may enter these bays in the case of fluid spillage within pilot's footwell area of the cabin. This OPTIONAL Service Bulletin provides a means for sealing the compartment via installation of gaskets, preventing such leakage.

7. Clean the underside of the Electrical Cover Assembly using a suitable nil-residue cleaner, such as MEK or Prepsol.
8. Apply the Vinyl Foam Tape (Item 01, Table 2) to the underside of the Electrical Cover Assembly as shown by the hatched areas of Figure 1.

9. Using a sharp knife, drill or similar, cut the Vinyl Foam Tape away from the fastening screw holes.
10. If necessary, the process detailed above may be used to create additional gaskets between other laminates in this area to ensure proper sealing.
