Nomad

SERVICE LETTER

00-1

NOMAD FUEL SELECTOR SYSTEM RIGGING

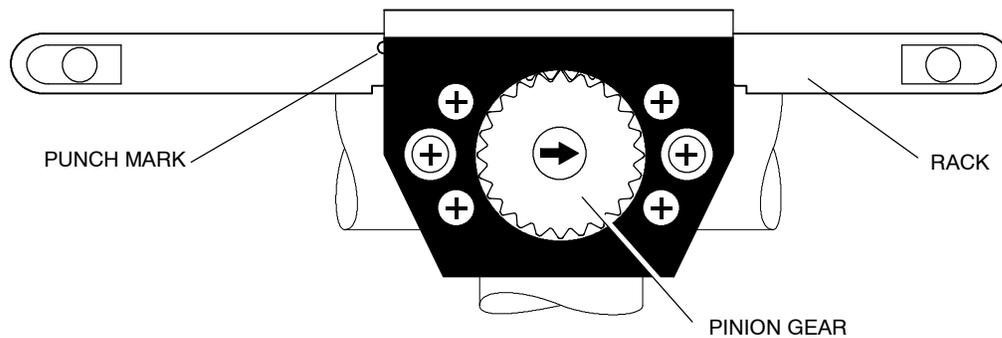
Figure 1 Directional Flow Valve

2. Incorrect indexing of the directional flow valve racks relative to the valve pinions/ports.

The small arrow visible at the centre of the directional flow valve pinion gear should point outboard towards the wing tip when the punch mark on the forward surface of the valve rack is aligned with the side of the rack housing (Ref Figure 1). The valve racks must be correctly located before inspection check 3 may be performed .

NOTE:
WHEN THE PUNCH MARK IS AT POSITION SHOWN,
ARROW MUST POINT TO WING TIP.

LOOKING AFT - LH VALVE SHOWN

Remove the valve rack housing and its dust cover. Re-install these parts with the valve rack positioned as described in the inspection section of this letter.

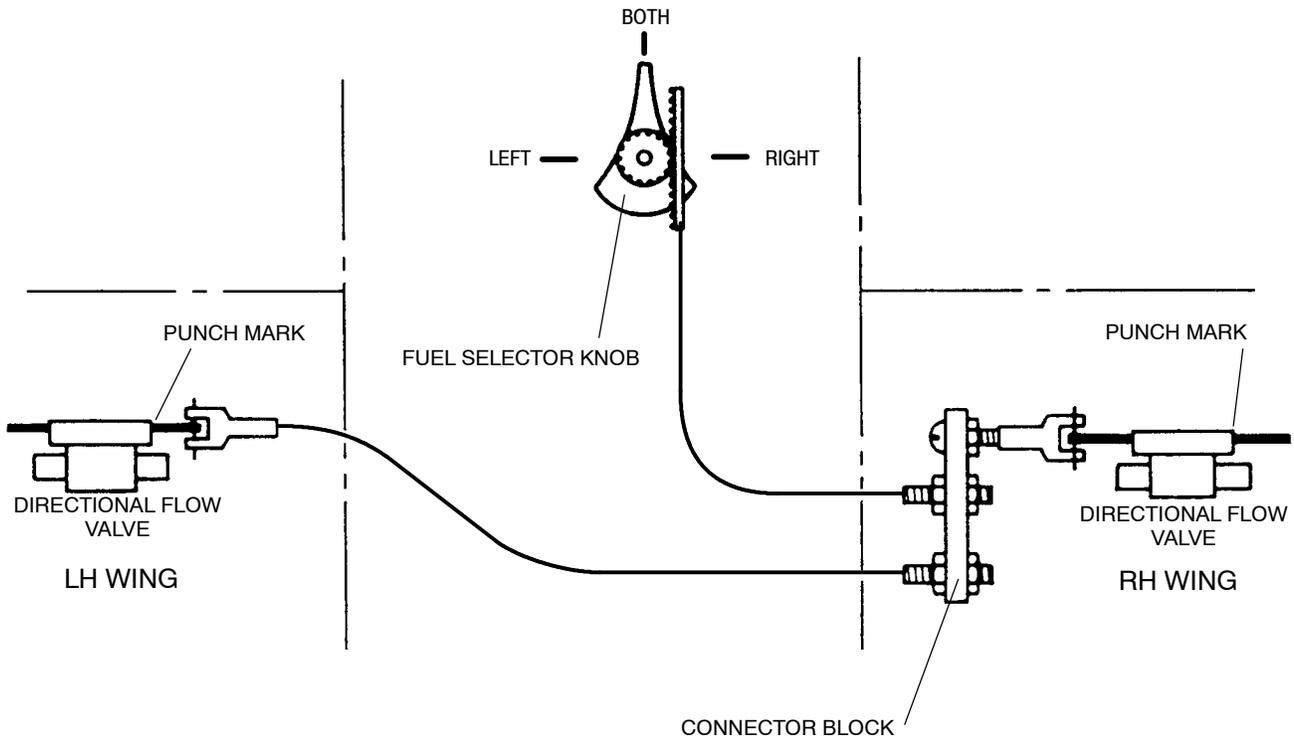
Figure 2 Rigging - Fuel Selector System

With the fuel selector knob in its middle detent position (Ref Figure 2), the tip of the Knob should align to within 0.25 inches of the marking adjacent to the word 'BOTH'.

The racks of the directional flow valves should align to within 0.065 inches of their centre positions when the fuel selector knob is rotated to its middle position ('BOTH') from either the LH or RH positions (Ref Figure 2). The centre position of the valves is determined using the punch mark on the forward face of the valve rack. When the valve is centred, the punch mark aligns with the side of the valve rack housing (Ref Figure 1).

Locate the cockpit fuel selector knob in its middle detent position. Remove the knob and let the selector shaft drop slightly to release its pinion gear from the rack. Re-position the selector shaft so that the selector knob, when re-installed, points to within 0.25 inches of the marking adjacent to the word 'BOTH'.

Adjust fuel selector cable ends as required to achieve the requirements of the inspection section of this letter.
