Service Letter

Inspection of wing spars.

All GA200 aircraft

SL-GA200-2013-02
Issue 1

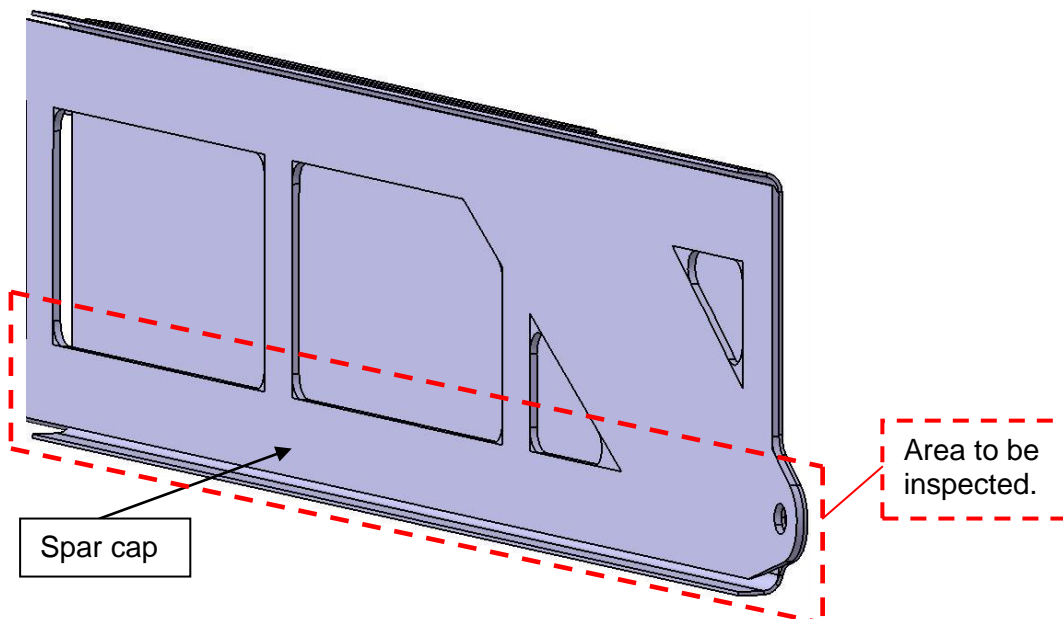
An instance of cracking has been reported in the lower section of the front spar cap on GA200 wing, near the wing attachment point. It has been found during the incorporation of optional service bulletin SB-GA200-2011-06 – Wing Spar Life Extension.

This Service Letter emphasises the importance of regular and thorough inspection to detect any potential damage, especially in the wing Spar caps region. It is recommended to inspect the Lower Spar Cap area from the fuselage pick-up to the fuel tank.

If cracks are found, please report to Customer Support Department using contact details below.
