SL-GA8-2017-34
Issue 1

Service Letter

Landing Gear Bolt Inspections – Rough Strip Operations

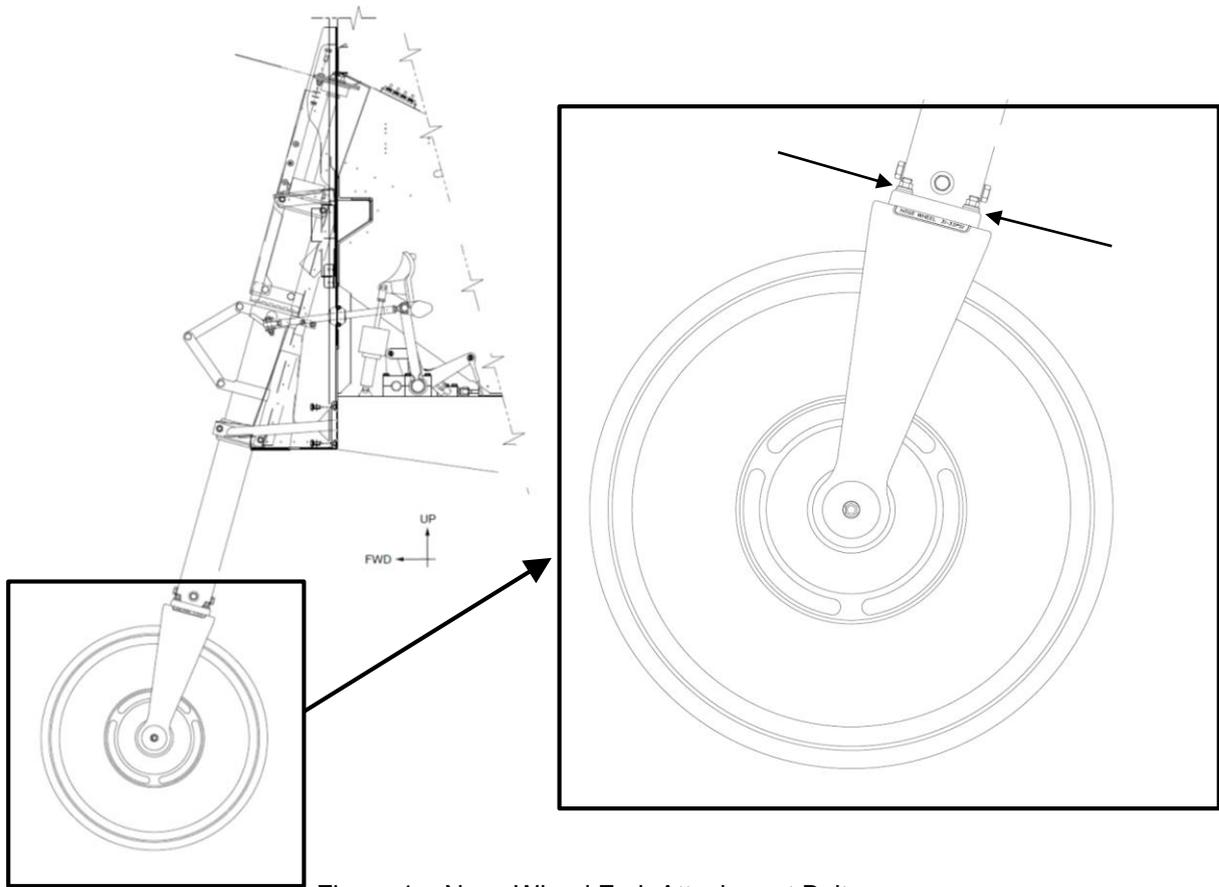
Figure 1 – Nose Wheel Fork Attachment Bolts

GA8 aircraft which frequently operate from rough strips experience accelerated wear on all undercarriage components. As noted in Section 4 of the Airplane Flight Manual, frequent checks of all landing gear components, tyres and brakes is warranted in these situations. In accordance with that advice, this Service Letter recommends additional maintenance on certain undercarriage fasteners.

1. Nose Wheel Fork Attach Fasteners:
 - i. Inspection to be carried out at intervals of 50 hours time in service, during normal scheduled maintenance (oil changes).
 - ii. In accordance with Chapter 20 of the appropriate GA8 Airplane Service Manual, torque the four (4) 5/16" fasteners holding the nose wheel fork to the nose leg assembly (shown in Figure 1).
 - iii. Any fasteners which are found to be loose are to be removed, the affected nuts and bolts inspected and replaced if damage or wear is found. This includes checking the nut for friction – minimum acceptable nut friction is 3 lb.in (0.34 N.m). Replacing both bolt and nut may be required to achieve this value.
