Service Bulletin

Control column wheel and aileron cable operating arm shaft inspection.

GA8 serial numbers GA8-00-004 through GA8-04-056.

Document: Service Bulletin SB-GA8-2004-11

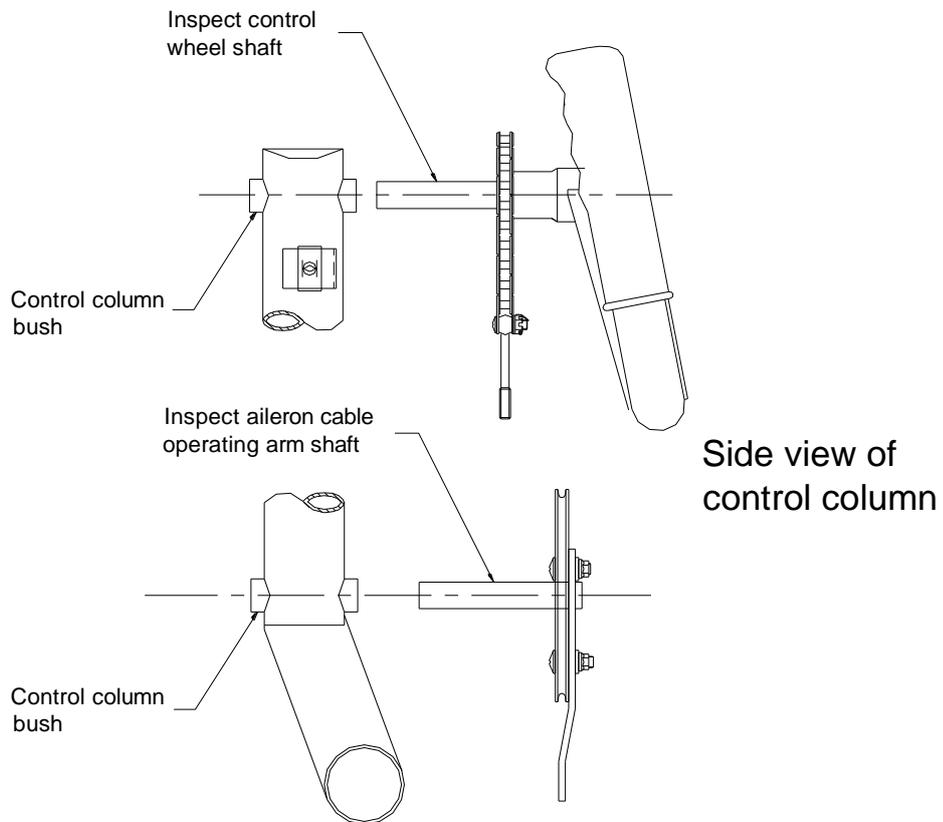
Figure 3

4. Disconnect the aileron cable-operating arm assembly from the aileron link plate (single control installation) or aileron link rod (dual control installation).
5. Remove the control wheel assembly and aileron cable-operating arm assembly from the control column.
6. Inspect the control wheel and aileron cable operating arm shafts for evidence of wear due to galling between the shaft and the control column bush. Refer to Figure 3.

7. If there is no evidence of wear then the shaft is serviceable and no further action is required. Re-install per section 4.
8. If there is evidence of light marking on the shaft as indicated by general even wear adjacent to the weldment then the shaft and the control column bush can be reworked (refer to section 2) or replaced with new bronze items (refer to section 3).
9. If there is evidence of significant marking on the shaft as indicated by scratches, scoring or galling then the shaft must be replaced and the control column bush reworked. Refer to section 3.

1. Remove the control wheel shaft from the control wheel assembly, and/or the aileron cable-operating arm from the aileron cable-operating arm assembly. A lightly marked shaft can be reworked by polishing out the marks provided the amount of material removed does not exceed 0.005".
2. Polish the bore of the control column bush to remove any high spots, particularly in the areas where weld may have penetrated.
3. Re-assemble the control wheel and/or aileron cable-operating arm assembly.
4. Reinstall the control wheel assembly and/or aileron cable operating arm assembly to the control column per section 4.
