Service Bulletin

Replacement of the alternate air door microswitch with a contactless proximity switch.

GA8 aircraft S/N GA8-00-004 to GA8-05-065.

Document: Service Bulletin SB-GA8-2004-15

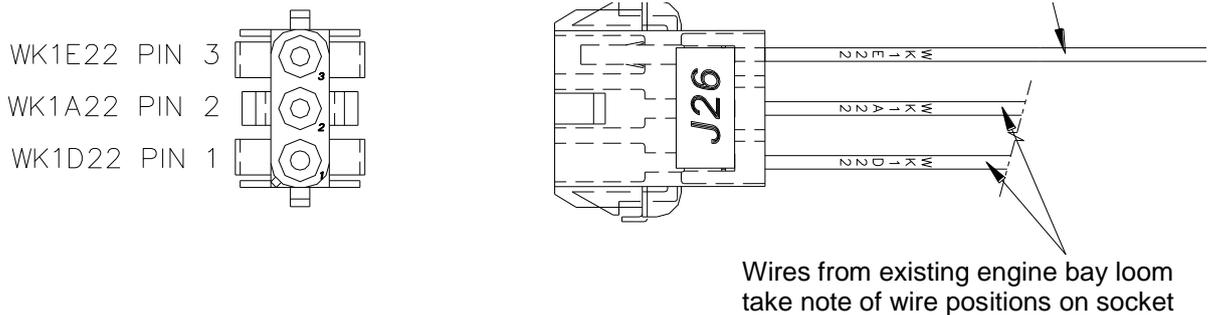
Figure 1: Socket wiring detail.

1. The existing microswitch utilizes two wires to function, whilst the new proximity switch requires 3 wires to function. The additional wire is routed to the stall warning breaker.
2. The existing 2 pin socket (J26) must be replaced with a 3 pin socket (also labeled J26) This is accomplished by removing the existing pins from the 2 pin socket and placing them in the 3 pin socket as shown below. Ensure that each wire is inserted into the correct position on the socket as indicated in the figure below.

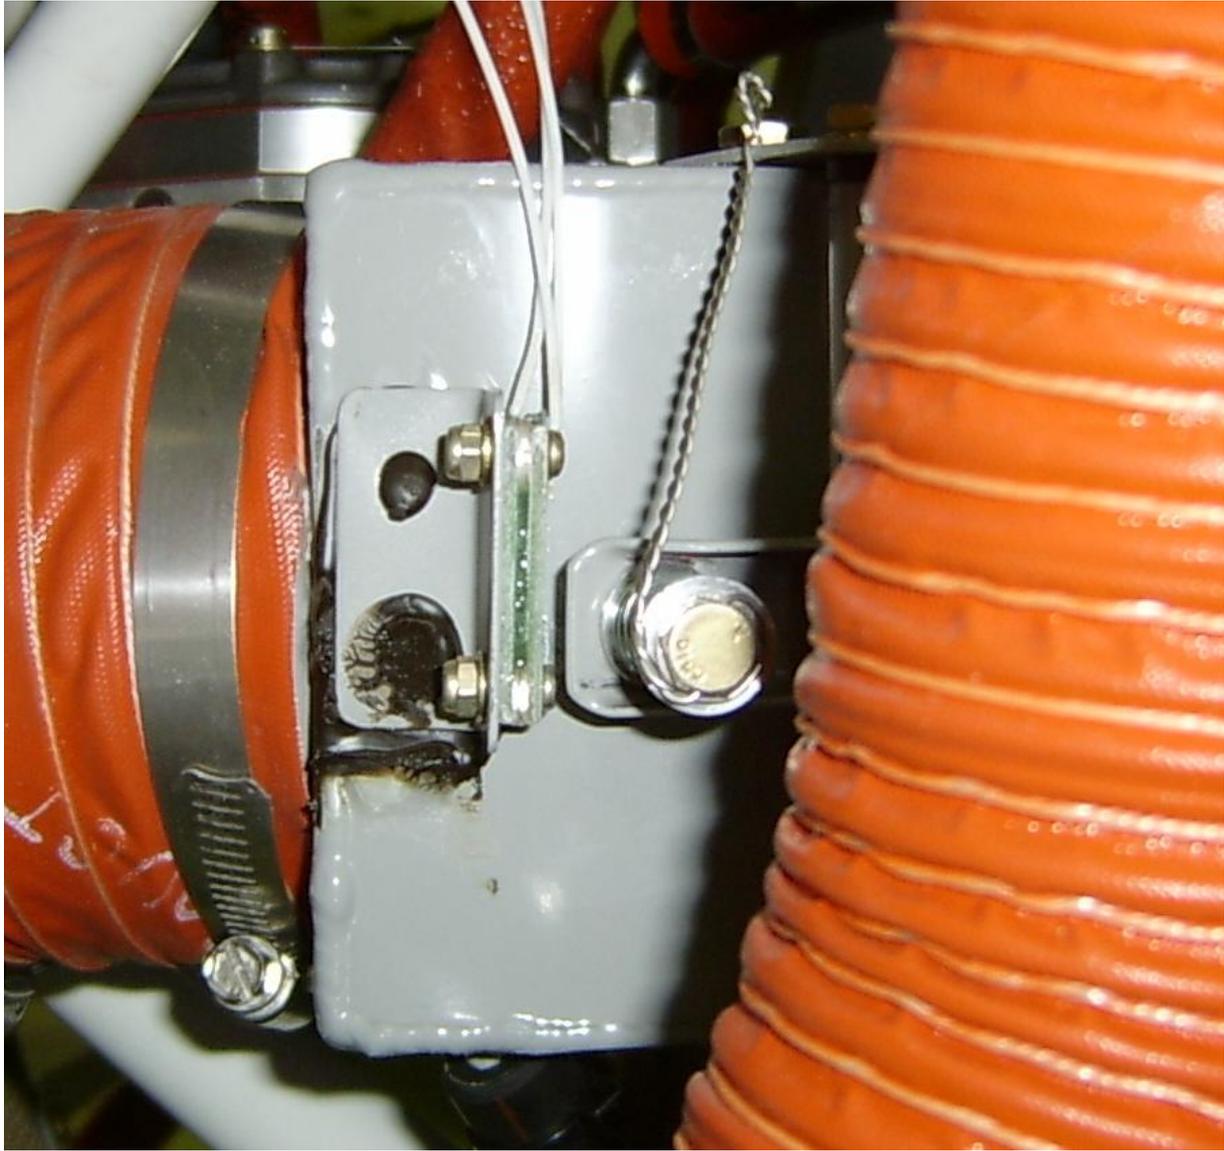
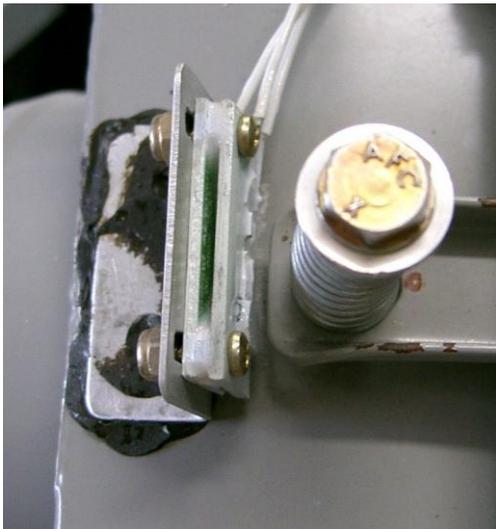
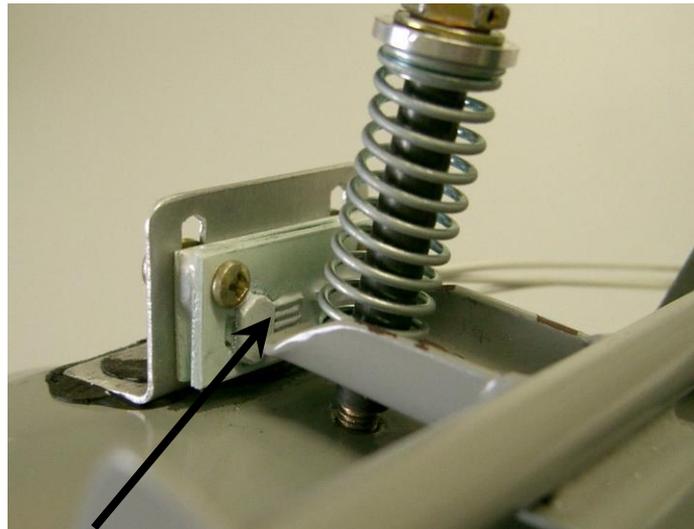
Figure 6: Switch bracket installation.

Ensure sensor element is placed in front of metal portion of the door return spring bracket

1. Using the photographs as a guide (figures 6 & 7), locate the proximity switch as close to the door return spring bracket as possible ensuring that the operation of the door does not bind on the proximity switch.
2. Typically most installations can utilize a gap of 0.050" (1.27mm) gap between the proximity switch sensor and the door return spring bracket.
3. Using sandpaper, roughen surfaces to be bonded. Apply PR to the proximity switch bracket and position in place on the airbox. Ensure that operation of the air box door maintains a minimum clearance between the door return spring bracket and the proximity switch.
4. Clamp the switch in place and check operation of the ALT AIR warning light with actuation of the alternate air door.
