Service Bulletin

Elevator Hinge Upgrade

GA8 serial numbers GA8-04-054 through GA8-07-114, and any GA8 aircraft prior to S/N GA8-04-054 retrofitted with machined hinge brackets by Engineering Release.

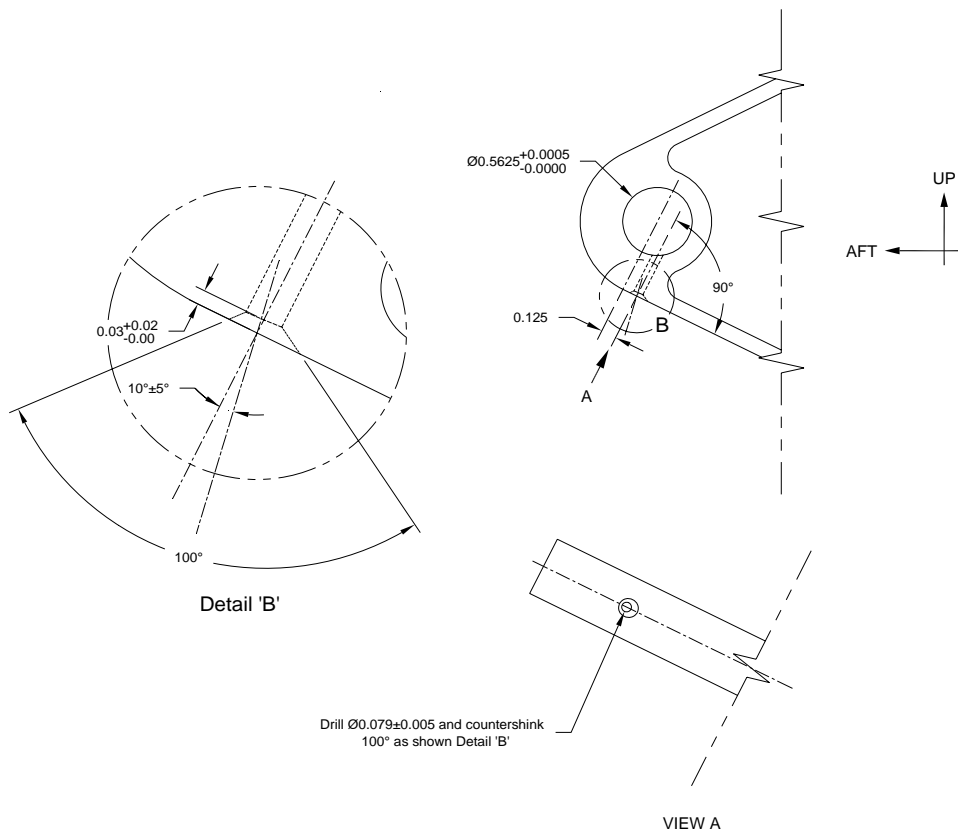
Figure 1

This Service Bulletin details the modification of the hinge brackets to allow installation of bronze alloy bushes as the wearing medium and for lubrication of the bearing surfaces.

- 1.3. Drill lubrication holes of diameter 0.079" \pm 0.005" [2.00 mm \pm 0.13 mm] in the elevator hinge brackets in accordance with figure 1, and countersink at 100° as shown.

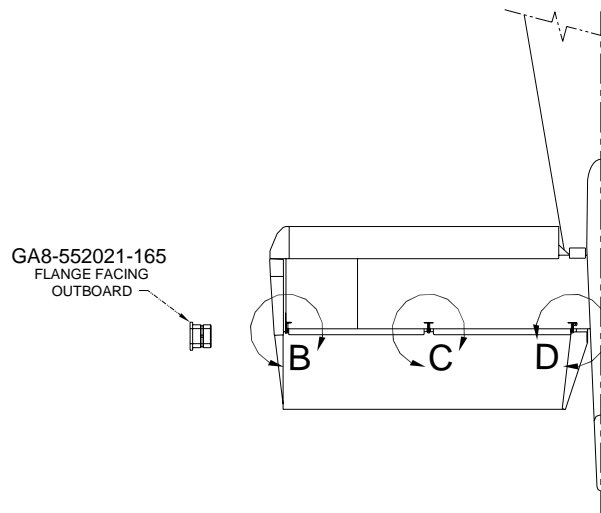
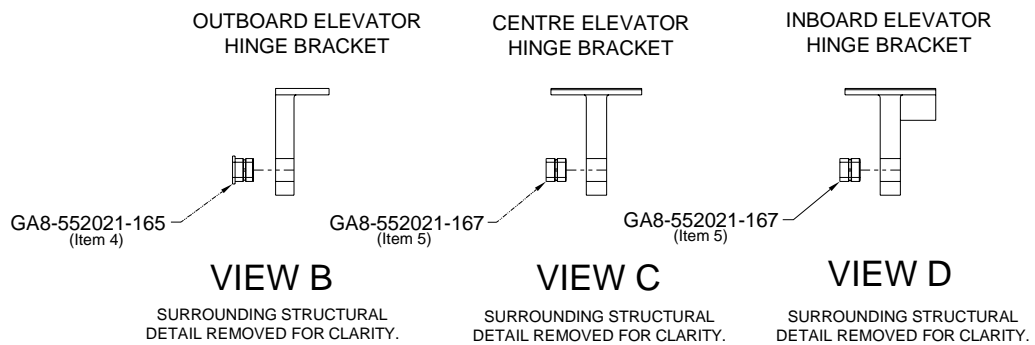
Figure 2

ELEVATOR HINGE OUTER BUSH INSTALLATION

- 1.4. Install the outer bushes (items 4 and 5) with an interference fit in the respective inboard, centre and outboard hinge brackets for each elevator hinge using Loctite 603 (or equivalent), with the flange of each outboard bush located on the outboard face of the respective hinge bracket. The inboard and centre outer bushes are identical. See Figure. 2
