Service Bulletin

Seat Repair

All GA8 and GA8-TC 320 Passenger Seats (GA8-252011-011 and GA8-252011-012)

SB-GA8-2012-93

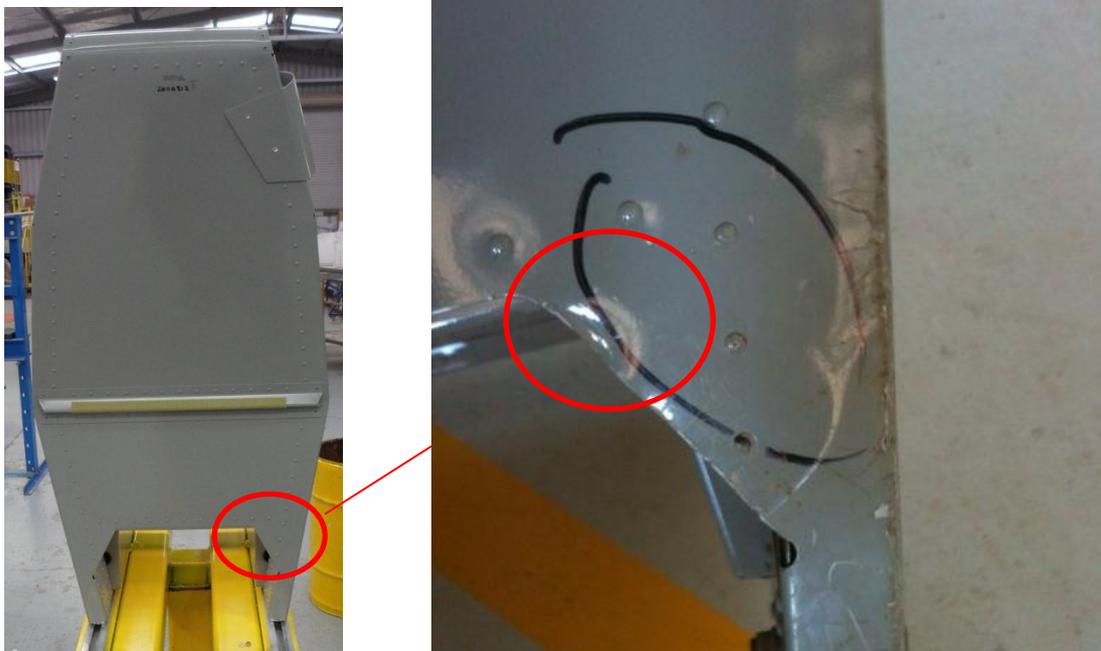
Instances of damage or creases have occurred in the lower seat back near where the seat base and seat legs meet. A typical example of this is seen below in Figure 1.

Figure 1 – Typical Seat Back Damage

Where the minor damage or creases in the lower seat back are found, this repair may be performed.

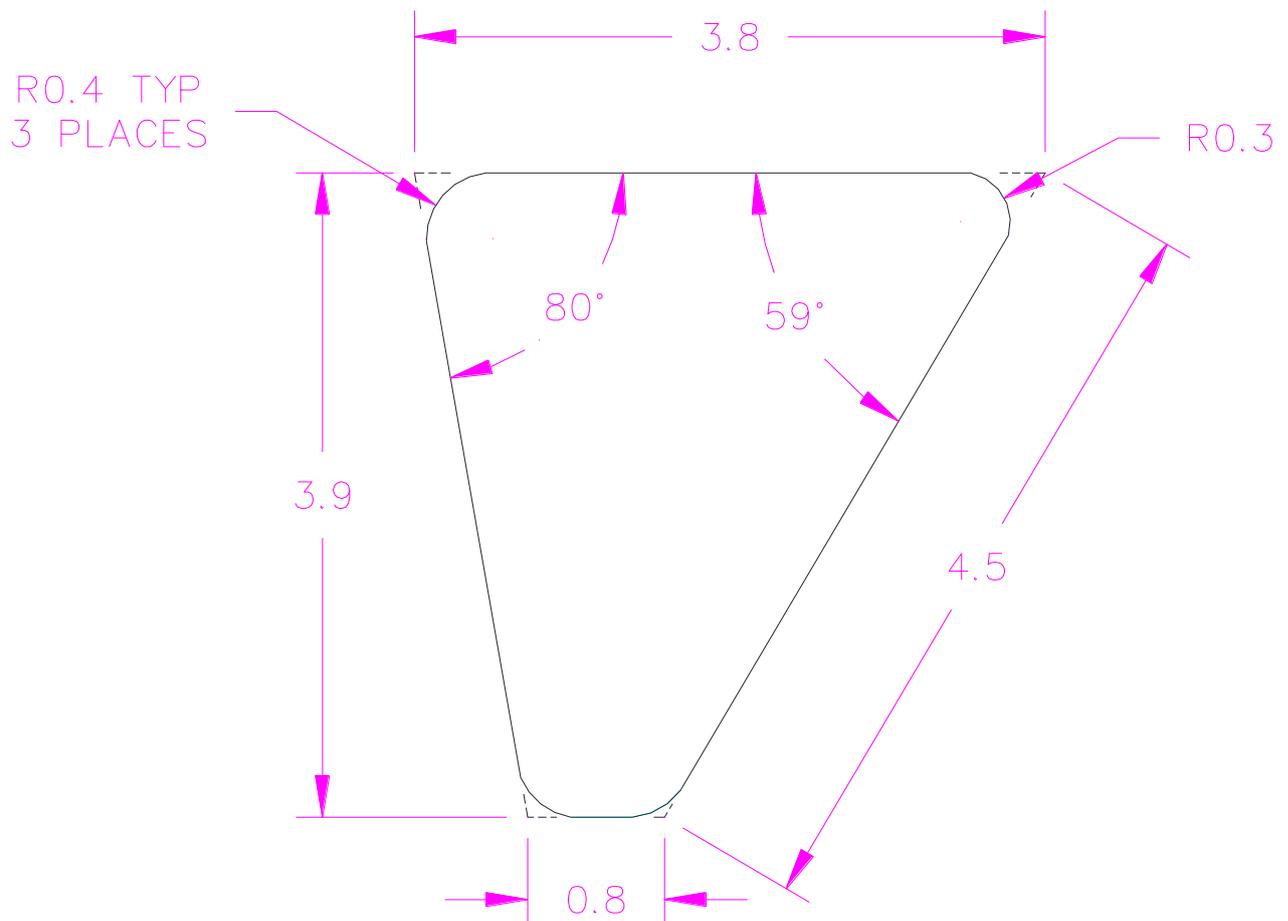
Figure 2 – Seat back patch.

Alternatively, fabricate seat back patches from Alclad 2024-T3 QQA250/5 with thickness of 0.032"

Dimensions (in inches) shown below in Figure 2.

Edges are to be de-burred and corners suitably radiused.

The patch is to be primed and painted to match current seat colour, before installation.

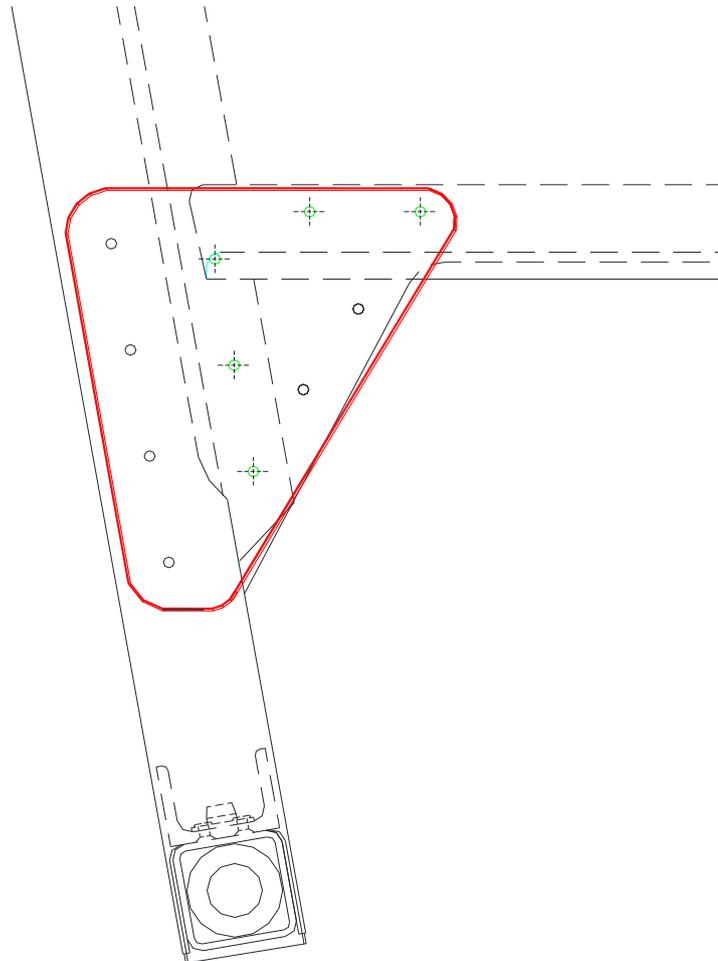
Figure 3 – Seat back patch location, LHS of seat shown. View is from behind seat.

1. If cracks less than 1/4" are present, blend out the crack and deburr the edge. If cracks are greater than 1/4" contact Gippsaero.
2. Remove rivets in the seat back in the location of the patch as depicted with crosshairs, below in Figure 3.

3. Position the new seat back patch as shown below in Figure 3.
4. Clamp in place. Back-drill where able into the seat back patch in these locations. Match existing hole locations onto the patch.

5. Six additional fasteners are to be added in the locations shown below (indicated without crosshairs). Holes are to be drilled #30. Ensure edge distance is maintained from centre of hole to edge of patch and other holes is greater than 0.3". A pitch of 1.0" is required for the row of 4 rivet holes into the seat leg. If using the GippsAero part GA8-952501-011 the additional fastener positions are in the part, drill into the existing seat through these holes.

6. Deburr the holes in the patch and seat.
7. Place repair patch in position and rivet using MS20470AD3-* rivets where possible. New holes will require blind rivets, TLPD424 or TLPD429* Pop rivets to be installed.

* Rivet length used to be assessed on installation.
8. Touch up the paint over the rivet heads as necessary.
