**SB-GA8-2014-116**

## Service Bulletin

Installation of a Secondary Starter Solenoid

All GA8 & GA8-TC 320 aircraft

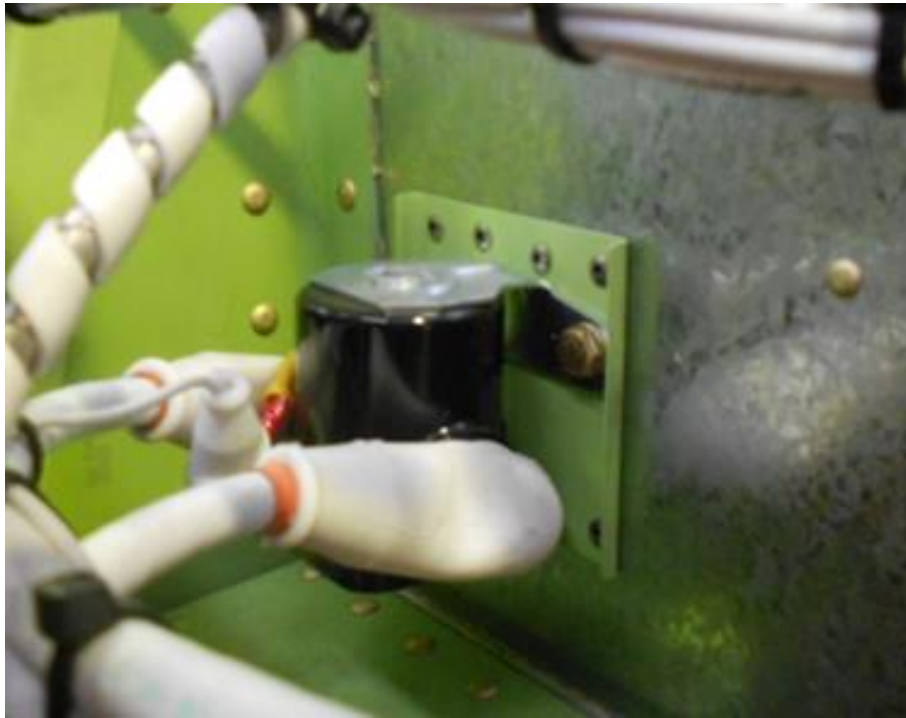
**Figure 3: Solenoid Mounted**

*A low resistance bond is required between the solenoid and the firewall. The bolts used to secure the solenoid shall provide the conductive path to the firewall. A resistance of less than 30 milliohms is required.*

- 1.9. Mount the inboard lug of the solenoid (SNLS-135) as shown in Figure 3 using Bolt (AN3-4A), Diode Assembly (GA8-246012-017 – mount the ring terminal as modified in step 1.8), Washer (AN960-10), Penny Washer (AN970-3 on aft face of firewall) and Nut (MS21042-3).
- 1.10. Mount the inboard lug of the solenoid (SNLS-135) using Bolt (AN3-3A), Washer (AN960-10), Penny Washer (AN970-3 on aft face of firewall), and Nut (MS21042-3).

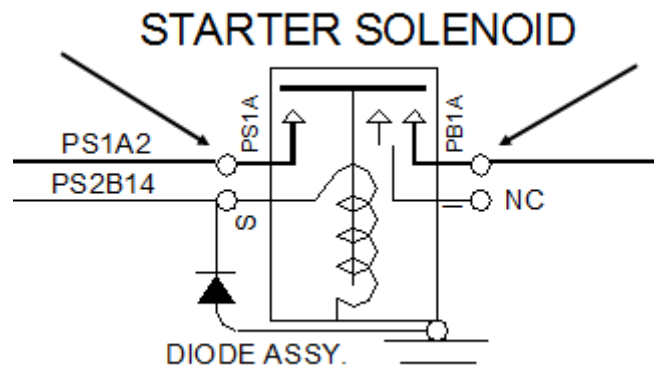
**Figure 8: Arrows indicate where a check for continuity is to be made.**

Confirm that the installed solenoid contactor terminals are open circuit in the absence of power to the field of the externally mounted starter solenoid. Refer to Figure 8. Replace the solenoid if an electrical path exists between the terminals.
