SB-GA8-2015-127

Service Bulletin

Flap and Aileron Arm Corrosion Rework

All GA8 and GA8-TC 320 aircraft.

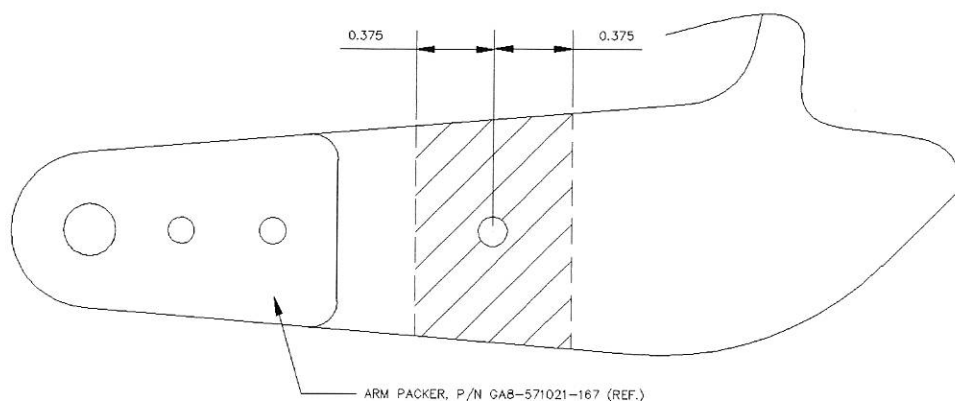
Figure 1- Area of Paint Removal for typical Arm

1. Remove the screw, washers and nut securing the Bonding Strap to the affected Arm and discard.
2. Remove all paint and primer from the affected area at least 0.375" either side of the fastener hole as shown in Figure 1.

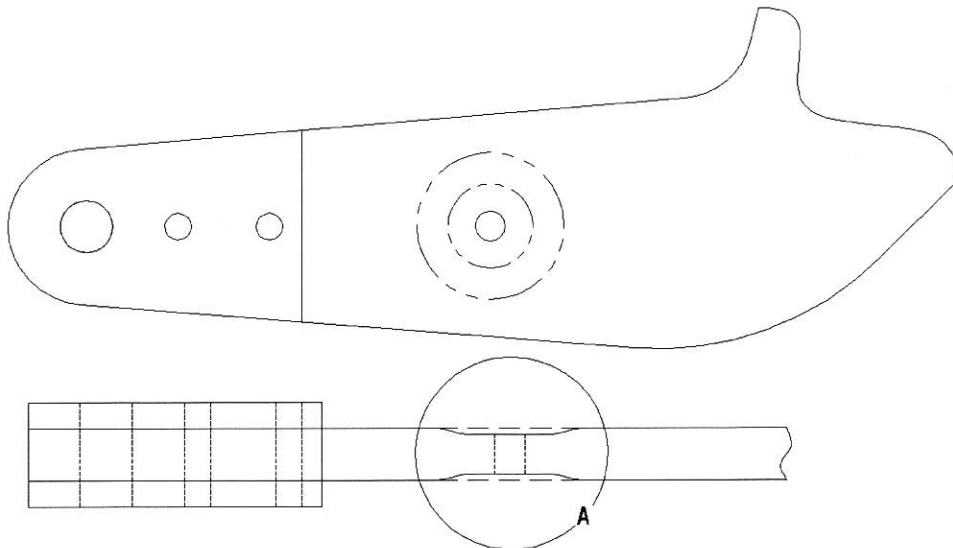
Figure 2 – Arm Rework at Bonding Strap Fastener Hole only

- 6.1. Perform rework to the Arm by blending. Remove a minimum amount of material and remove the corrosion found whilst not exceeding a maximum depth of 0.030" in the region around the Bonding Strap attachment hole. Ensure a blend ratio of at least 7:1 is achieved as described in Figure 2 and Figure 3, and that the resulting surface finish of the blended area is at least 63 µin. Ra;

THE ARM MUST MAINTAIN A MINIMUM THICKNESS OF 0.190" AT THE BONDING STRAP ATTACHMENT HOLE

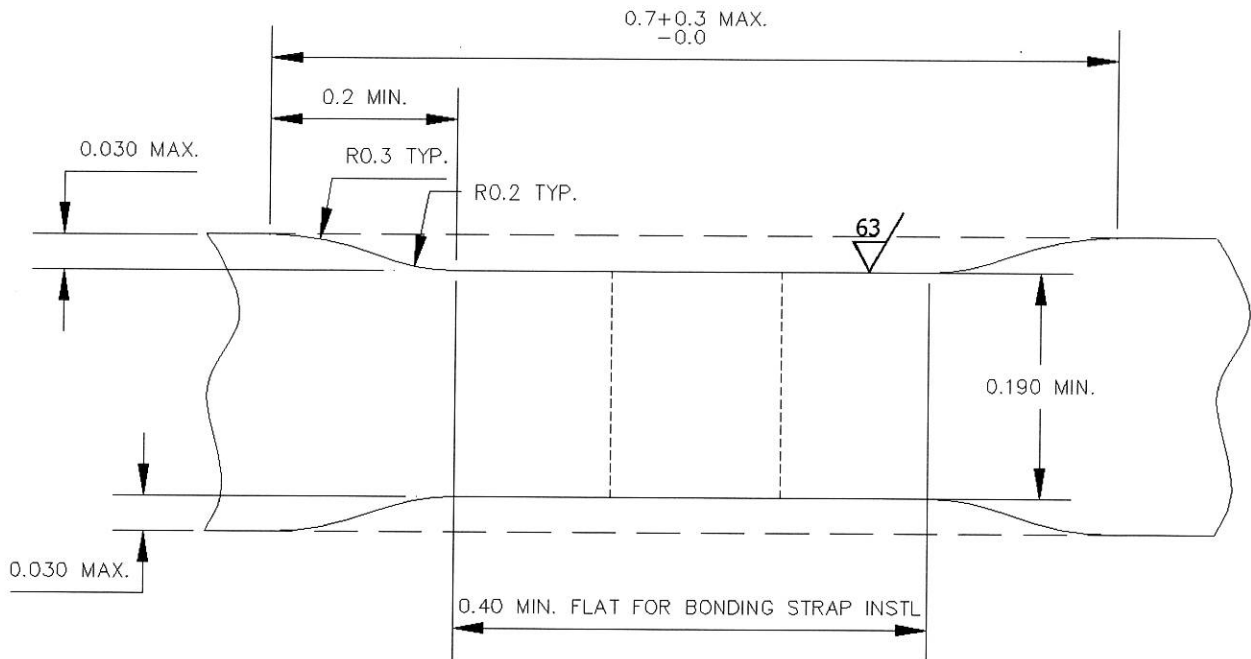
Figure 3 – Detail A: Rework at Bonding Strap Fastener Hole

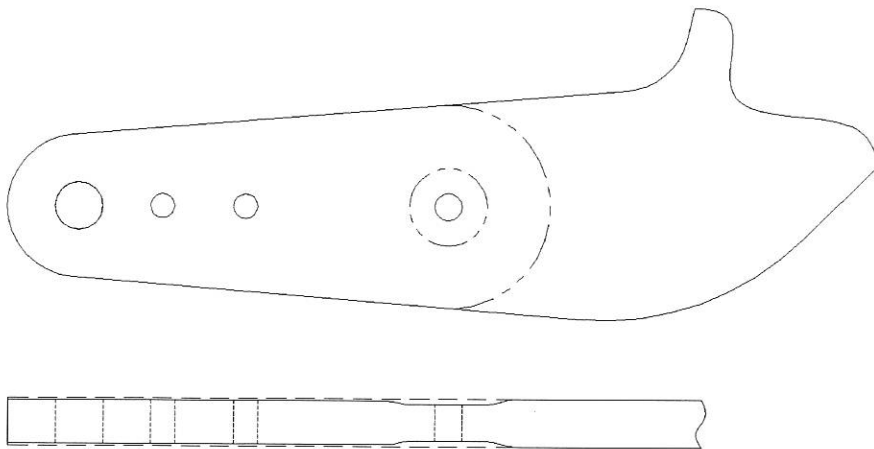
Figure 4 – Arm Rework at Bonding Strap Fastener Hole and under Packers

- 6.2. If the Packers are removed in Step 5, perform rework to the Arm by blending. Remove a minimum amount of material and satisfactorily eradicate the corrosion on the Arm's faying surface whilst not exceeding a maximum depth of 0.005". Ensure the reworked surfaces remain parallel as shown in Figure 4 and Figure 5 and that the resulting surface finish of the blended area is at least 63 μ m. Ra.

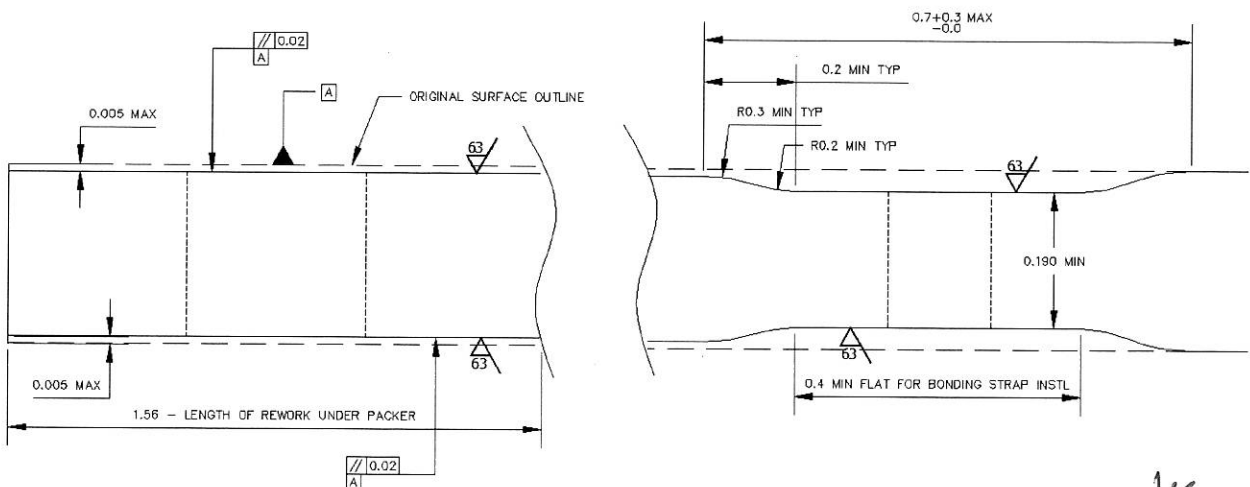
Figure 5 – Arm Rework at Bonding Strap Fastener Hole and under Packers
