SERVICE BULLETIN NO: NMD-53-10

TITLE: Fuselage - Additional Drain Holes in Stub Wing and Cabin Bottom Skin (Mod N629)

FUSELAGE, ADDITIONAL DRAIN HOLES IN STUB WING AND CABIN BOTTOM SKIN (MODIFICATION N629)

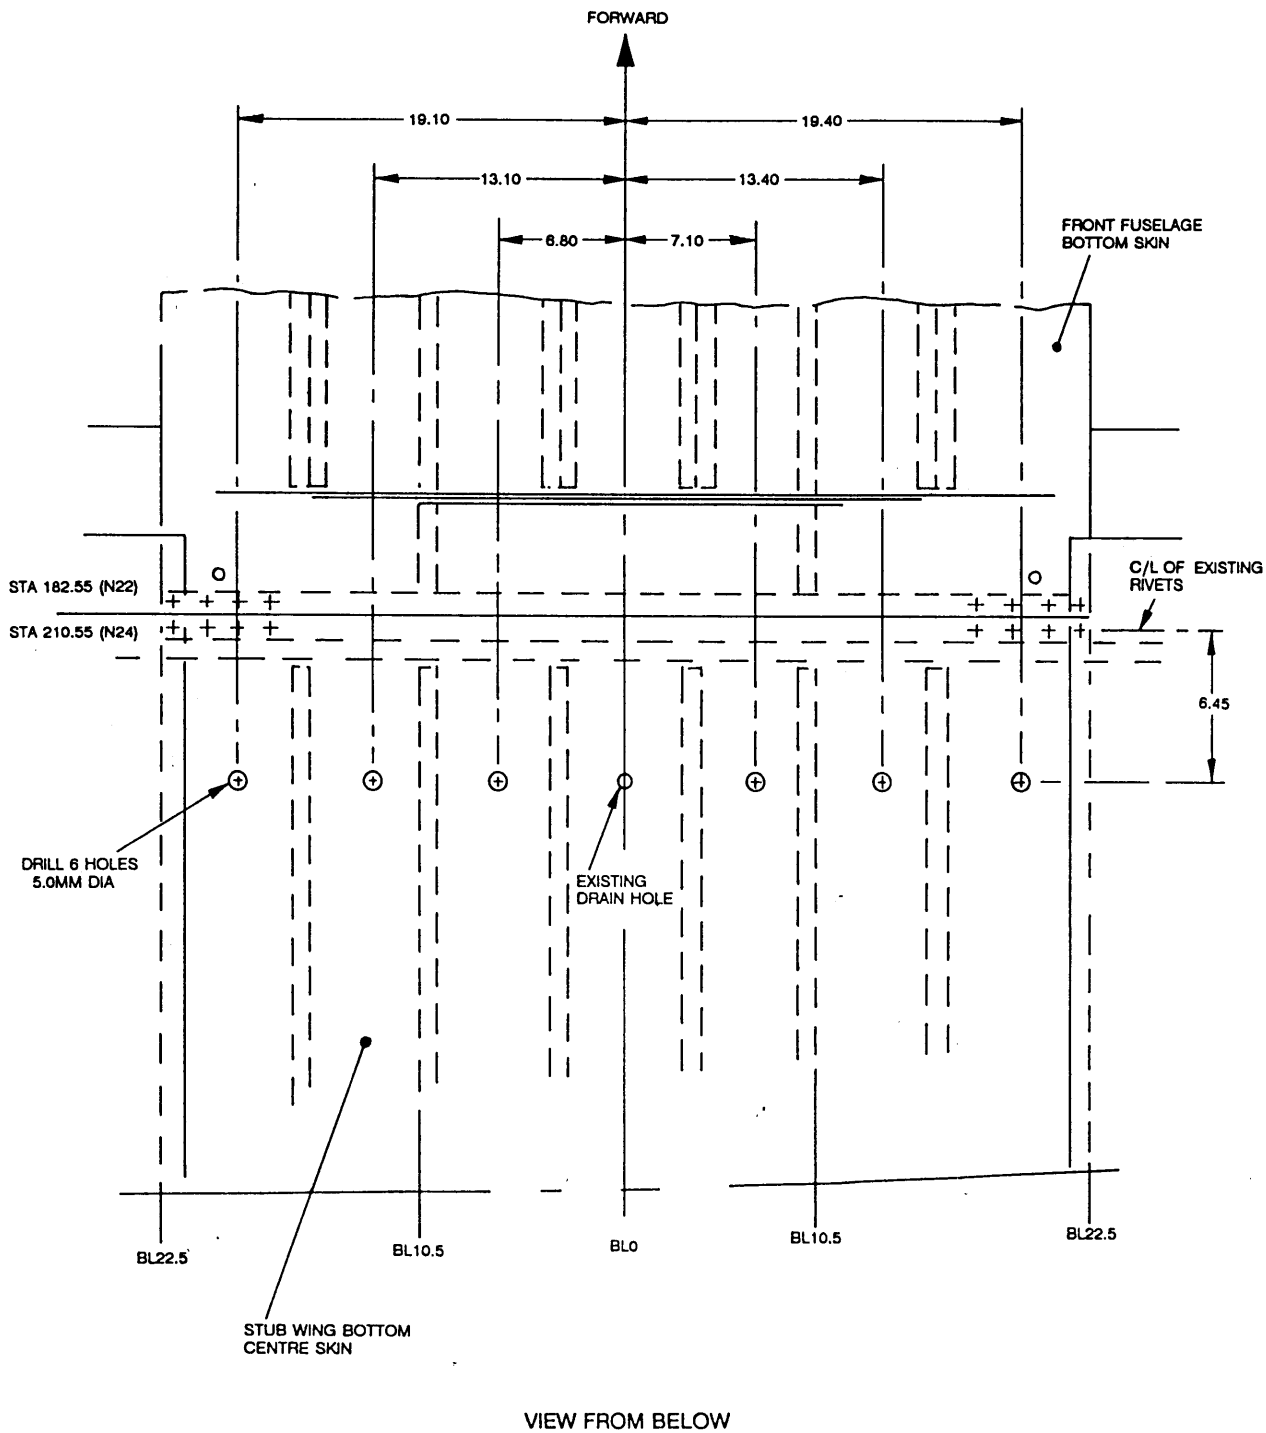
To prevent rainwater from collecting and causing burning of the landing gear relay contacts which results in landing gear malfunction.

Position of Additional Drain Holes
Figure 1

- A. Referring to Figure 1, mark positions for six additional drain holes.
- B. Using a 5.0mm dia. drill, drill out the six holes. Deburr holes and clear all swarf from area.
- C. Touch up base metal with Alodine 1200S, epoxy prime and paint to suit aircraft colour scheme.
