SB-GA8-2005-23

Service Bulletin

Forward Cargo Door Slide

All GA8 serial numbers.

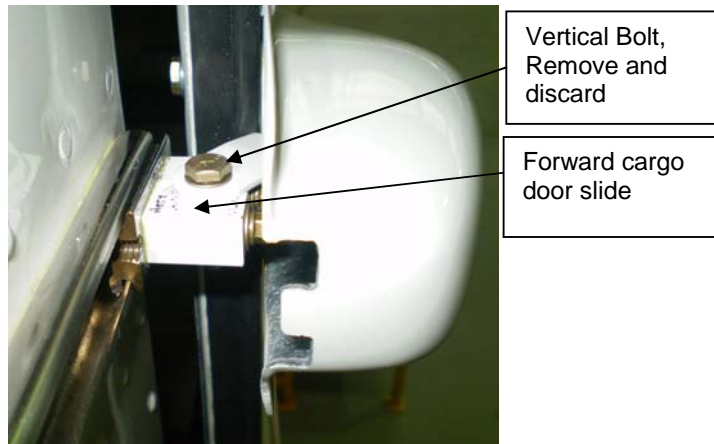
1. Open the door handle so that the door swings out to gain access to the Forward Cargo Door Slide Assembly, see Figure 1 below.

Figure 1: Forward Cargo Door Slide with door swung open.

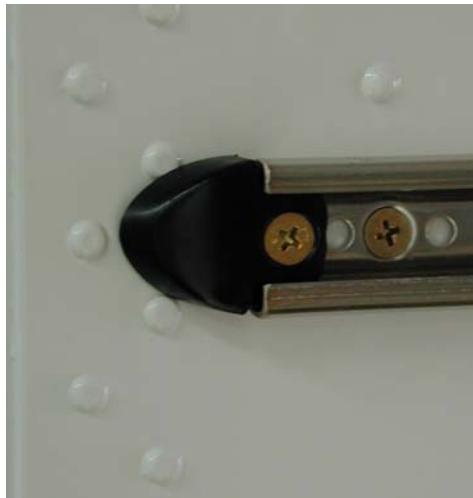
2. Remove the Forward Cargo Door Slide, by removing the vertical bolt and sliding the slider out of the track. On earlier versions of the Airvan it would be necessary to remove the Nylon Track End as shown in Figure 2 below to be able to remove the slider.

Figure 2: Nylon Track End

6. Reinstall new slider assembly and refit the Nylon Track End if it was removed.

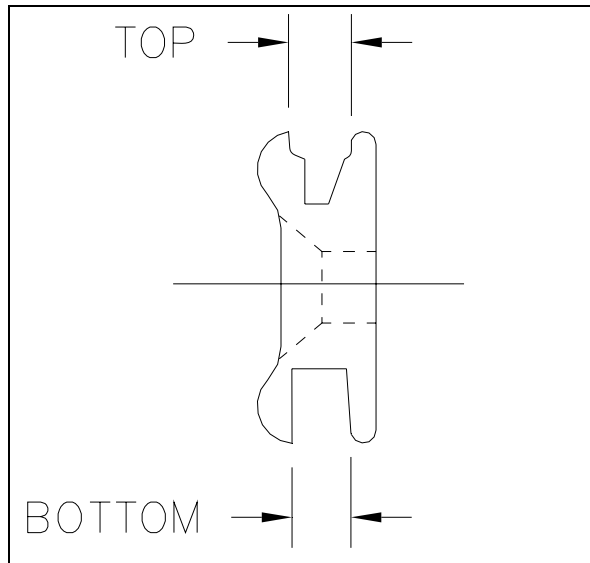
3. Figure 3 below shows how a worn part normally looks and where to measure the groove width. The TOP and BOTTOM profile differs on a worn part and as such both the top and bottom slide grooves are to be measured with a calliper.

Figure 3: Worn slider indicating where to measure.

4. Measure the groove width and if the groove is wider than 0.145" at any point along the slider or if the part is cracked or excessively worn a new slider, Item 1, must be fitted.
5. Irrespective of Item 1, Items 2 to 7 **MUST** be fitted as shown in Figure 4 and listed in Table 2 below.

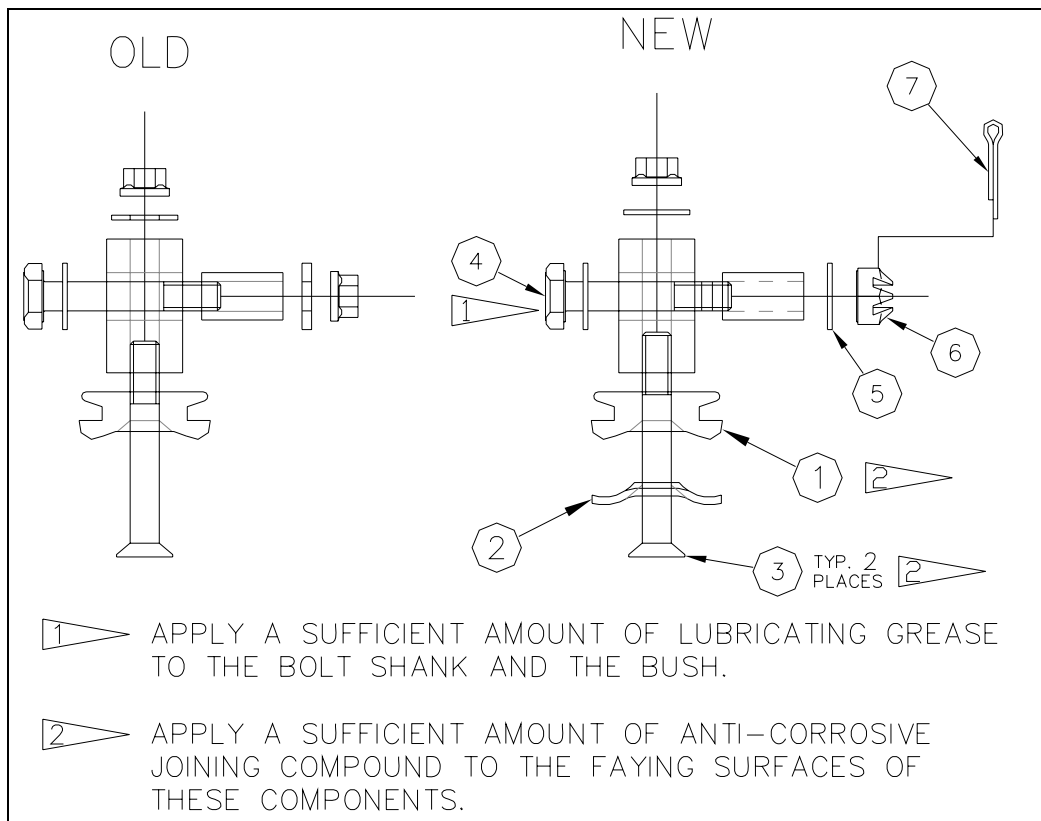
Figure 4: Old (left) and New (right) Forward cargo door slide.

ITEM	OLD ASSEMBLY	NEW ASSEMBLY	QTY
1	GA8-521022-149	GA8-521022-149 (If old part is worn)	1
2	-	GA8-521022-151	1
3	MS24694-S64	MS24694-S65	2
4	AN3-10A	AN3-11	1
5	AN960-10	AN960-10L	1
6	MS21042-3	AN310-3	1
7	-	MS24665-132	1

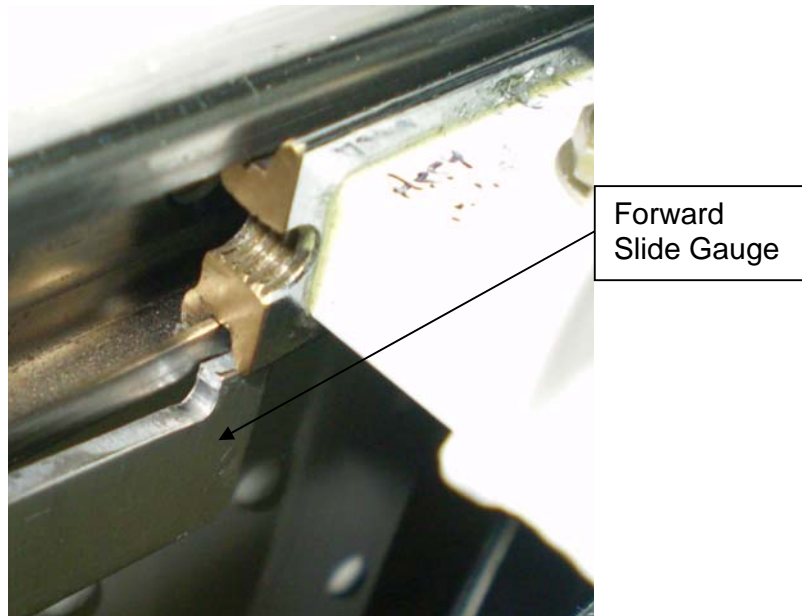
1. Open the door handle so that the door swings out to gain access to the slider (see ACTION 1, Para 1)
2. Try to insert the Forward Slide Gauge (Item 8, Table 1) between the slider and the track as shown in Figure 5 and Figure 6 below. Standard Feeler gauges made up to 0.098" (0.023"+0.024"+0.025"+0.026") may also be used.

Figure 5: Checking with the Forward Slide Gauge (all four corners require checking)

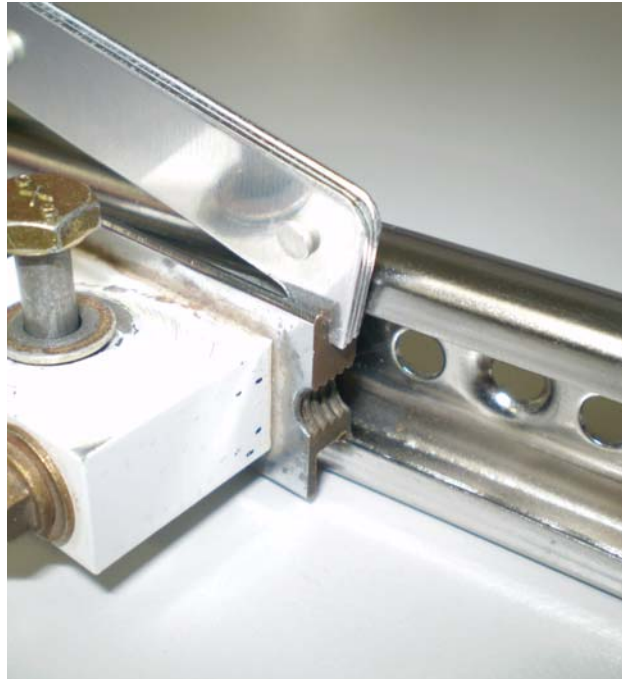
**Figure 6: Forward Slide Gauge inserted between the slide and track, indicating a worn part.
(Removed from aircraft for clarity only, checking can be done while installed)**

3. If it is possible to fit the Forward Slide Gauge or feeler gauge between the track and slider (as shown in Figure 6 above) at any of the four corners carry out ACTION 1 Para 2 to 4.
