ALERT SERVICE BULLETIN

FLIGHT CONTROLS — RUDDER CONTROL LEVER SHAFT

ANMD-27-51

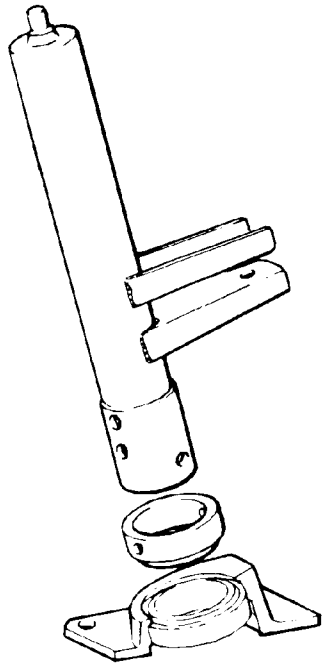
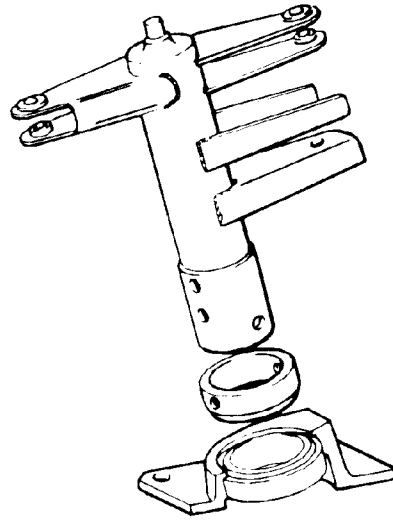
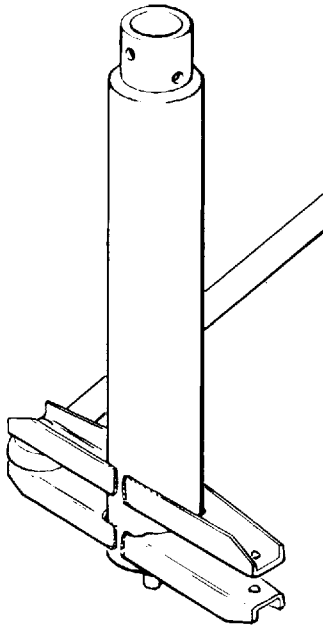
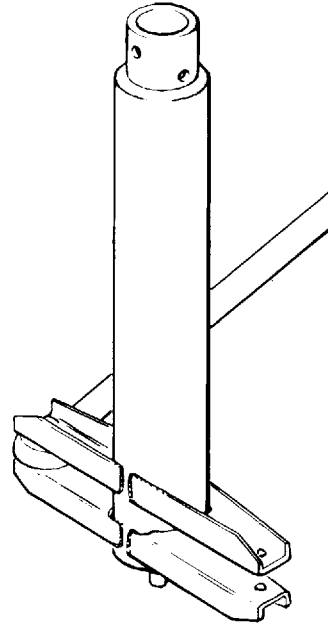
Since the introduction of Alert Service Bulletin ANMD-27-23, a recent failure of an upper control lever shaft (P/N 1/N-45-1103) has occurred. The purpose of this Alert Service Bulletin is to introduce an initial inspection followed by on-going inspections of all the rudder control lever shaft joints until a terminating modification can be made available. All failures have occurred during ground operations and nosewheel steering/rudder loads are now considered to be the primary cause.

Both upper and lower rudder pedal control lever torque shafts are subjected to an initial inspection (in-situ or removed) for signs of cracking at the lever weld joints and for adequate lever plate thickness, followed by a repeat inspection interval. The repeat inspection includes a requirement for an additional inspection after certain operating conditions occur involving the likelihood of abnormal rudder pedal loads.

- (a) Remove the rudder pedal and control column guards in the flight compartment to gain access to the rudder control lever shafts.
- (b) Carry out a dye penetrant inspection of rudder control lever shafts P/N's 1/N-45-1102 or 2/N-45-1102, whichever is fitted, (LH and RH), 1/N-45-1103 and 1/N-45-1104 (Ref IPC Chap 27-20-02 Figure 4 Item 6, (2 off, 1 L/H and 1 R/H), also items 10 and 11) for cracking in the area of the welded joints between levers and the tubular shaft, paying particular attention to the ends of the welds at the lever flanges (Ref Fig 1). If the lever shafts are found to be cracked they shall be removed and replaced by new or serviceable items in accordance with Nomad MM Chap 27-20-09 before further flight.

- (c) Measure and record the thickness of all lever shaft side plates on items P/N's 1/N-45-1102 or 2/N-45-1102, whichever is fitted, (LH and RH), 1/N-45-1103 and 1/N-45-1104. Record dimension and condition of each item, on the Recording Page attached to this Alert Service Bulletin and forward to ASTA.

- (d) If lever shaft side plates are less than 0.050 in thickness, contact ASTA before fitment or further flight.
- (e) New lever shafts side plates should be measured before use. Any item found to be less than 0.050 in should not be used. If spares are not available contact ASTA for advice.
