Nomad

SERVICE BULLETIN

TRANSMITTAL LETTER
FOR
SERVICE BULLETIN NMD-55-5

**HORIZONTAL STABILISER — VERTICAL FIN AND TRIM TABS —
STRUCTURAL AND OPERATING MECHANISM INSPECTION
AND MODIFICATION**

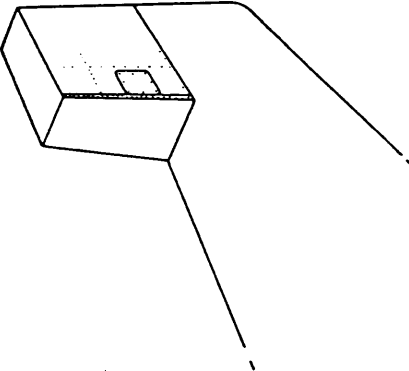
VIEW ON L.H.S. AIRCRAFT (DORSAL REMOVED)

- Part 3.
- a. Rework left side of stub fin to provide access panel (Ref. Fig. 1).
 - b. Remove countersunk rivets where side skins attach stub fin forward spar (on both sides of fin). Attach reinforcing strips to rivet line of side skins at stub fin forward spar using rivets as detailed in Fig. 1.
 - c. Using torch and mirror carry out visual inspection of internal stub fin structure. In particular inspect vertical stringer emanating from rudder lower hinge doubler.
 - d. Vertical stringers: Replace or repair in accordance with Structural Repair Manual 53-10-11 Fig. 2.
 - e. Manufacture and install "Z" stiffener as detailed in Fig. 2.
