# Service Bulletin

Horizontal Stabiliser Trim Indicator Inspection

GA8 serial numbers GA8-00-004 through GA8-06-100.

Document: Service Bulletin SB-GA8-2006-35

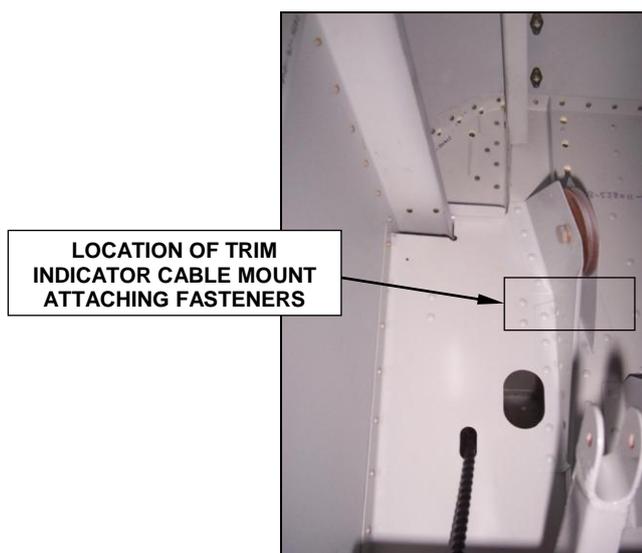
Figure 3 (View A) Looking Aft

- 1.4. If deflection of the trim indicator cable mount occurs with the horizontal stabiliser trimmed to the full leading edge down position, an inspection for cracking and other damage of the bulkhead and cable mount is required. To adequately inspect the bulkhead (location indicated in figure 2), remove the large access panel on the lower tail cone skin and inspect the forward face of the bulkhead around the trim indicator cable mount attaching fasteners (refer to figure 3). If defects are found, contact Gippsland Aeronautics. If no defects are found, perform the adjustment to the trim indicator cable in accordance with section 2 of this Service Bulletin (Rod End Adjustment Procedure).
