SB-GA8-2016-163

Service Bulletin

Horizontal Stabiliser Attachment Area Inspection and Reinforcement

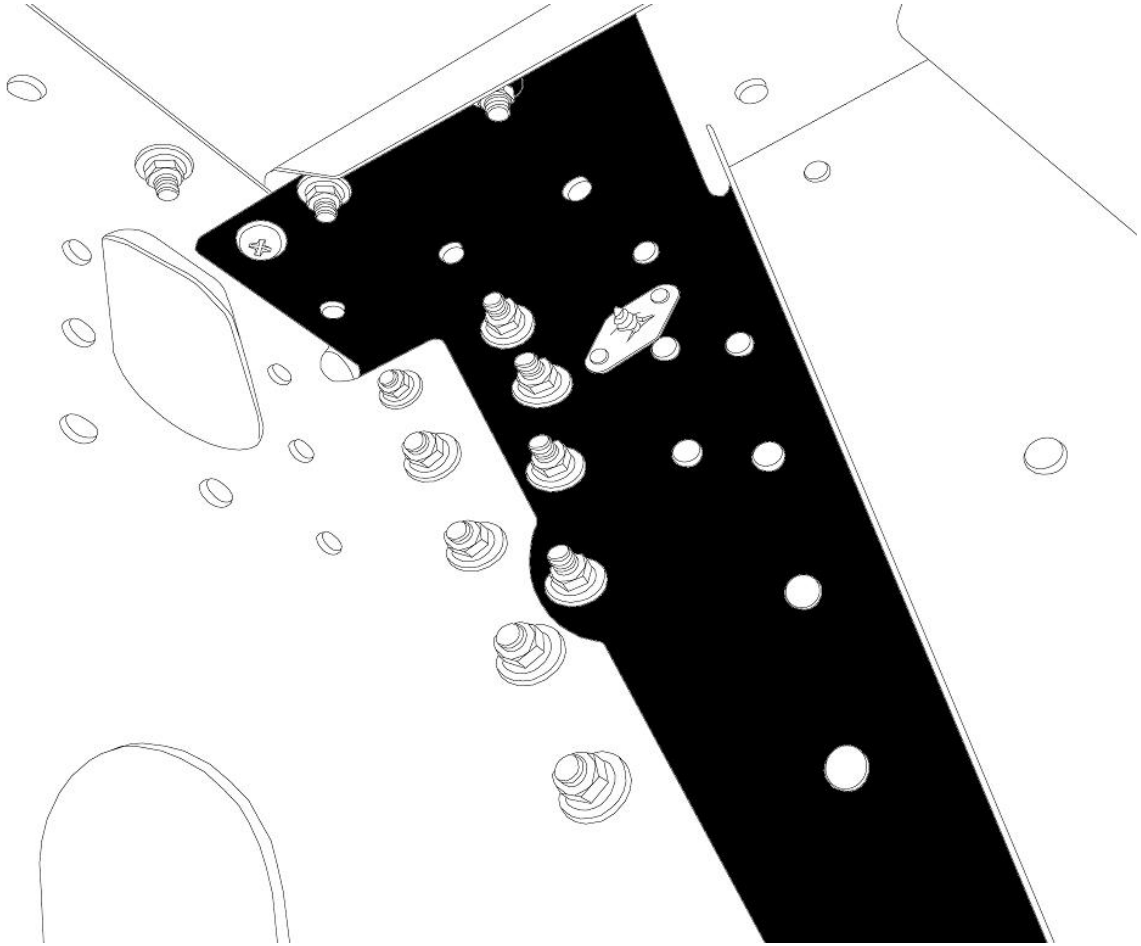
Figure 1 – Original Production Configuration of LHS Interior Aft Skin Doubler
(Doubler highlighted)

An improvement to the assembly sequence of the Tailcone Skin, Aft Bulkhead and Interior Aft Skin Doublers has been implemented which improves the fit of the Elevator Travel Stops. Figure 1 and Figure 2 highlight the difference: the Doubler flange is either above or below the top Aft Bulkhead flange. Refer to these images when completing **Part E** of this Service Bulletin.
