**SB-GA8-2014-116**

## Service Bulletin

Installation of a Secondary Starter Solenoid

All GA8 & GA8-TC 320 aircraft

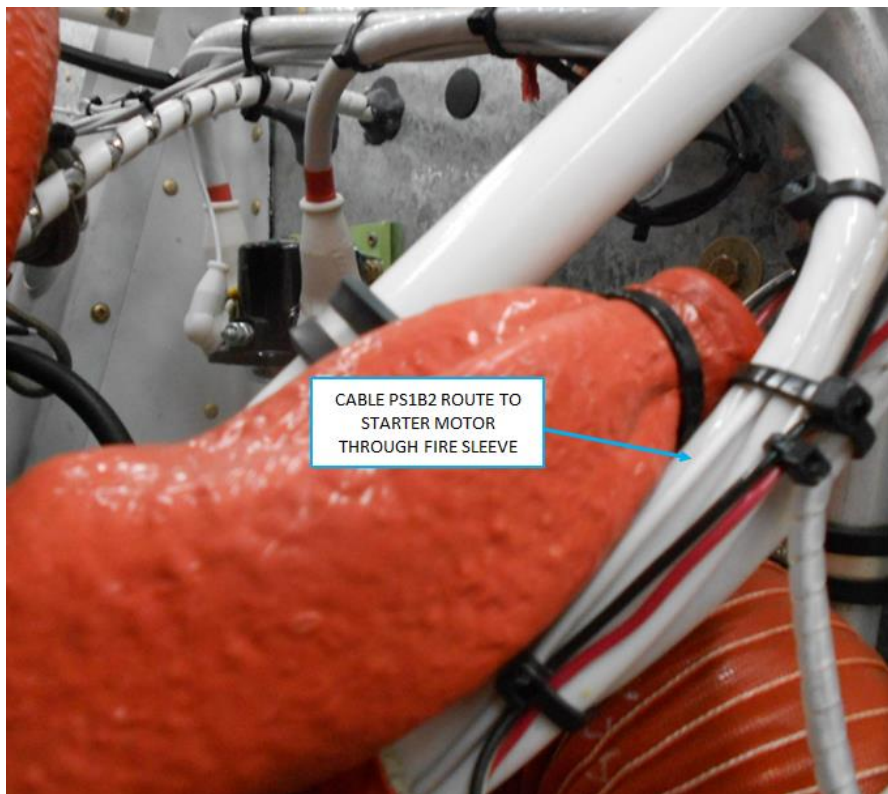
**Figure 5: Cable Routing, View Looking Inboard on LHS**

- 2.7. Using the supplied 55" length of Wire AWG White ETFE (MS22759/16-2-9), crimp the terminal ring red (324112-0) and heat shrink the sleeve to both ends. Identify the cable PS1B2.
- 2.8. Slide the cable PS1B2 assembled in step 2.7 through the fire sleeve forward to the engine starter motor and attach with the hardware retained in step 2.2. Pass the other end through the supplied terminal nipple (MS25171-3S) and attach to the outboard terminal of the solenoid with the hardware supplied. Slide the terminal nipple into position. For routing details see Figure 4 & Figure 5.
- 2.9. If installing a new starter at this time, verify freedom from rubbing or chafing of looms with adjacent equipment or structure. In particular, verify that that wiring connected to the starter motor is not chafing against the second alternator if installed.
